Analysis of Daylight Control in a Chateau Interior

Abstract: Assessment of daylighting in the residential hall of a historical chateau is presented. The evaluation is based on both the daylight measurement and simulations. Illuminance levels in the interior were controlled in accordance with requirements for light exposition of light sensitive materials. Valuable paintings and claddings as well as wallpapers and furniture upholstery in the hall are extremely light sensitive and they need to be protected from light damage. The daylight measurements and simulations give an overview of daylight conditions in the annual profile for clear sky conditions and for different levels of window shadings.

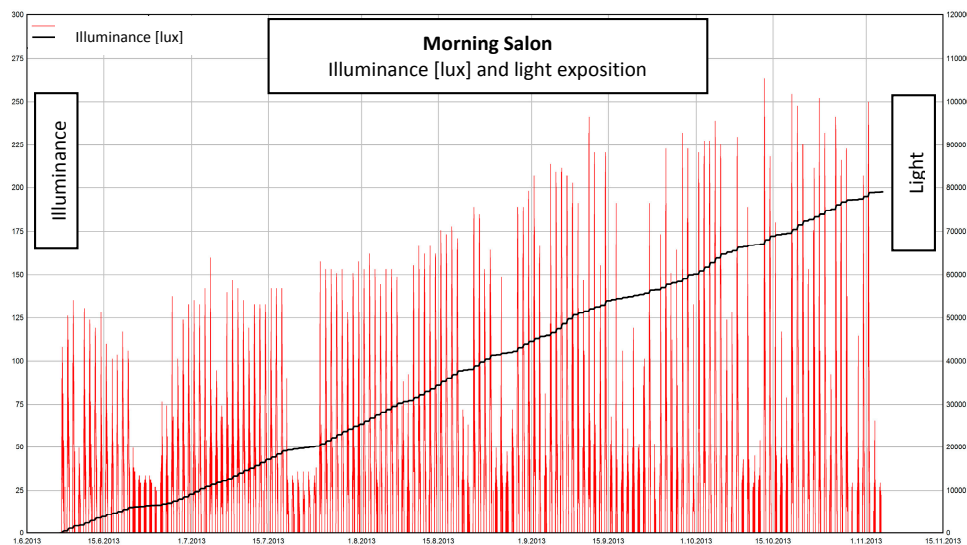
Illuminance data processing brought important information. Light exposure monitoring in October 2013 showed extremely high light exposition of about 80,000 luxhours [24] (Figure 12).

Figure 12. Graph from the data from light measurement in the Morning Salon—illuminance [lux] and light exposition [luxhours] monitoring interval from July to October 2013 [24].

Reasonable explanation of such high values seems to be negligent solar shading activation by the staff. This was confirmed by a test using Light Check light dosimeters, and after a 90-min time exposition very high values were found at the window jambs. High light exposition might be very negative for light-sensitive materials and cause serious and irreversible change and deterioration of quality of the materials such as paintings or upholstery. This finding has led to demands for detailed study of the daylight level in the Morning Salon under different conditions in the annual profile assessment.

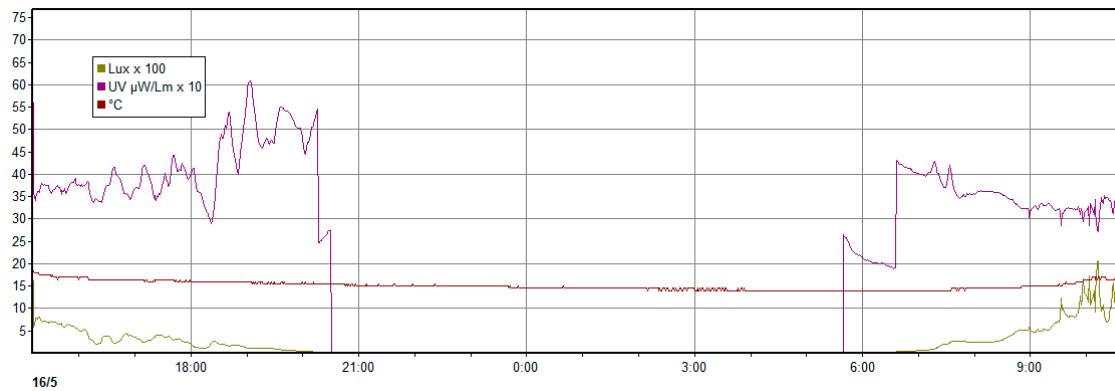
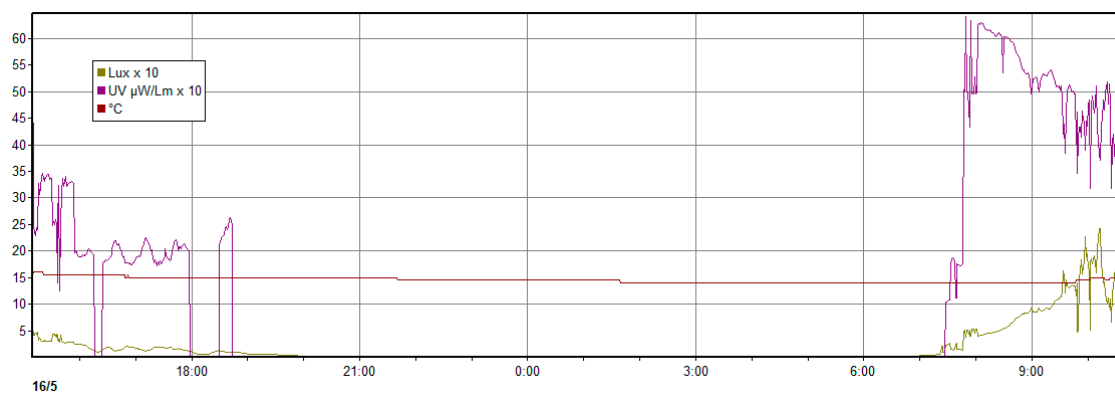
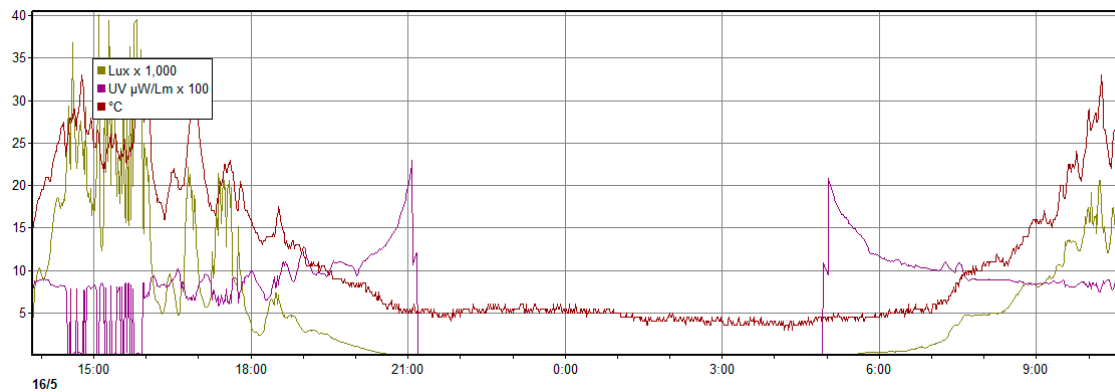
Results of the continual measurements of illuminance ($\text{lux} \times 1000$), UV radiation power and temperature are shown in Figure 14 for internal values at positions A and B as well as external measurements at position C. It is visible from the graphs that illuminance and temperature increase in the morning. Higher illuminance rise is from about 9:00. Afternoon illuminance is lower because of the salon windows' south-east orientation. The UV radiation power is greatest early in the morning at sun rise and in late afternoon during the sun set. It exceeds the limits of maximal permitted standards [25,26] $75 \mu\text{W}/\text{lm}$ [27] (Thomson, 1978) better $10 \mu\text{W}/\text{lm}$ [28] (Saunders 1989). It points to the fact that the Morning Salon windows should have solar shadings activated all the time in the morning and in the afternoon to protect fading and light damage of the salon interior.

Figure 14. Illuminance, UV radiation and temperature in the Morning Salon (monitored time from 16–17 May 2016).

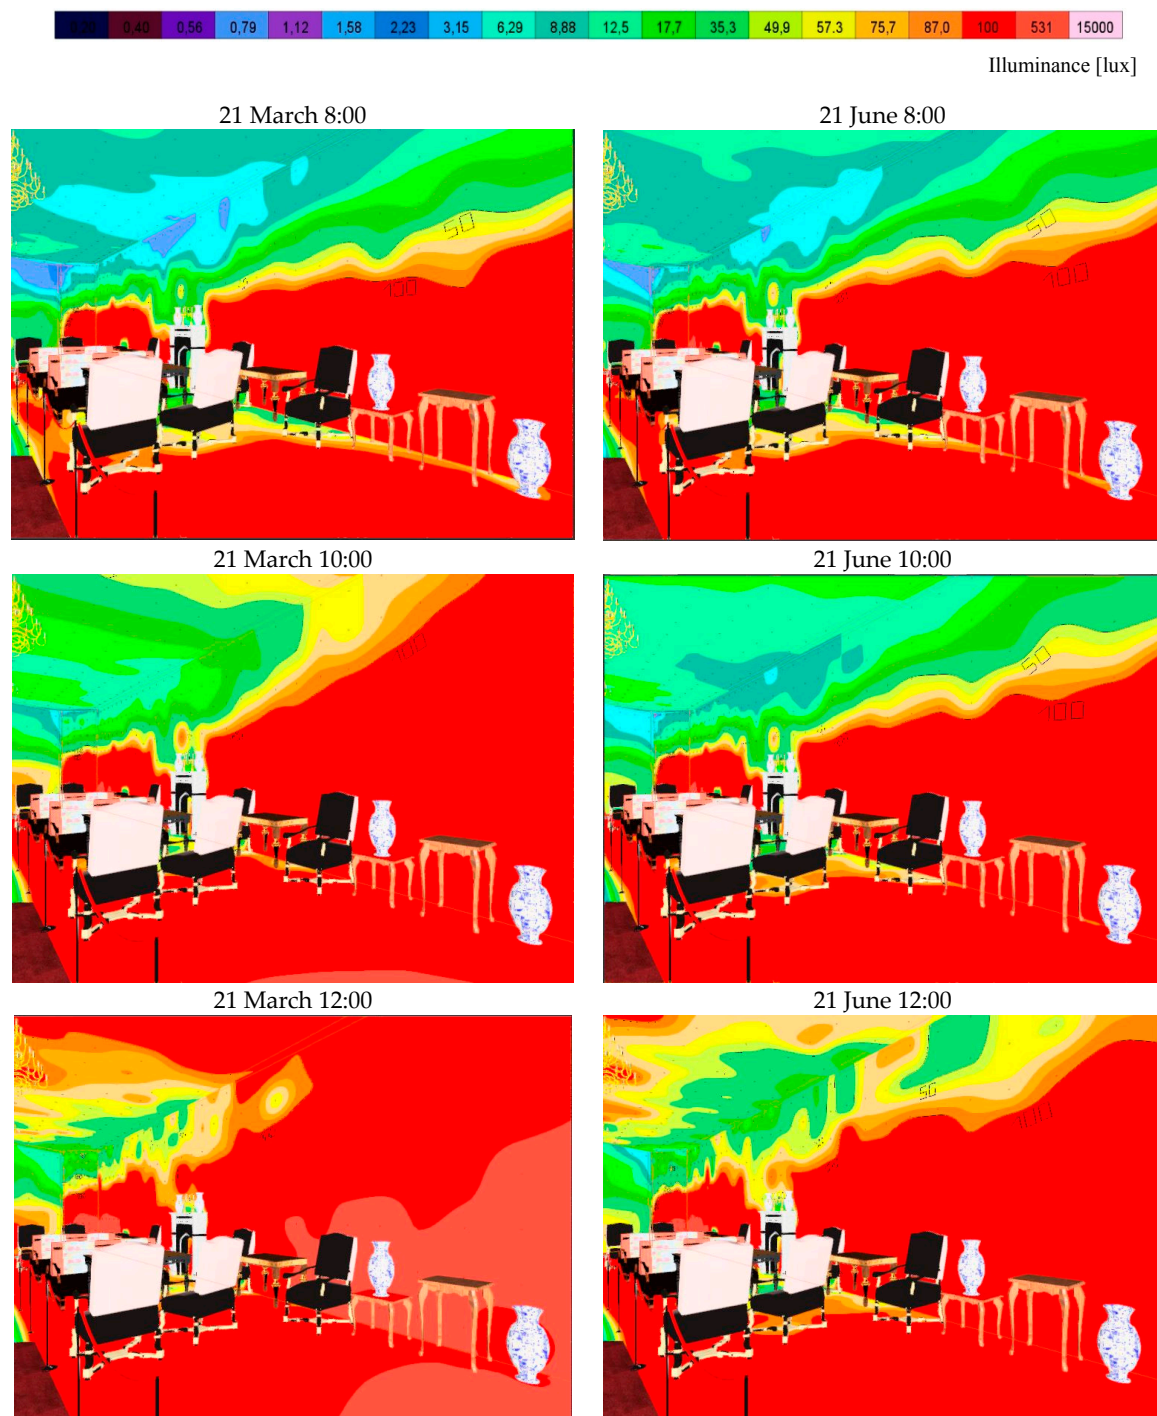
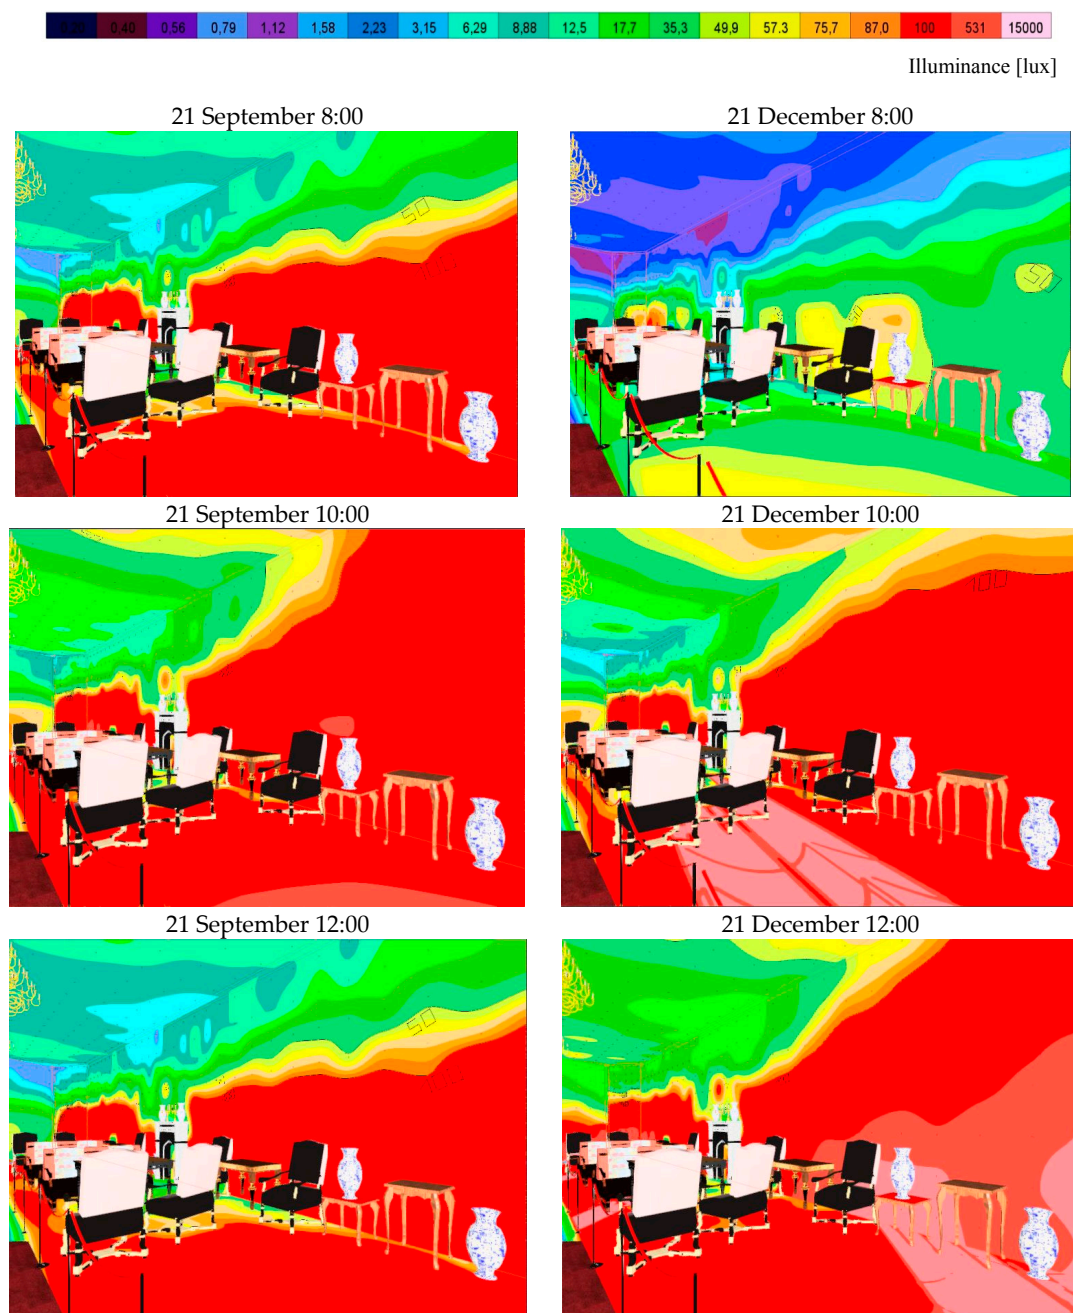
The false color schemes shown in Figures 16 and 17 give an overview of the illuminance in the viewed part of the salon. The light limit of 50 lux is shown in yellow; the orange part is for illuminance between 50 and 100 lux. The red color in the simulations means the places where illuminance level exceeds 100 lux. It means these parts are affected by very high illuminance, which is negative for the light-sensitive interior materials. It is obvious that the wide part of the wall with painting and floor and furniture in the morning time is exposed to very high light limits in case the windows are without shadings. The daylight simulations were completed for the variations with the window shading activation at 25, 50, and 75% (25% unshaded glazed area close to the window sill), simulated for noon (Figure 18).

Figure 16. View to the wall opposite to windows—illuminance (lux) levels for 21 March and 21 June.

Figure 17. View to the wall opposite to windows—illuminance (lux) levels for 21 September and 21 December.

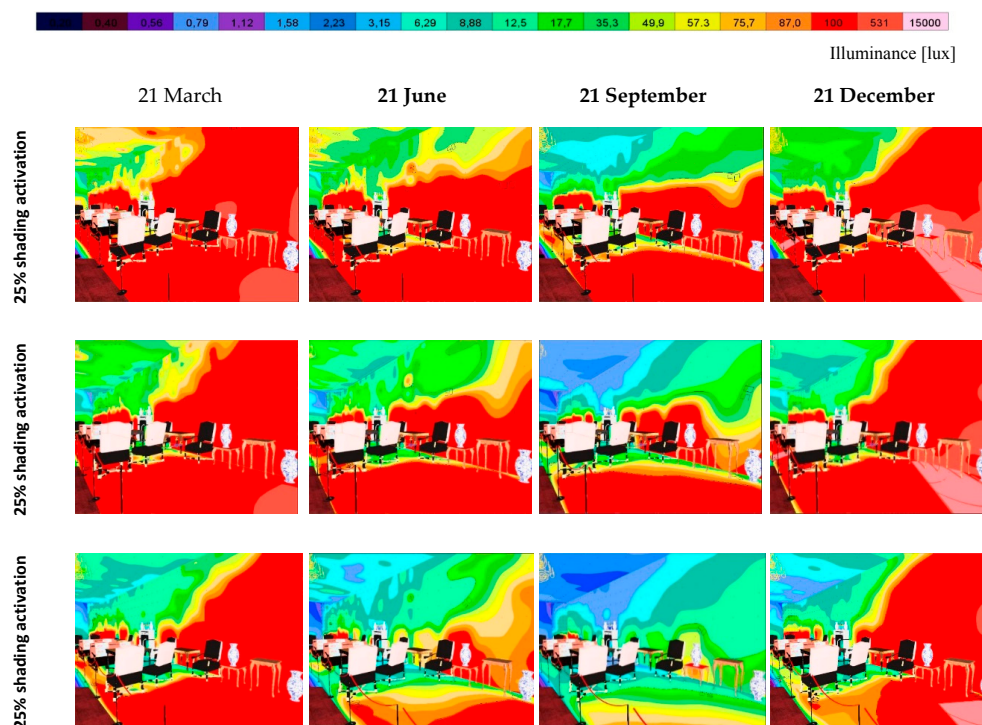
Figure 18. View to the wall opposite windows with shadings activation for 25%, 50% and 75%.

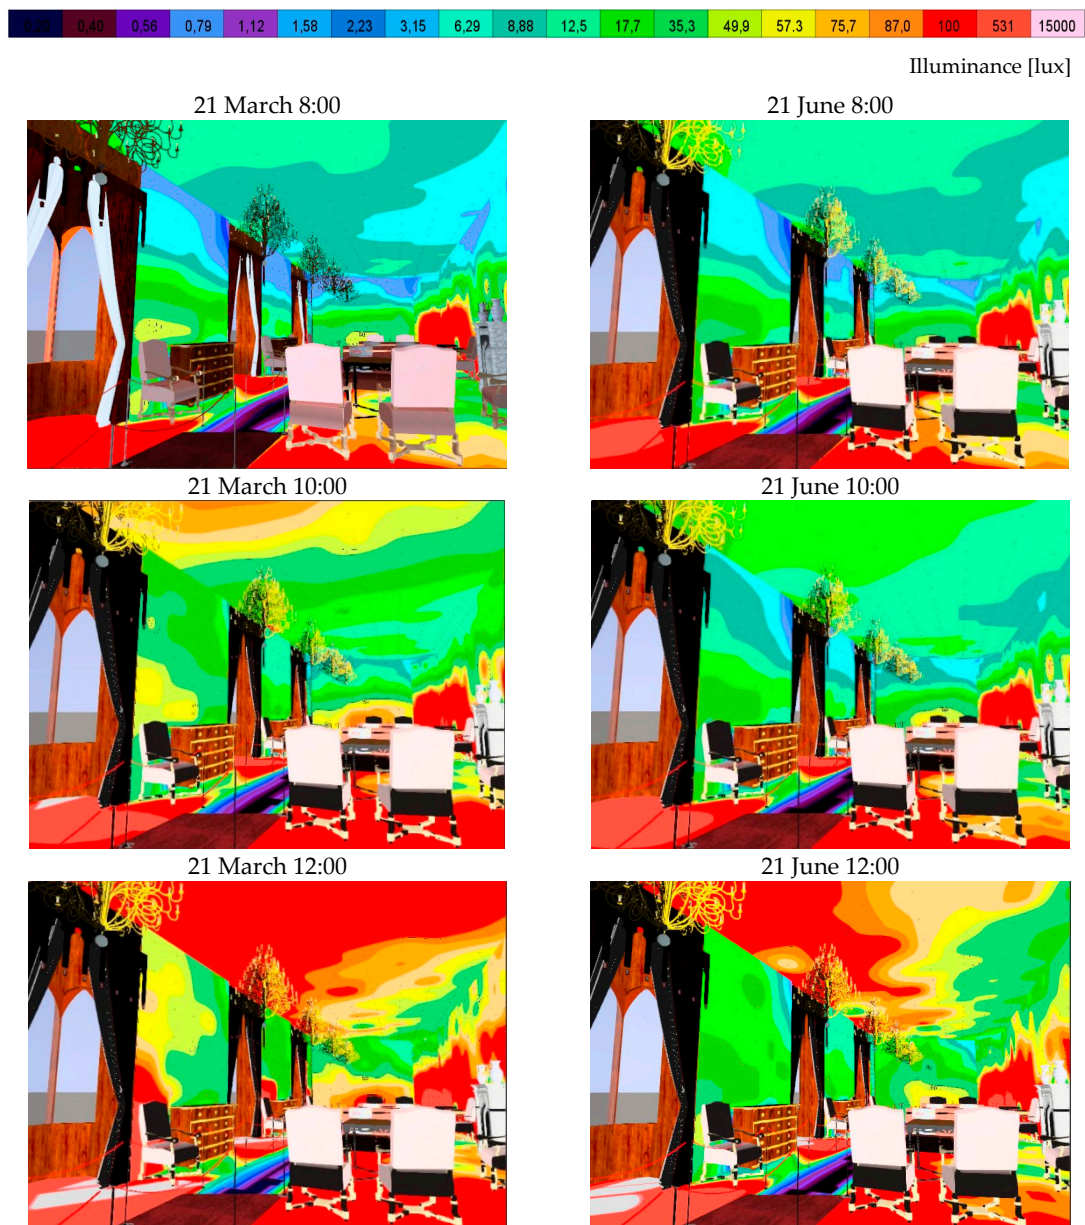
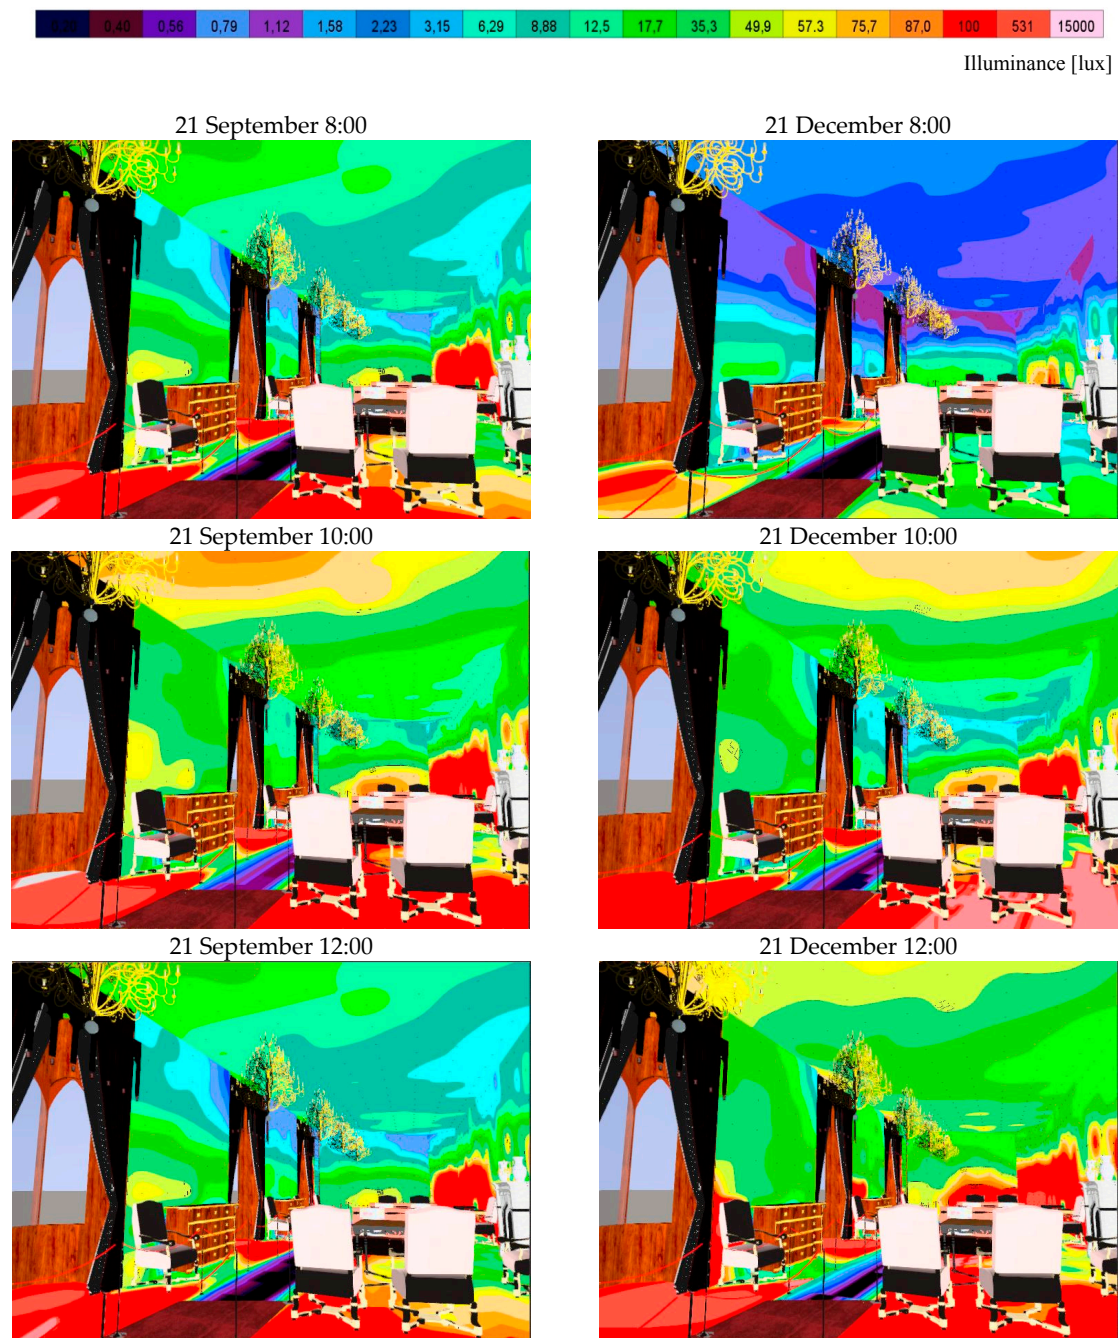
The simulations for the view to the windows shows that the high rise of illuminance is between 10:00 and noon. The floor area is highly affected. Ceiling soffit has increased illuminance level from March to June and between September to December. The view to the windows was also simulated for shading activation at 25%, 50%, and 75% (Figure 22).

Figure 20. View to window area—illuminance (lux) levels for 21 March and 21 June.

Figure 21. View to window area—illuminance (lux) levels for 21 September and 21 December.

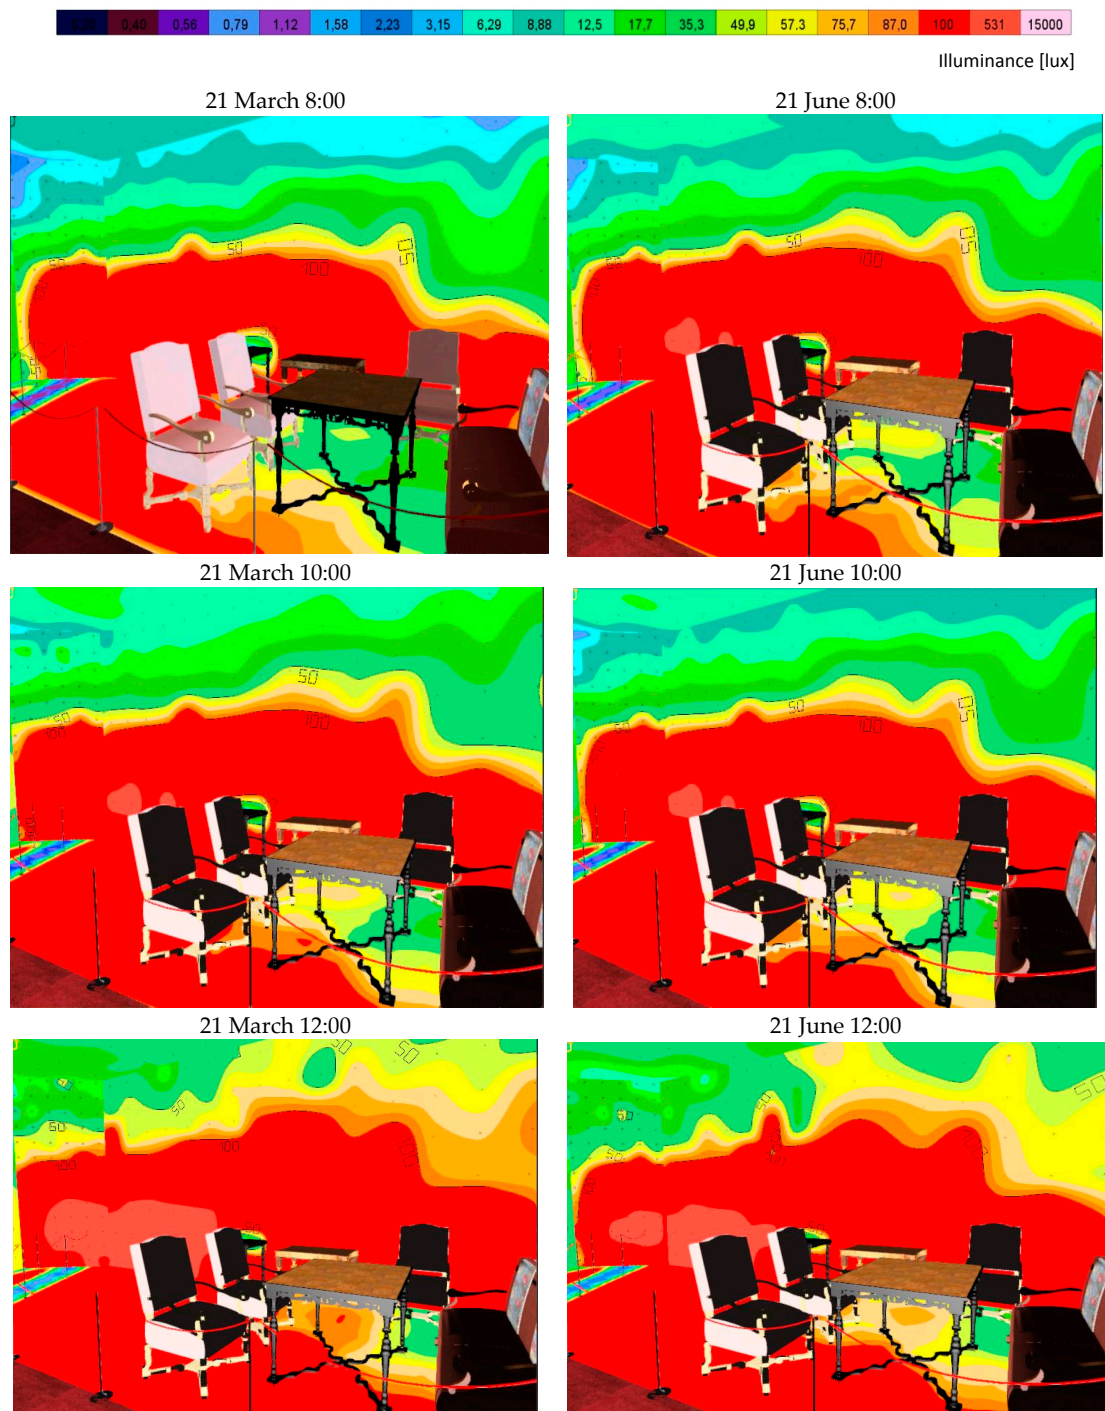
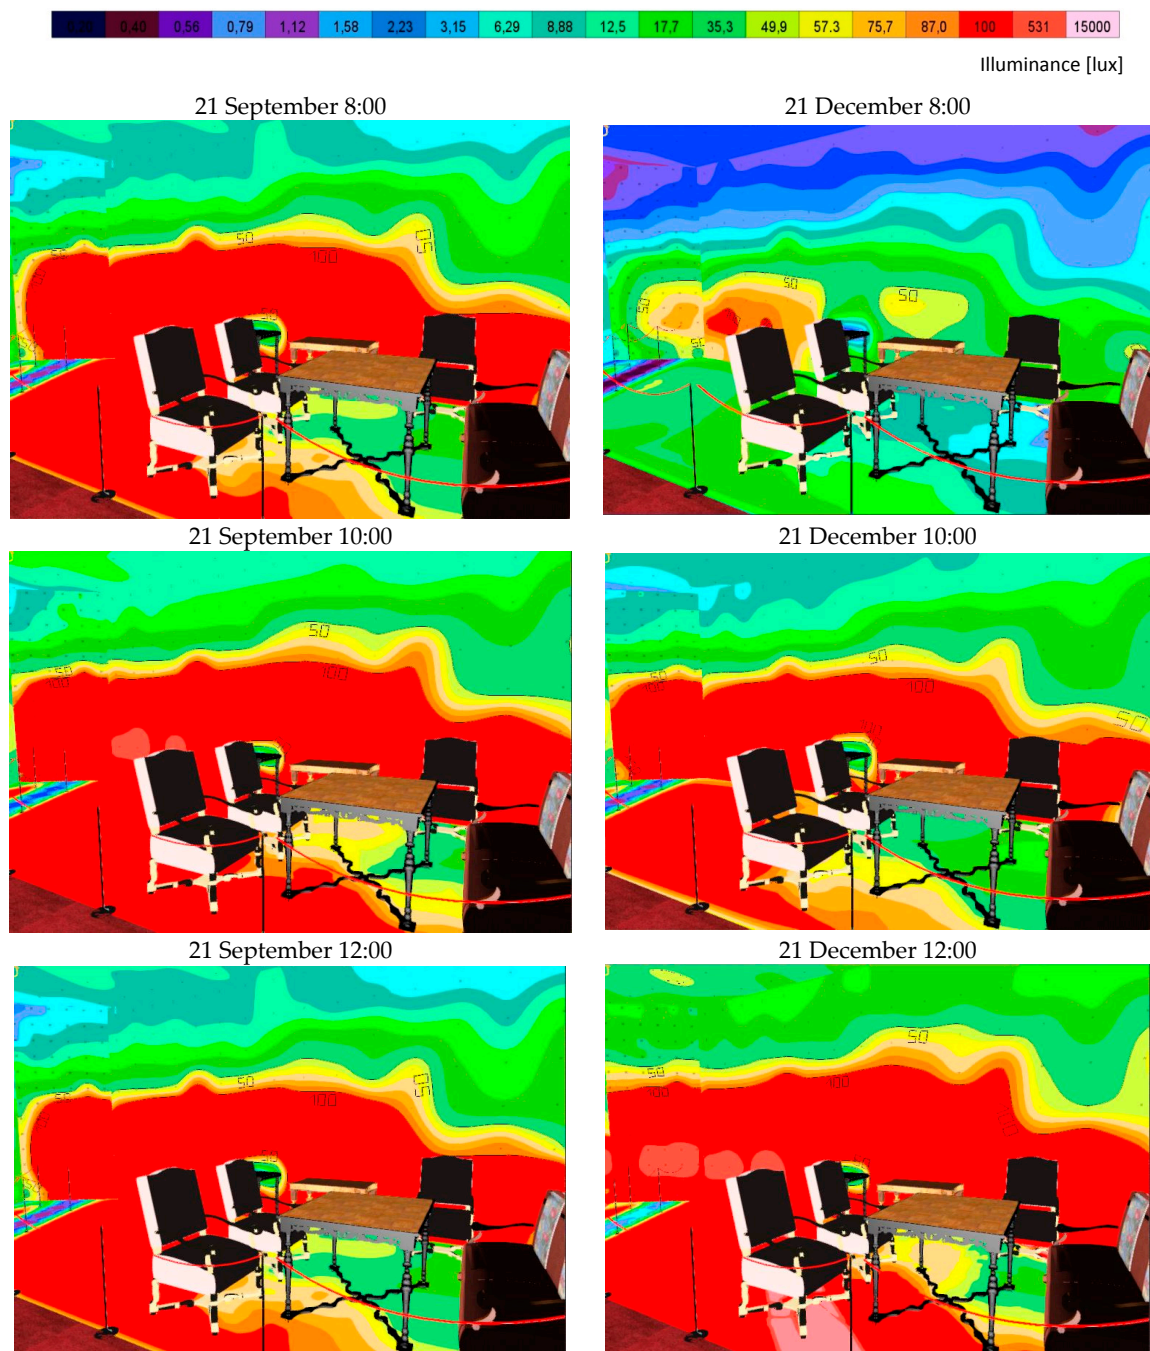
The area of the furniture location in the middle of the salon is all the time exposed to high illuminance level, as it is seen from the simulations in Figures 24 and 25. This is a problem influencing the quality of textiles of armchairs and sofa upholstery in the salon. The furniture area was also simulated for variations with the window shading activation for 25%, 50%, and 75% shown in Figure 26.

Figure 24. Furniture—illuminance (lux) levels for 21 March and 21 June.

Figure 25. Furniture—illuminance (lux) levels for 21 September and 21 December.

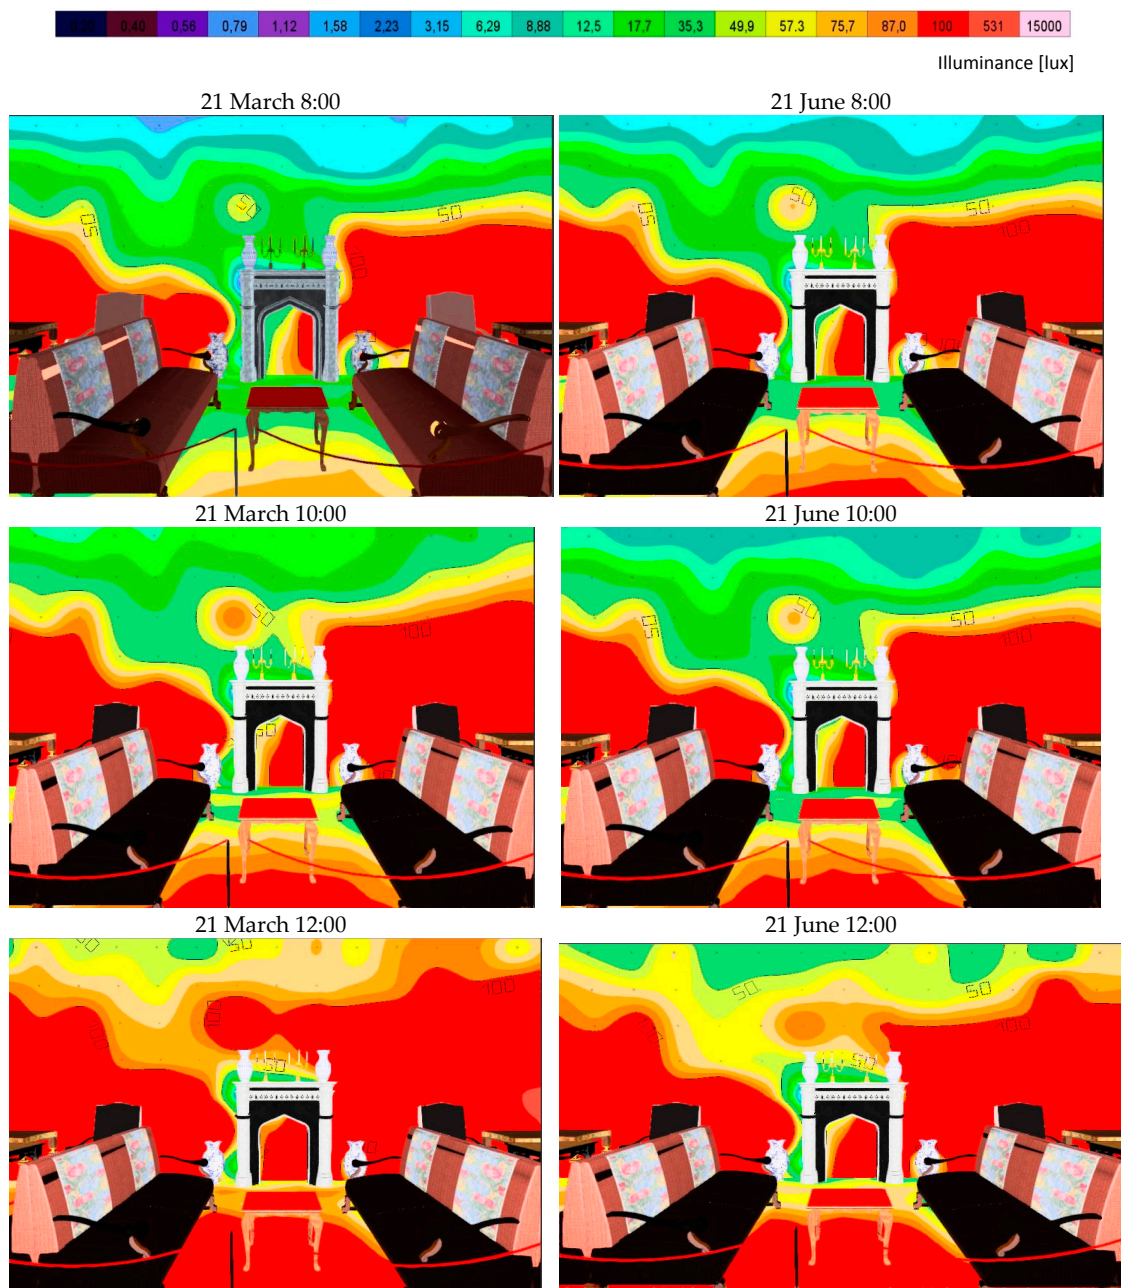
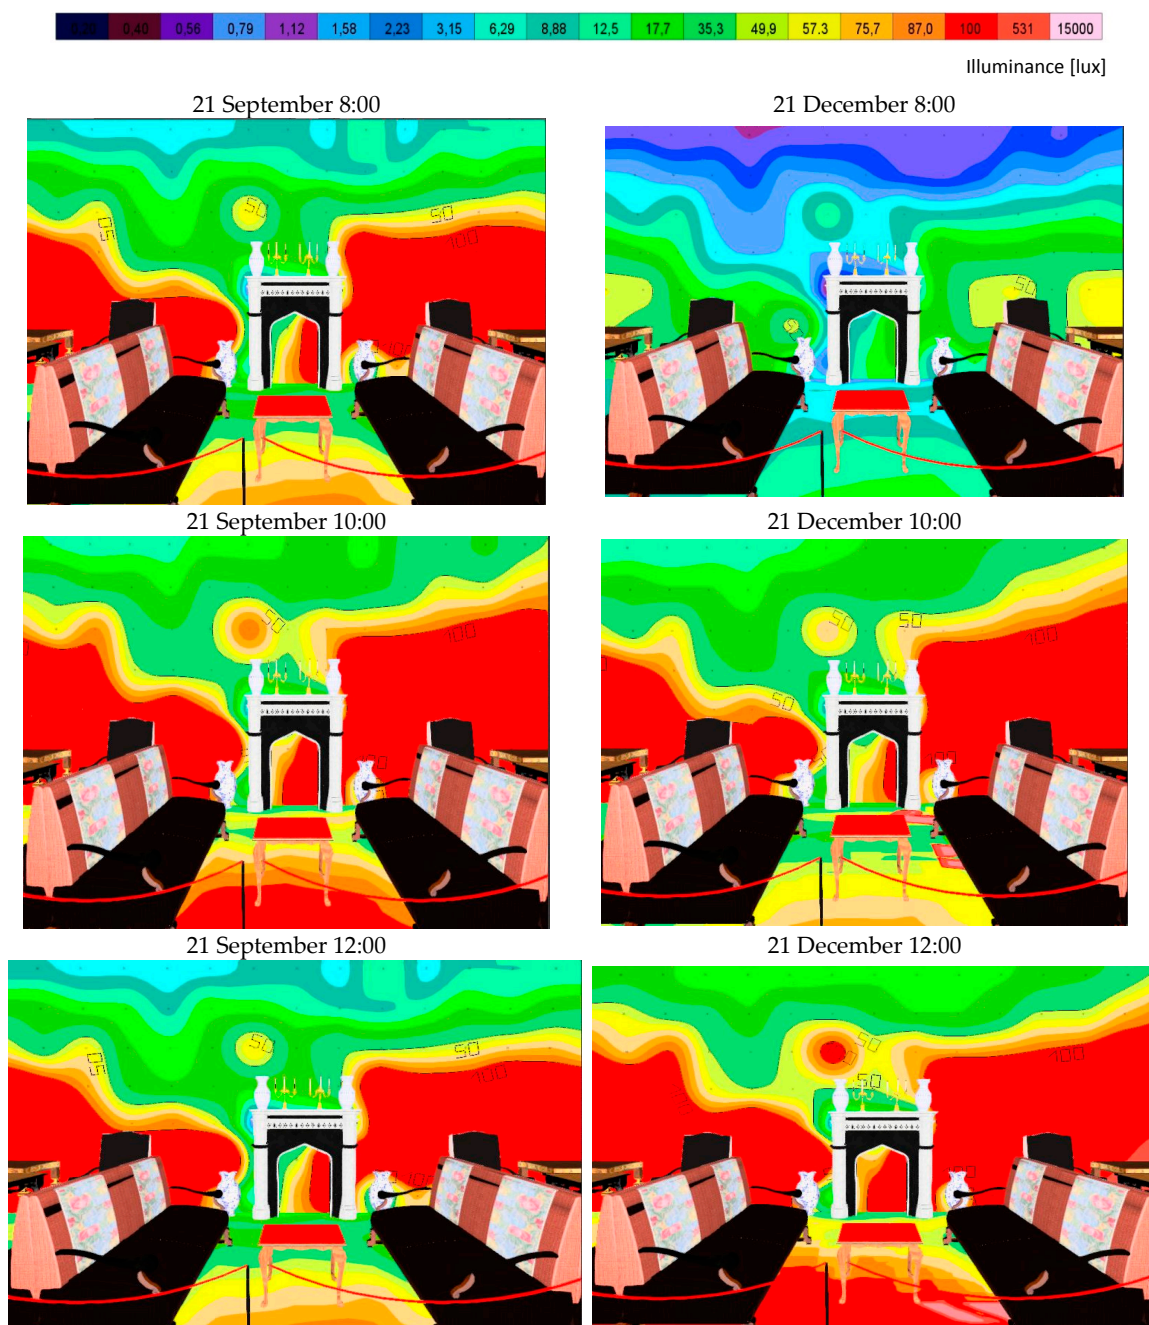
The area of the painting is overexposed for a substantial part of the year. It represents a high potential damage of painting degradation and color bleaching. The view of the painting was simulated for shading activation at 25%, 50%, and 75%, as shown in Figure 30. The light level on the vertical plane close to the painting (Figure 31) is shown in detailed evaluation in Figures 32 and 33.

Figure 28. View to the painting—illuminance (lux) levels for 21 March and 21 June.

Figure 29. View to the painting—illuminance (lux) levels for 21 September and 21 December.

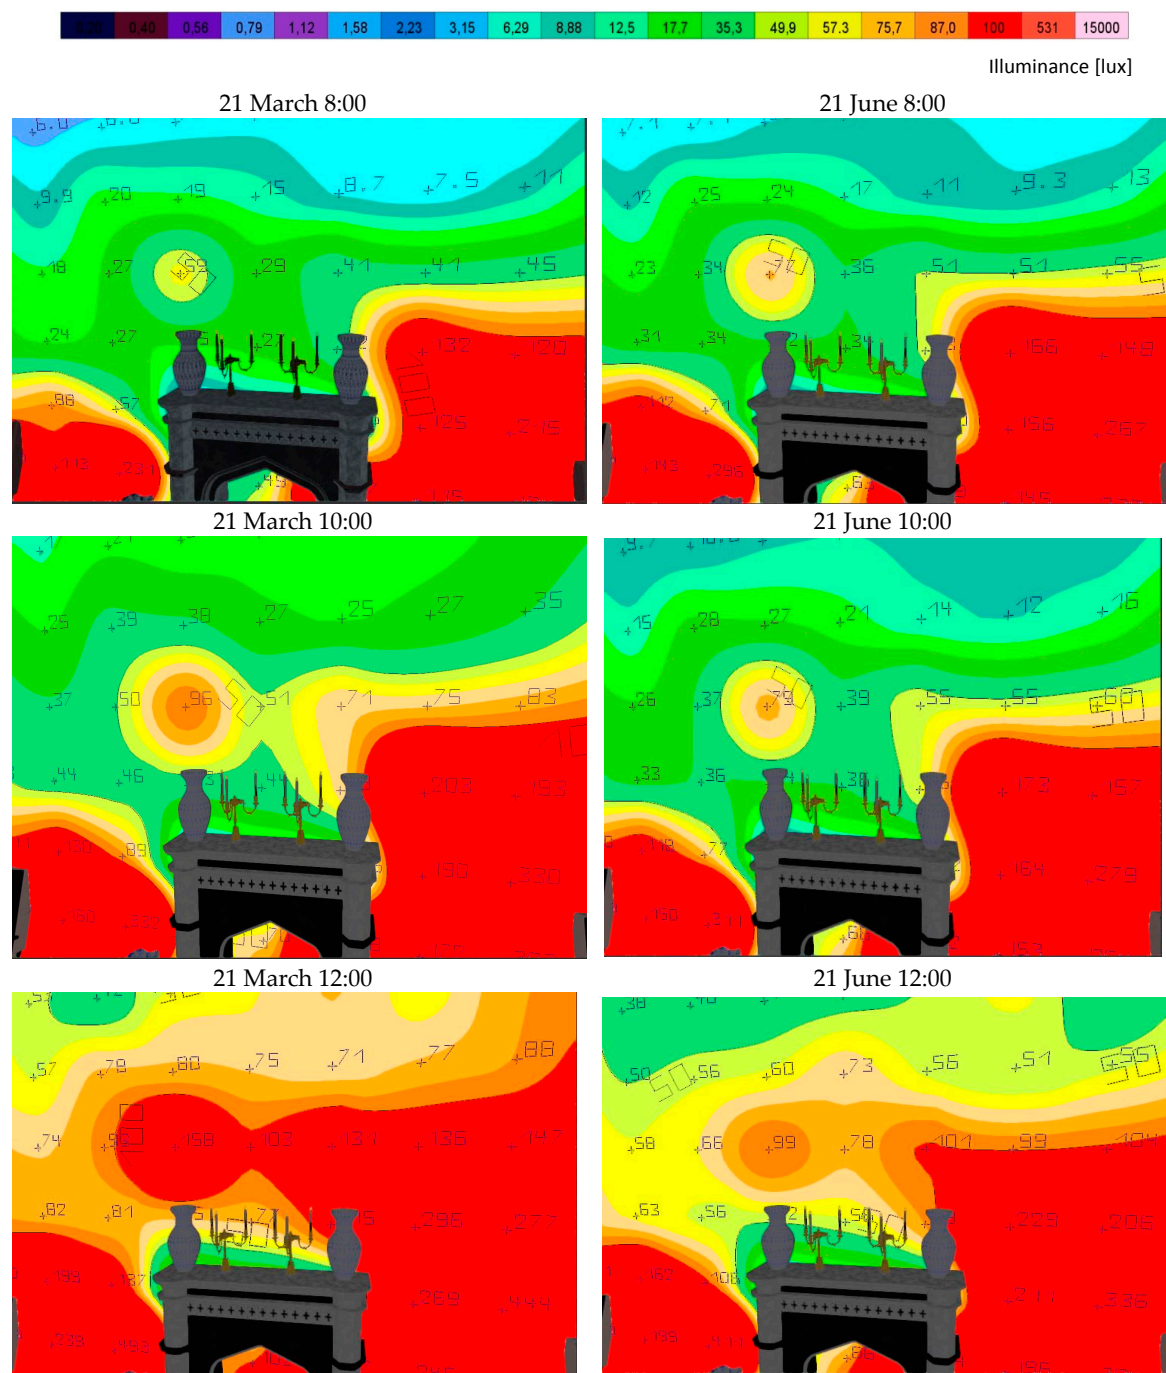
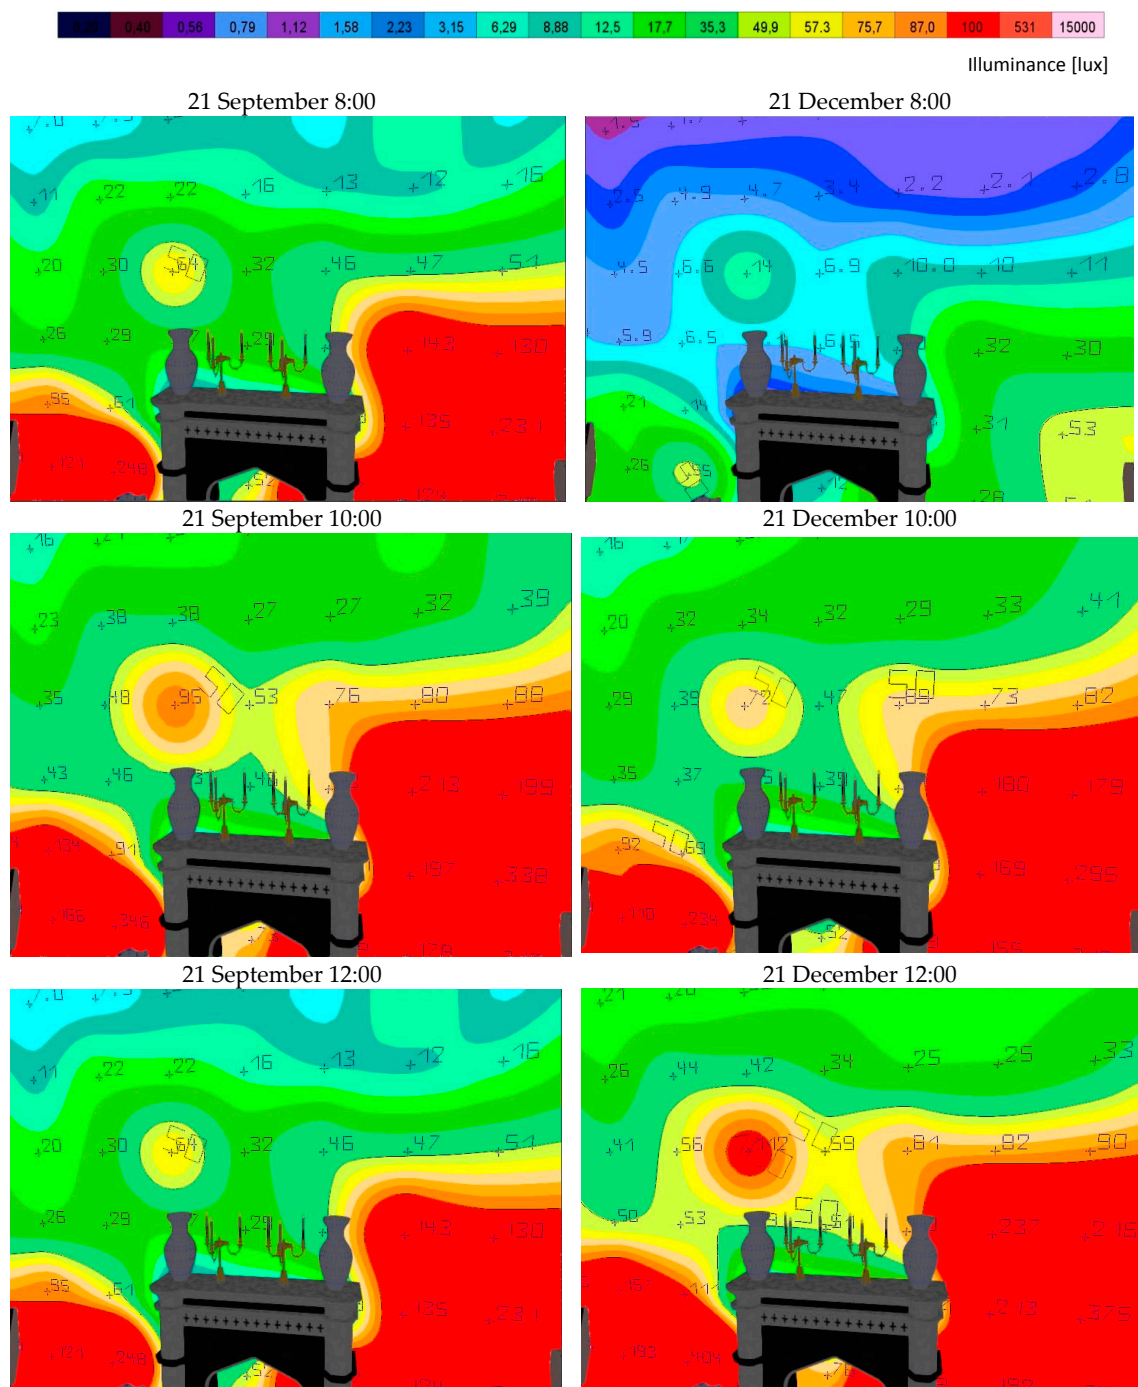
Figures 32 and 33 give an overview of the illuminance level of a part of the vertical plane close to the painting is over the 50-lux limit all year except in the early morning time in December. The painting light exposition was also studied for window shading activation at 25%, 50% and 75%, as shown in Figure 34.

Figure 32. Detail view to the painting—illuminance (lux) levels for 21 March and 21 June.

Figure 33. Detail view to the painting—illuminance (lux) levels for 21 September and 21 December.

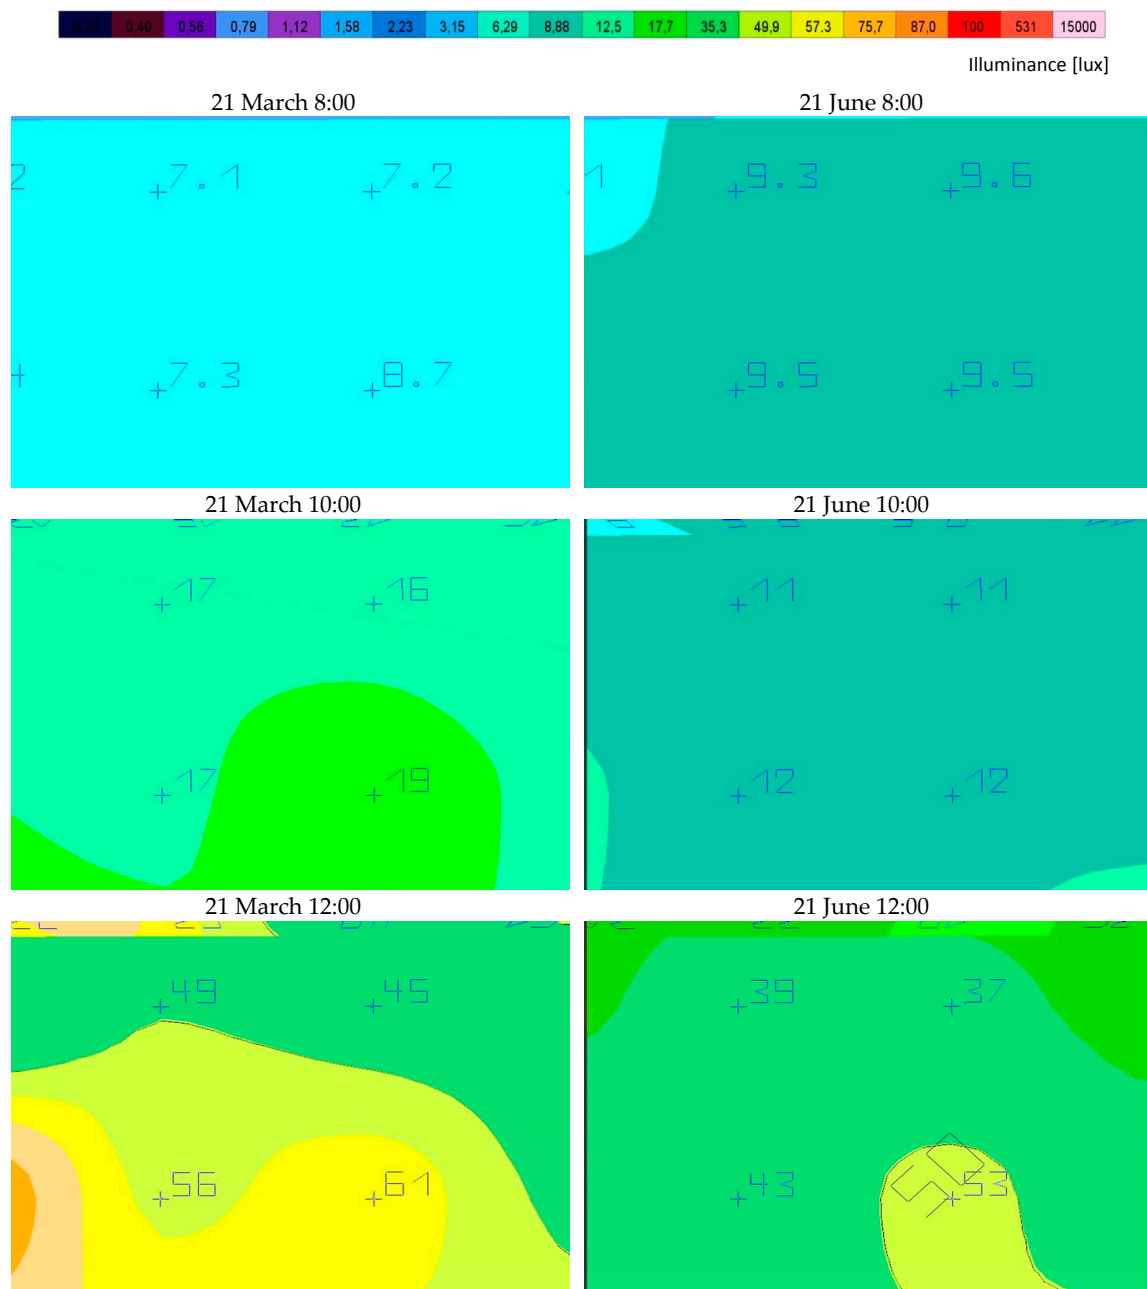
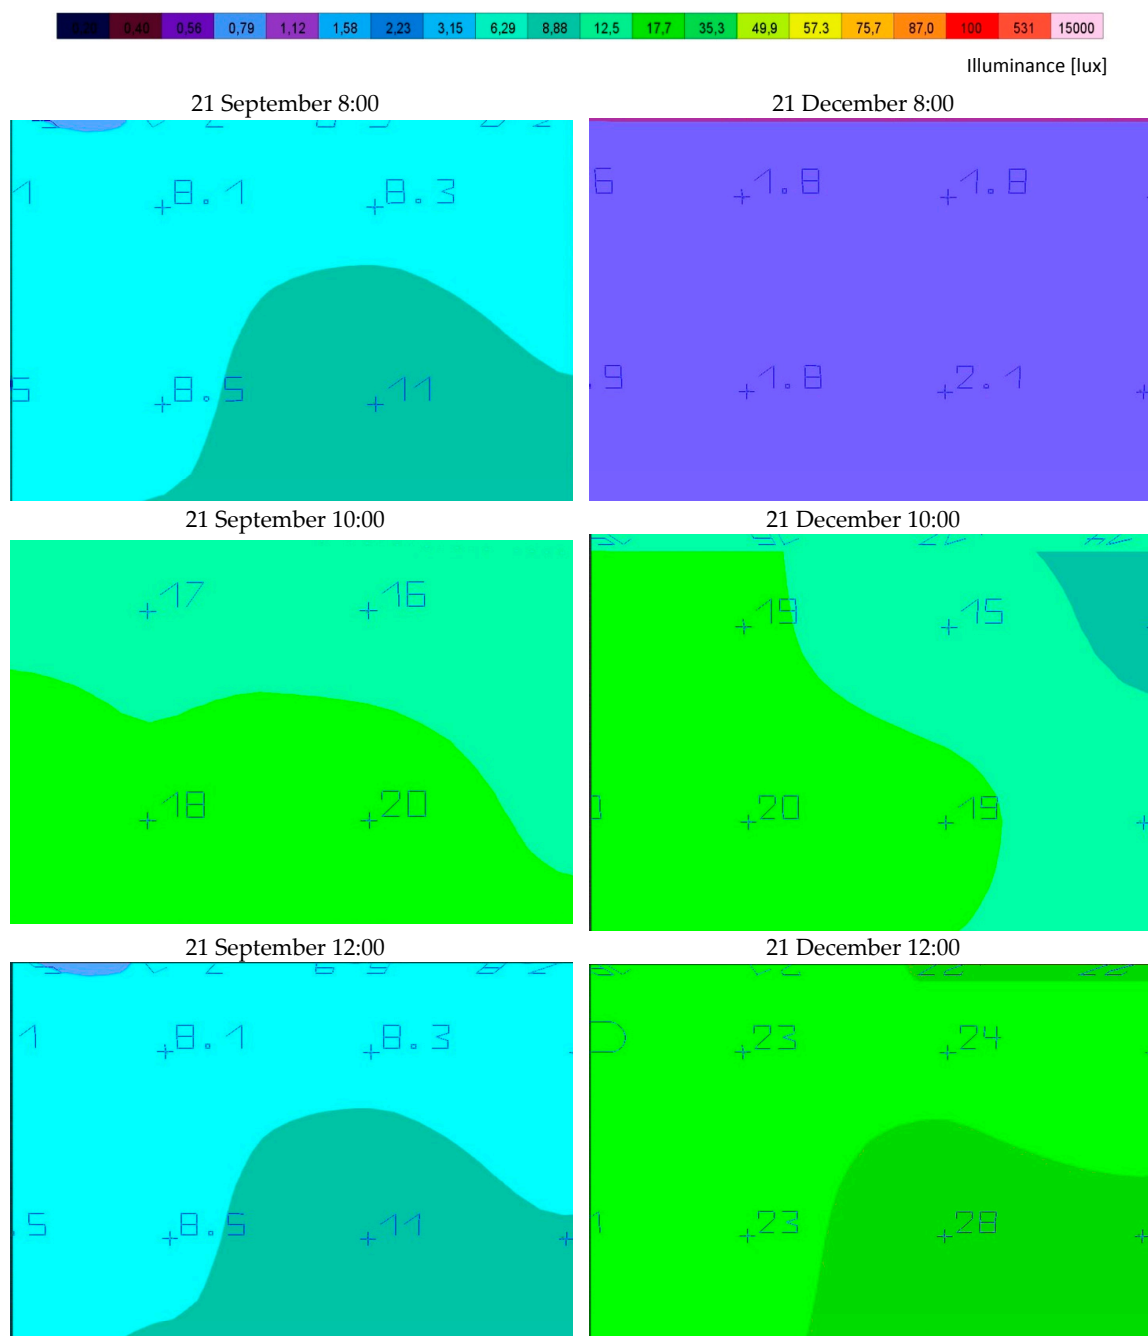
The simulation outputs in Figures 36 and 37 show that the wallpapers are exposed to higher illuminance levels in the period of year between March and June at noon. The rest of the year the wallpaper decoration is not damaged because illuminance level close to the ceiling wallpaper surface is not for more than 50 lux.

Figure 36. Detail view to the wallpaper—illuminance (lux) levels for 21 March and 21 June.

Figure 37. Detail view to the wallpaper—illuminance (lux) levels for 21 September and 21 December.
