Possibilities and pitfalls of revitalizing the timber structure of an industrial building from the 19th century from the viewpoint of diagnosis

V Hermankova, O Anton, P Cikrle, T Komarkova and M Stehlik

Department of Building Testing, Faculty of Civil Engineering, BUT in Brno, Veveri 95, Brno, Czech Republic

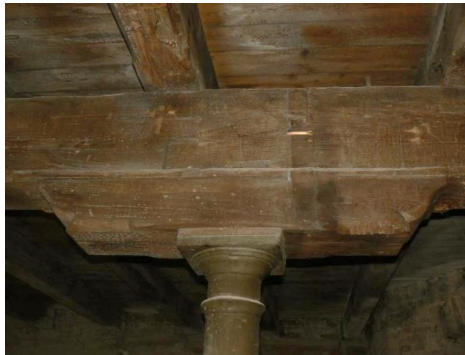
Figure 4. The girder is connected with splayed heading joints above some of the pillars.

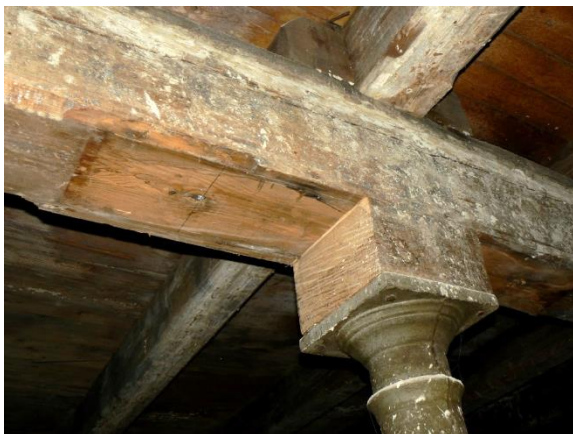
- In many places of the ceiling, the outer parts of headpieces with steel bolts had been removed in the past, and this impaired the functionality of the pillar – headpiece – girder whole (figures 5 and 6).
- There are large shrinkage cracks in the girders (figure 7).
- In many places of the ceiling, parts of beams were cut out, and in the floors, there are holes for the facilities (figure 8).
- At the location of the elevator shaft, parts of beams were removed without replacement (figure 9).
- Removal of parts of beams, and highly inappropriate prostheisng performed (figure 10).

Figure 5. The outer parts of the saddle removed.

In a number of places, the outer parts of headpieces between pillars and girders, including steel bolts, were removed in the past. If ceiling structures are maintained, we recommend their adequate functional replacement.

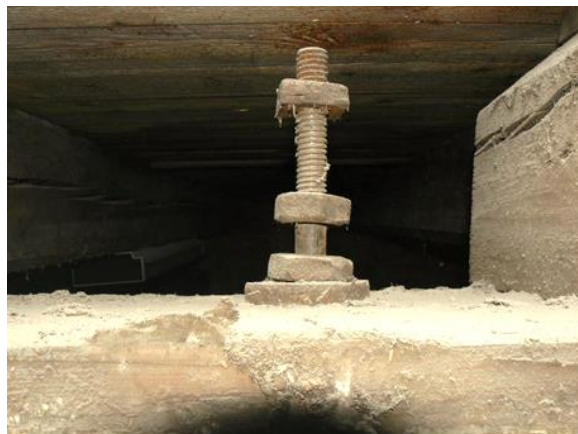
Figure 6. Non-functional steel bolt.

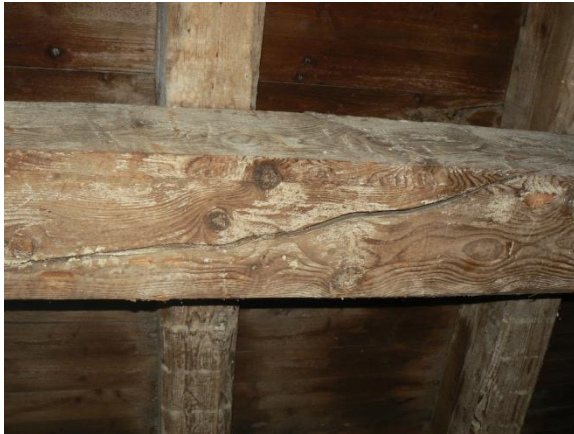
Figure 7. Shrinkage crack in the girder.

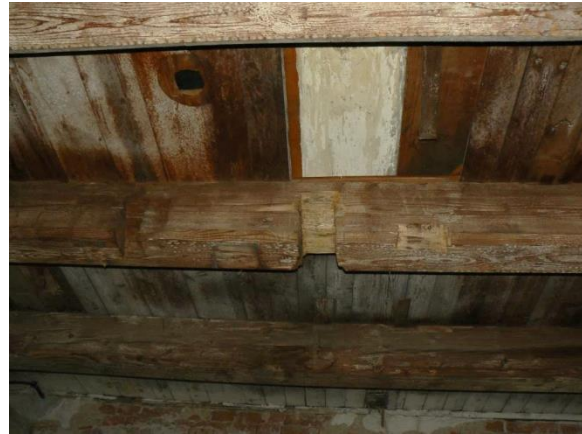
Figure 8. Weakening of the supporting beam.

In many places of the ceilings, end sections of girders (elevator shaft) and end sections or other sections of beams were removed in the past, and they were either not replaced or replaced in an inappropriate manner. We recommend adequate replacement of the missing parts of the elements.

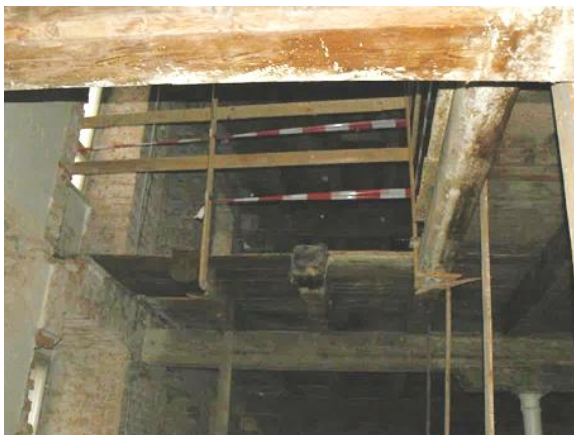
Figure 9. Removal of beams without replacement.

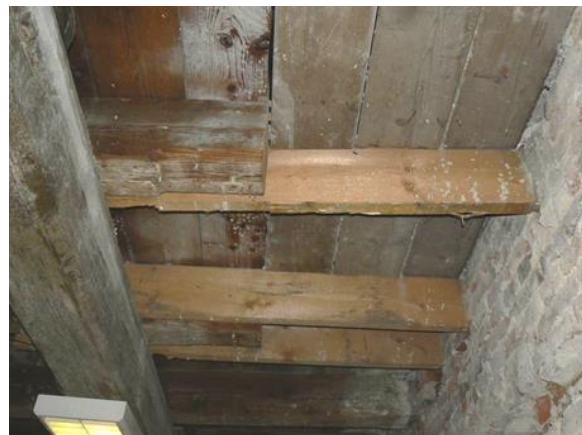
Figure 10. Incorrectly performed prosthesis.

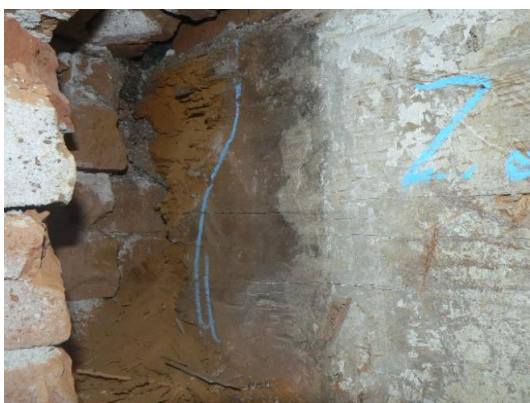
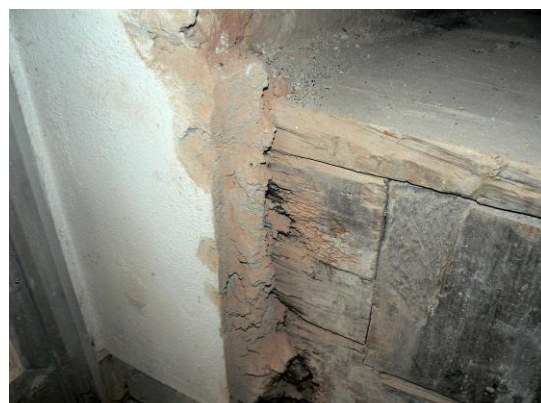
Most of the elements in the ceiling structure had no visible biotic damage (they do not have traces of decay or affection by timber boring insects). The exceptions are, however, heads of three girders which are visibly damaged by decay and timber boring insects to a varying extent (figures 11 and 12). The actual damage can have a far greater extent because this damage typically spreads through the centre of the element first and only then gets to the surface of the structure.

Figure 11. Biotic damage to the girder.

Figure 12. Biotic damage to the girder.

Biotic damage to timber detected in the girder heads is a fundamental problem. Considering the fact that it was one third of the probes on the girder heads, it cannot be excluded that the same damage occurs in other (non-tested) elements. That is why we recommend to gradually expose all the heads and if biotic damage is found, to exchange them.
