Research Article

A Fractographic Study of Bending/Torsion Fatigue Failure in Metallic Materials with Protective Surface Layers

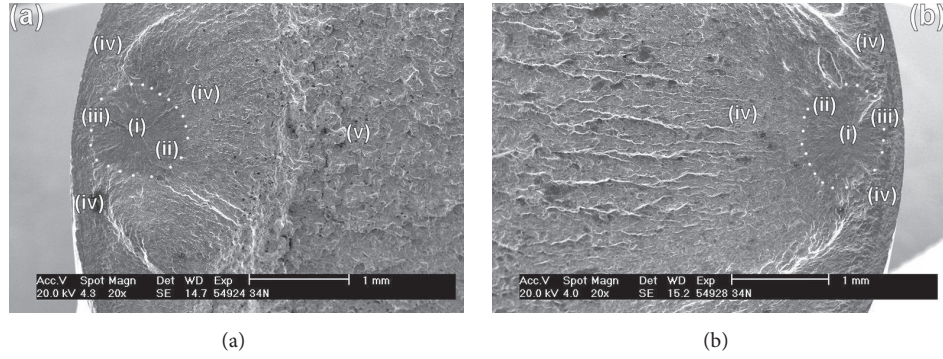
3.1. Nitrided Steel Specimens. The nitrided steel specimens were tested in the high cycle fatigue domain (fatigue life, N_f , was from 2.0×10^5 to 6.1×10^6 cycles) and they all failed by an internal “fish-eye” type of fracture because the applied loading was too low to damage the nitride layer and cause the failure from the surface. The cracks always initiated at nonmetallic inclusions in the core material and formed a nearly elliptical internal fish-eye crack [6] (Figure 1). Failure sequence consisted of (i) decohesion of the inclusion-matrix interface (which, most likely, constitutes a major part of the total life [7]), (ii) growth of the internal fish-eye crack, (iii) sudden breakage through the low-toughness nitride layer, (iv) fast, atmosphere-assisted crack growth [13], and (v) a final quasistatic fracture of the intact middle cross section. This is demonstrated in Figure 1 showing the fracture in the specimen tested under combined bending-torsion loading where two fish-eye cracks initiated at the opposite sites experiencing the maximum bending stress. The cracks initiated in a depth of 0.68 mm at an inclusion with effective diameter of $\sim 20\ \mu\text{m}$ (Figure 1(a)) and in a depth of 0.58 mm at an inclusion with diameter of $\sim 15\ \mu\text{m}$ (Figure 1(b)).

FIGURE 1: Initiation sites in nitrided steel specimen subjected to combined bending-torsion loading ($Z = 0.63$, $N_f = 2.0 \times 10^5$ cycles) with the failure sequence phases marked in images.

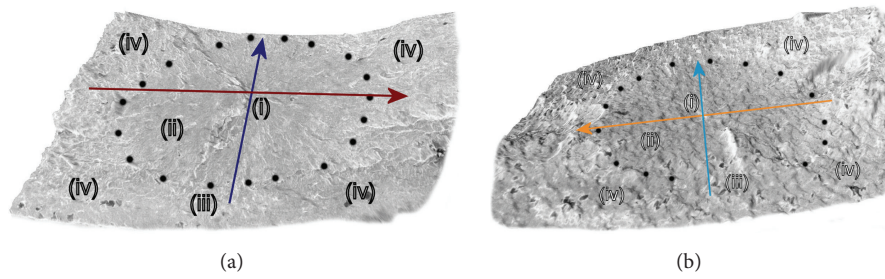
A general tendency of the fish-eye cracks was to grow in opening mode I as revealed by the orientation of the crack plane that changed from being perpendicular to the specimen's longitudinal axis for pure bending to a tangential inclination (along the circumference) of $\sim 45^\circ$ for torsion. Figure 2 shows arbitrarily rotated 3D images of the fish-eye cracks from Figures 1(a) and 1(b). The inclination angle of the fracture surfaces was determined from the orientations of the intersecting profiles marked in Figure 2. In this case, the radial inclination (toward the centre) α_r was negligible and the tangential inclination α_t was $\sim 30^\circ$ (Figure 3) in correspondence with the applied torsion-dominant loading regime ($Z = 0.63$).

FIGURE 2: 3D images of the fish-eye cracks from Figure 1.

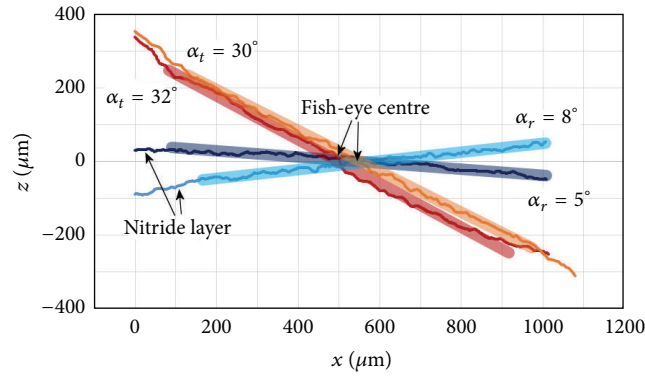
FIGURE 3: Profiles marked in Figure 2 with highlighted fish-eye segments.

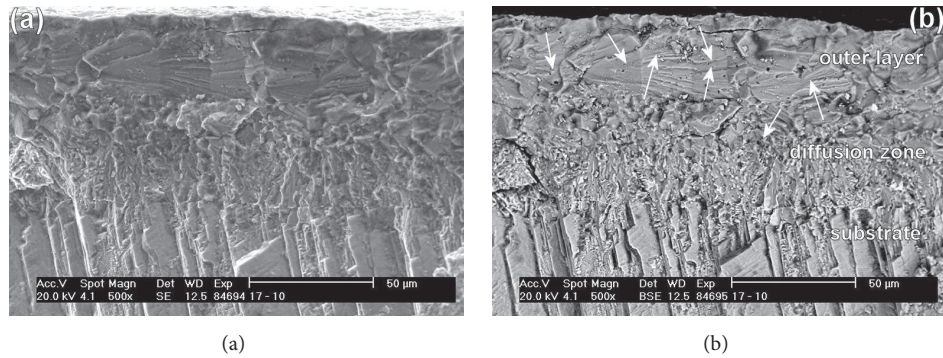
FIGURE 4: Initiation site in specimen with aluminide DC subjected to combined bending-torsion loading ($Z = 0.58$, $N_f = 6.0 \times 10^4$ cycles) using (a) secondary (SE) and (b) back-scattered electrons (BSE).

layer and the diffusion zone, especially in the BSE imaging mode (Figure 4(b)). Figure 5 shows the initiation sites in specimens tested under pure bending and torsion in the low cycle fatigue region. In general, high applied loading caused cracking and partial coating spallation, particularly under regimes involving torsion (short delamination cracks are also seen in Figure 4).

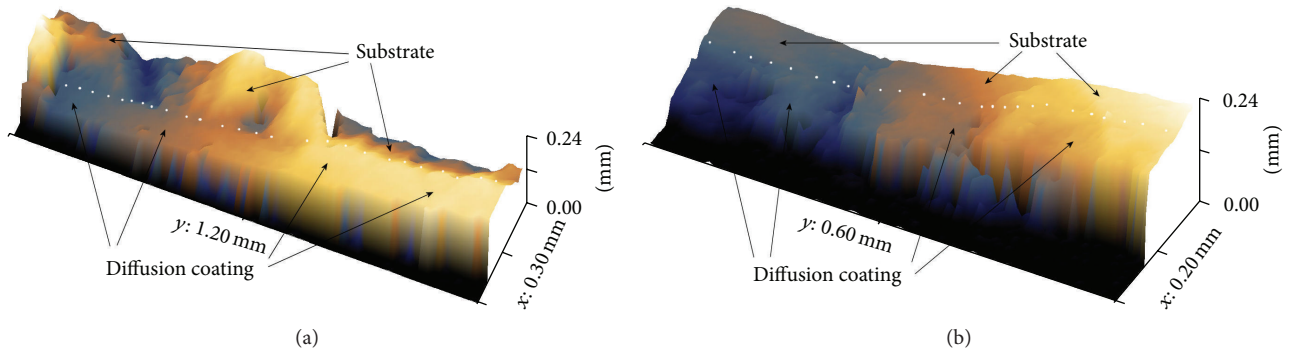
FIGURE 5: 3D view of initiation sites in specimens subjected to (a) bending ($Z = 0$, $N_f = 6.3 \times 10^3$ cycles) and (b) torsion loading ($Z = 1$, $N_f = 7.0 \times 10^2$ cycles).

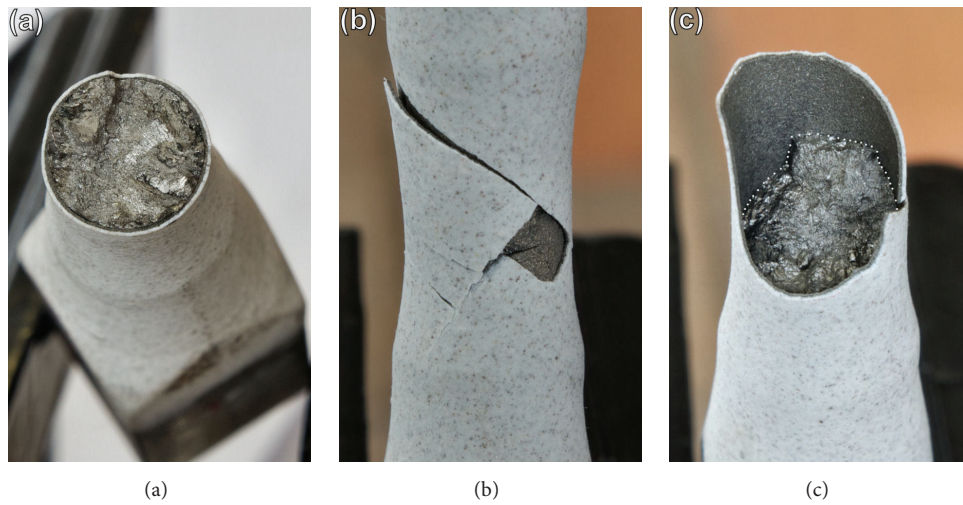
FIGURE 6: Macroimages of specimens with TBCs subjected to (a) pure bending ($Z = 0$, $N_f = 1.3 \times 10^5$ cycles), (b) combined bending-torsion ($Z = 0.64$, $N_f = 6.6 \times 10^4$ cycles), and (c) pure torsion loading ($Z = 1$, $N_f = 2.1 \times 10^5$ cycles).

delamination of the coating from the substrate (Figure 6). The reason for such large-scale delamination is shearing of a mechanically bonded layer that induces high normal stresses at geometrically irregular coating/substrate interface along the specimen. Delamination occurred also under pure bending loading but was limited to the two opposite specimen sides that experienced maximal bending stress (Figure 7) [9].

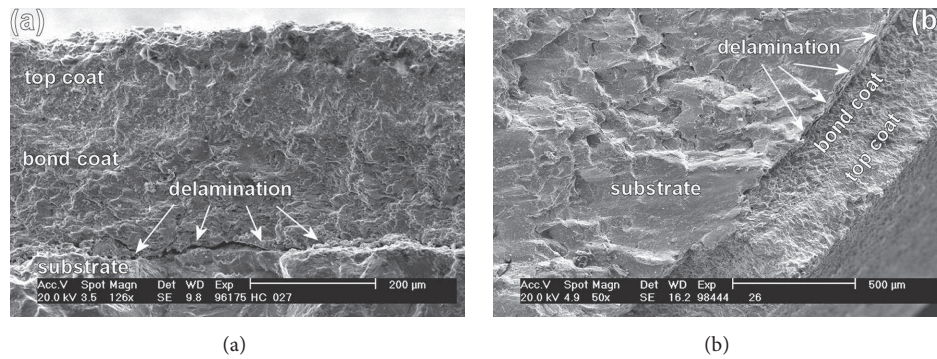
FIGURE 7: Initiation sites in specimens with thermal barrier coatings subjected to (a) bending ($Z = 0$, $N_f = 2.7 \times 10^4$ cycles) and (b) combined bending-torsion ($Z = 0.64$, $N_f = 4.2 \times 10^4$ cycles) loading.

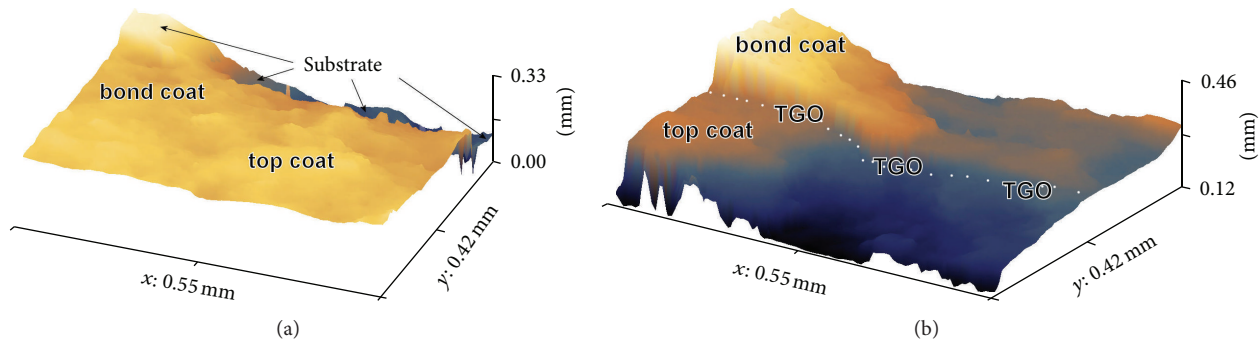
From the mechanical point of view, the bond-coat/substrate interface was the weakest part of the studied system, as was also observed earlier for the similar TBC systems [16, 17]. The top-coat/bond-coat interface, on the other hand, presented a rather weak barrier at which the crack front locally somewhat deviated if the applied stresses were low or if the thermally grown oxide (TGO) layer was present (Figure 8(b)). In this case, a complex fracture behaviour of the TGO layer was observed including the cracks through the thickness and along its interfaces [9]. Interestingly, this had no impact on the fatigue life of oxidized specimens which was comparable to that of as-sprayed samples.

FIGURE 8: 3D view of initiation sites in specimens with TBCs subjected to pure bending: (a) as-sprayed specimen ($N_f = 1.3 \times 10^5$ cycles) and (b) oxidized specimen with $\sim 5 \mu\text{m}$ thick TGO layer between the bond coat and the top coat ($N_f = 8.6 \times 10^5$ cycles).
