## 10th International Conference on Air Transport – INAIR 2021, TOWARDS AVIATION REVIVAL

# Bird strike as a threat to aviation safety

Jaroslav Juračka<sup>a</sup>, Jiří Chlebek<sup>a\*</sup>, Viktor Hodaň<sup>a</sup>

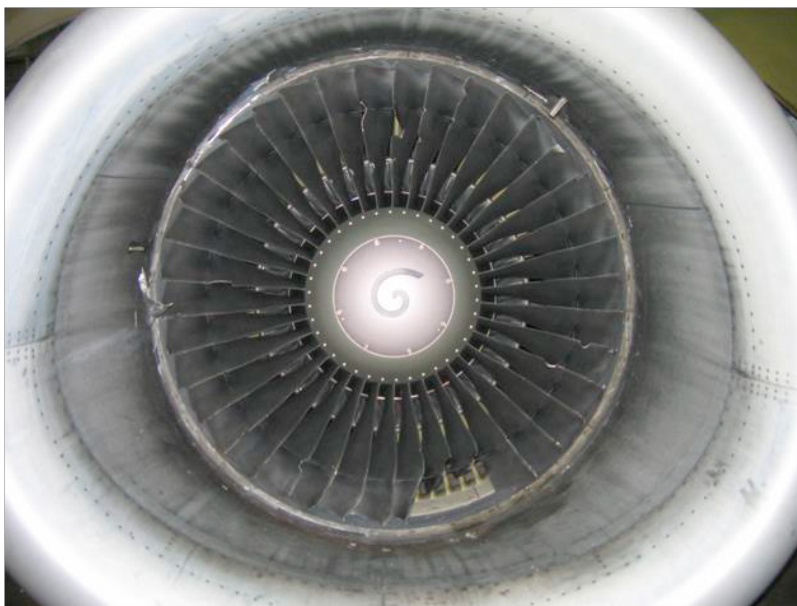
On landing at the LKPR and inspection by operator's technical staff it was confirmed that the engine 2 had been seriously damaged (Fig.4). Other damage, to the skin, airframe, or the supposed damage to the main landing gear wheel tyre, has not been found.

The engine 2 was seriously damaged as a consequence of having sucked a bird. Directly on the stand of the aircraft it was found that the fan blades were damaged, the inlet cowl inner wall had been pierced, and a small amount of fuel had leaked from the engine control system. A closer inspection revealed that assemblies on the engine outer part and their hinges (starter, Main Engine Control, fuel pump) were damaged too.

Fig. 4. Overall view of engine inlet (AAII of the Czech Republic)

Based on this findings and after discussion with the engine manufacturer it was decided to remove the engine and send it to a foreign repair shop to know the damage in more detail and the way and scope of repair.

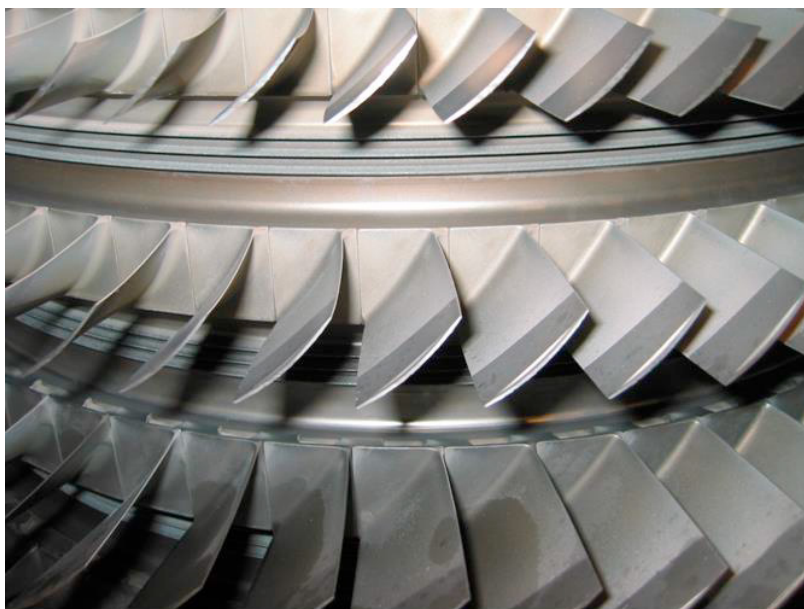
Apart from the damage already mentioned, extensive damage to the compressor was also found. The low pressure and high pressure rotor blades were ground off by the contact with compressor case and seriously damaged. The combustor was without damage only some deposit of brushed dust from the compressor was found. The high pressure turbine had its cooling holes blocked with brushed dust, which caused its overheating (Fig.5, 6). The low pressure turbine moved to the rear due to the nut of bearing 1 coming loose, thus making contact between the rotor and stator of the turbine, resulting in low pressure turbine damage (Final Report No. CZ-08-562, 2009).

Fig. 5. Abrasion of high-pressure compressor blades (AAII of the Czech Republic)

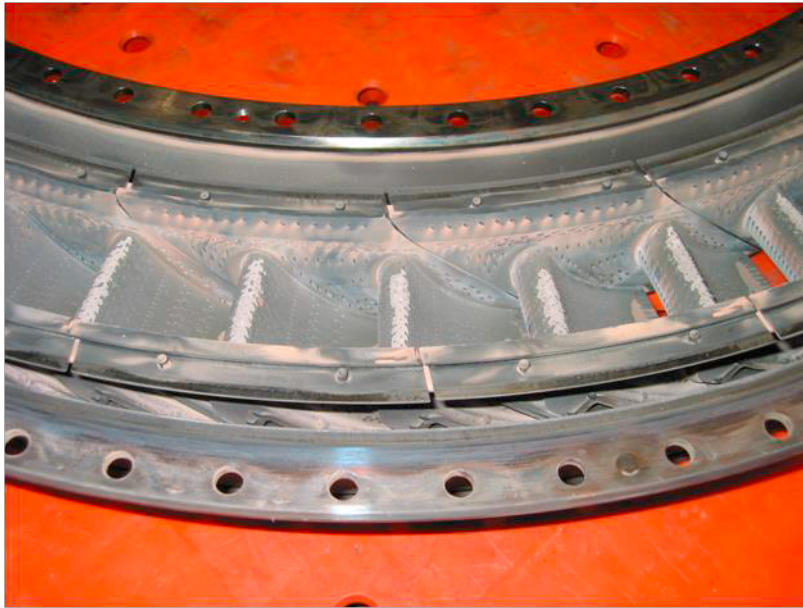
Fig. 6. Deposit of abrasion dust on high-pressure turbine stator blades (AAII of the Czech Republic)

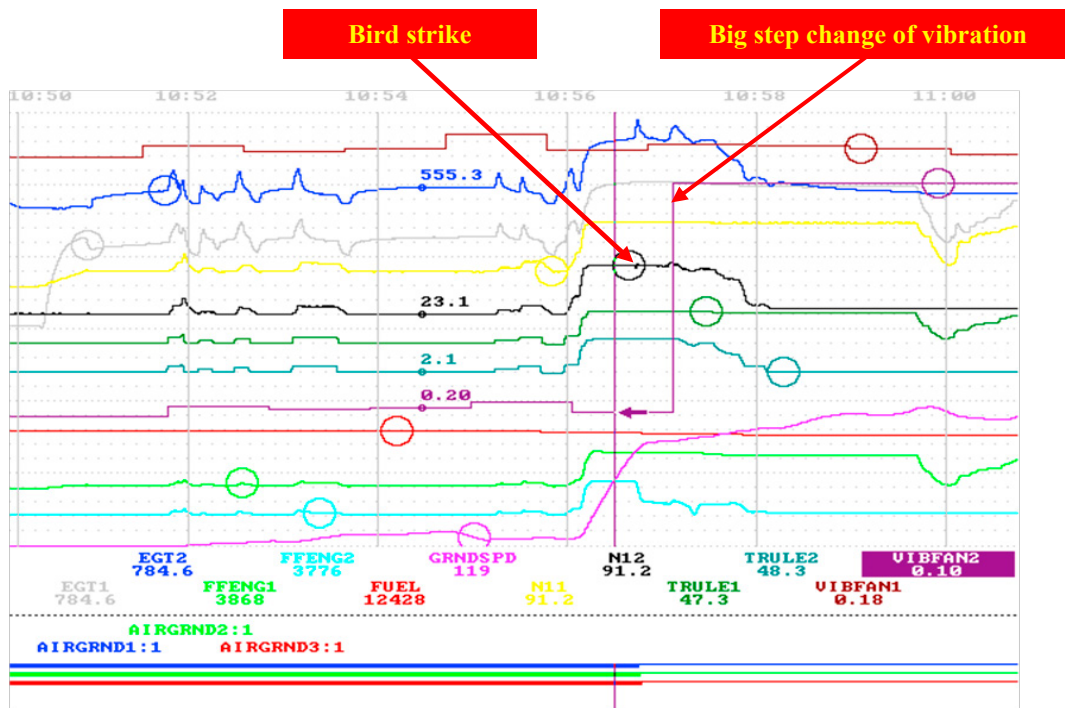
It is evident from the recording that engine's parameters had not deviated from standard values till the moment the bird was absorbed (Fig.7).

Fig.7. Engine parameters as recorded at the time of collision with bird (AAII of the Czech Republic)

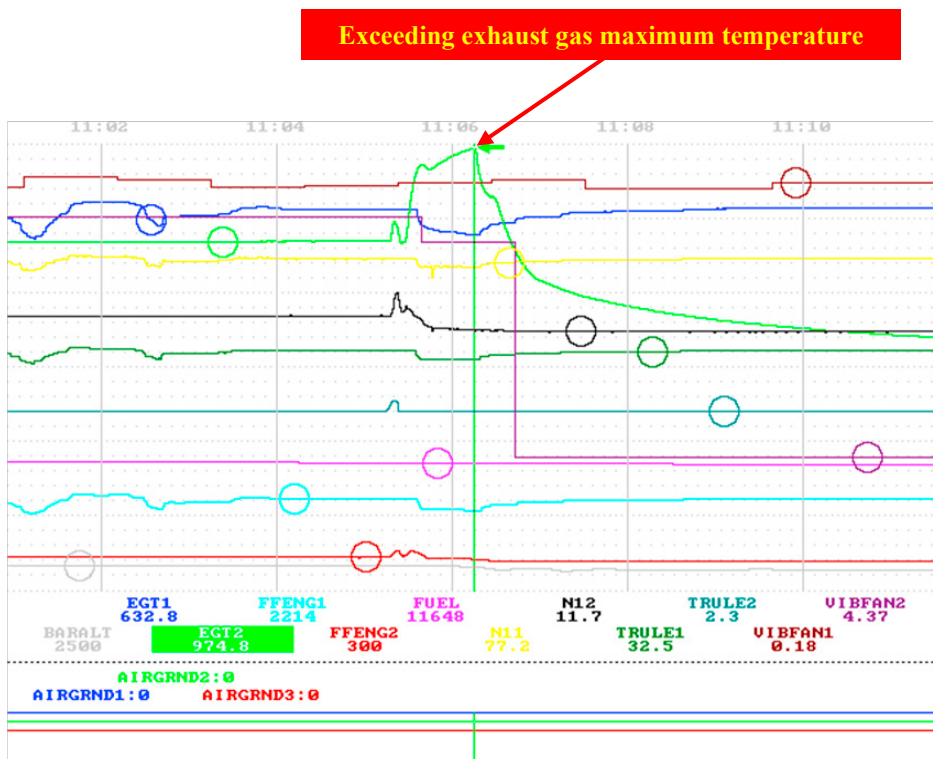
- 10:54:28 engines 1 and 2 are on idle regime, parameters of either engine are steady and vibrations of fans of either of them are at value 0.20
- 10:56:28 take-off regime set in the course of take-off run, fan vibration of engine 1 at value 0.18, fan vibration of engine 2 at value 0.10
- 10:56:43 at an airspeed of 166.5 kt revolutions shoot of engine 2 low-pressure compressor (take in a bird)
- 10:57:08 ramp change of engine 2 fan vibration from 0.10 to 4.88; engine 1 fan vibration at 0.27 value
- 10:58:07 engine 1 regime reduced to flight idling
- 11:05:27 exhaust gas began to rise from 531.4 degrees Celsius
- 11:06:15 exhaust gas maximum temperature reached 974.8 degrees Celsius (Fig.8).
- 11:06:18 engine 2 shut down

Fig.8. Engine parameters as recorded when exceeding exhaust gas maximum temperature (AAII of the Czech Republic)
