Effective way to reconstruct arch bridges using concrete walls and transverse strands

Abstract. There are more than 500 masonry arch bridges in the Czech Road system and about 2500 in the Czech Railway system. Many of them are cracked in the longitudinal (span) direction. The barrel vaults are separated by the cracks into partial masonry arches without load bearing connection in transverse direction. These constructions are about 150 years old and they are also too narrow for the current road system. This paper presents a strengthening method for masonry arch bridges using transverse post-tensioning. This method is very useful not only for strengthening in the transverse direction, but widening of masonry arches can be taken as secondary effect especially in case of road bridges. Several bridges were successfully repaired with the use of this system which seems to be effective and reliable.

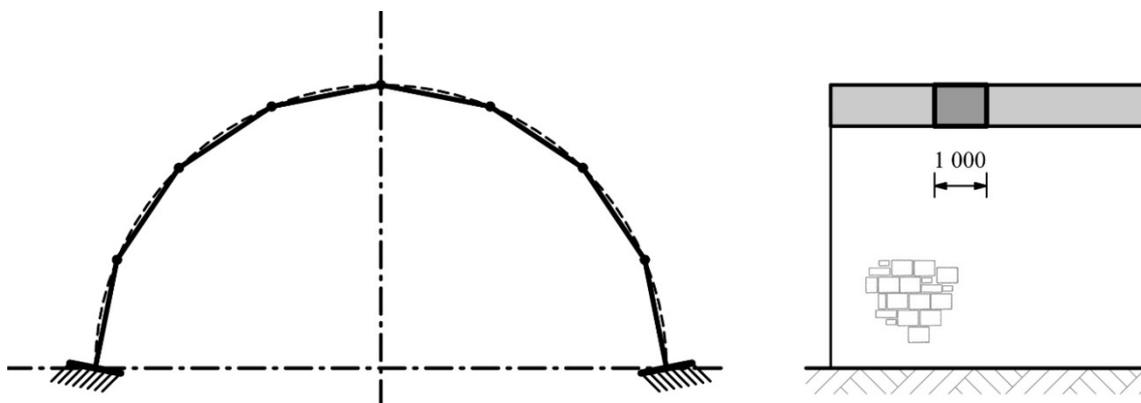
Figure 1. Frame model of a masonry cylindrical vault.

Some masonry arch bridges were built with cylindrical vaults. The type of vault is usually a half of the circle or a part of the circle in the longitudinal direction. For calculation of their load bearing capacity a simple frame model is used (Figure 1). There are only normal forces and bending moments acting on the cross section. There are no forces in the transverse direction in this case. But real vaults are separated by cracks in the longitudinal direction creating more sections (Figure 2). These cracks are typically situated in the central area of the vaults. They are also situated near the left and right edges in a distance about 1.5 m.

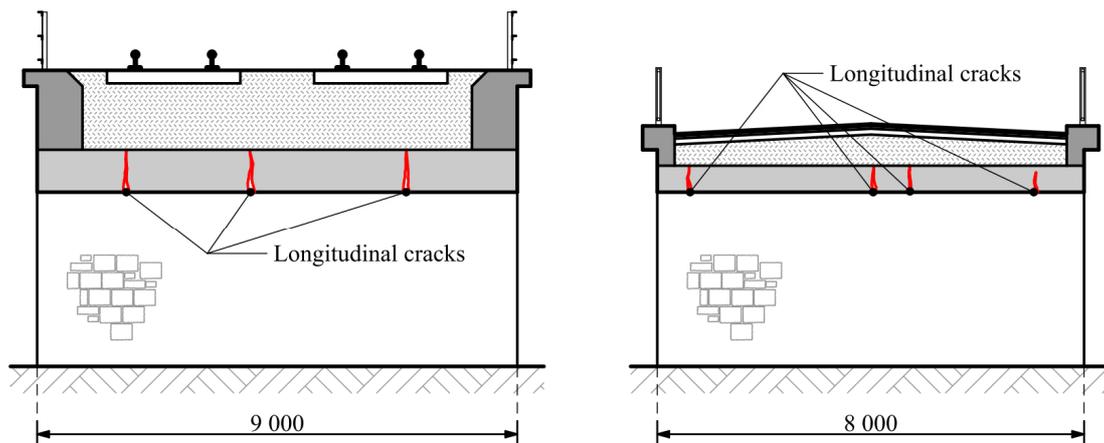
Figure 2. Railway (on left side) and road (on right side) masonry arch bridges; barrel vaults were cracked in the longitudinal direction.

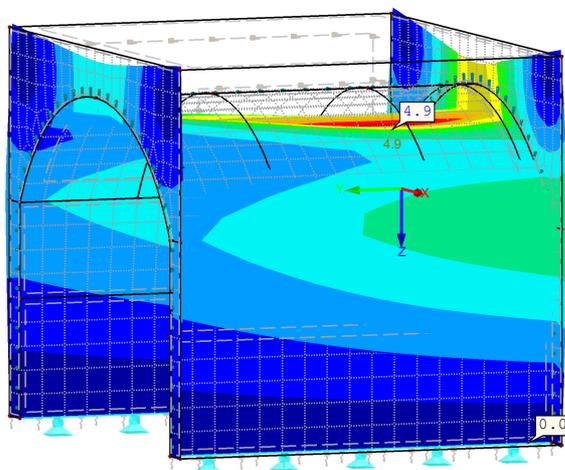
Figure 3. Deformation of the shell model due to live load.

A shell model can be used for explaining the central cracks. Deformation of the vault using the shell model is shown in Figure 3. We obtain internal forces (normal force and bending moment) in both directions: in the longitudinal direction (axis X) and in the transverse direction (axis Y) too. Because of very low tensile strength of masonry in the transverse direction cracks can appear in the central part of vaults. Explanation of the existence of cracks near edges is not so clear. There are also horizontal forces due to traffic load in these areas. These cracks are large, their widths were observed from 10 to 30 mm. Sometimes their size is about 100mm and this part of vault is fully separated from the face (spandrel) wall. In this case the structure is unstable and the bridge should be closed to traffic.

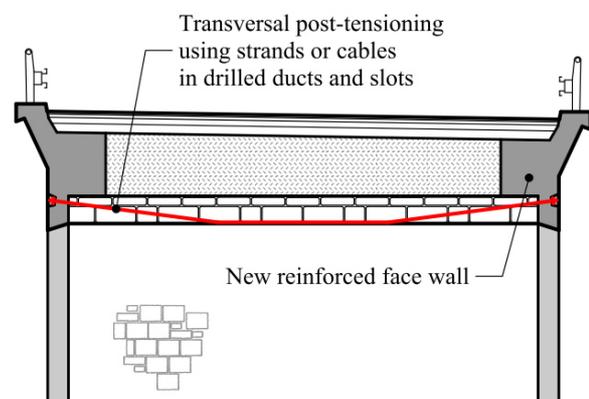
Figure 4. Arrangement of transversal post-tensioning.

Structural strengthening is based on an analysis of the vaults using the shell model. Tensile forces in the masonry barrel vault are taken by transverse post-tensioning (Figure 4). Post-tensioning is achieved by transverse cables. Cables usually consist of monostrands, each with two or three pieces. They are pushed into drilled cable ducts and slots prepared in advance in the masonry. Diamond drilling and sawing technology should be used. The special drilling support has to be used for preparing of cable ducts. Anchorages are positioned into new widening reinforced concrete (RC) walls. Prestressing forces are distributed by them to the crown and supporting abutment walls, so no

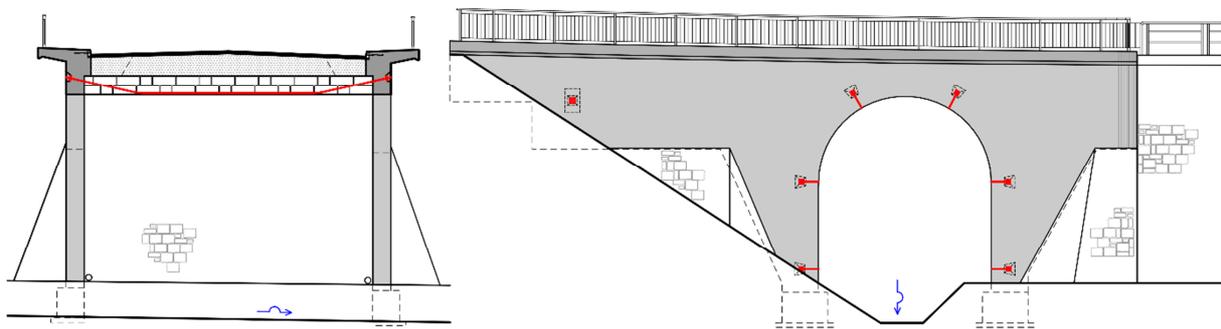
Figure 5. Example of design reconstruction of a road bridge using transversal post-tensioning with RC face walls.

crushing of stones or brick masonry due local pressure takes place. New RC face walls can also be used for widening of the bridge. This is the second benefit of this method and can be used in case of the road bridges. Widening can be large because the span of the cantilever can be designed up to 3m length without difficulties. Stability of the new face walls is blocked by forces in the anchorages. Those prestressing forces should be taken from force equilibrium in horizontal direction. Active forces are the horizontal part of earth pressure due to traffic load and embankment over the vault multiplied by safety coefficient 1.5 or the partial safety coefficient design method can be used. Passive forces are in fact prestressing forces in the anchorages. A check of the stress in masonry vault in horizontal direction is also necessary. According to the experience a value 20% of strength of masonry in perpendicular direction can be taken into account. The example of a real road bridge reconstruction using described method is given in the pictures below (Figures 5, 6 and 7).

This road bridge was built in 1880. It is situated on 1st Class road No14. The main structure is a barrel vault with face walls. Span of the vault is 6.6 m (Figure 5). Construction comprises sandstone masonry.

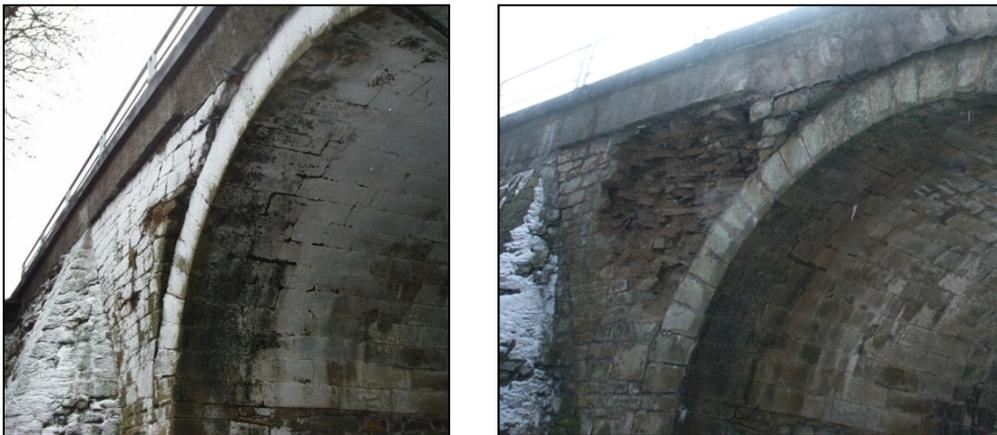
Figure 6. Collapse of the old masonry face wall due to water, frost and ice.

Longitudinal cracks similar to those shown in Fig. 1 and buckling of one face wall were observed in 2002. The buckling became so extensive through the years that finally a part of face wall collapsed (Fig. 6). The traffic over the bridge was stopped. Design for reconstruction using strengthening of this vault by transverse post-tensioning was made in 2003. It is based on transverse cables with anchorage in the new RC face walls. Widening of the bridge was achieved as a secondary effect. The reconstruction was made in 2003 by MADOS MT ltd., the post-tensioning with drilled cable ducts was made by Mitrenga-stavby ltd. Further pictures show the bridge after repair works (Figures 7 and 8).

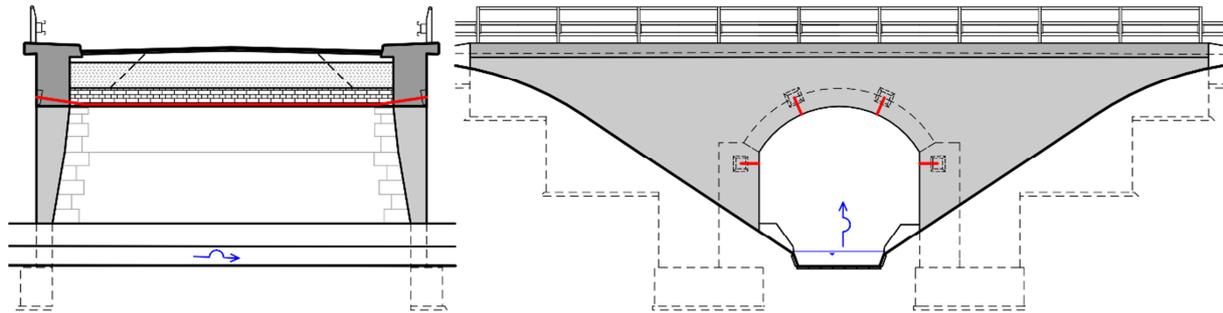
Figure 7. Plan of the structure measured during prestressing; left - cross section of the vault with cables; right - view of new face wall with anchorage ducts for four cables.

The vault is cylindrical with its center line in the shape of a circular segment from masonry 450mm thick. Lime mortar was used, partly flushed away, of strength 0.2 to 0.4 MPa. The span was 4.5m, width of the vault 10m, length of newly realized face walls 18.4m. The plan of the structure is in Fig. 7.

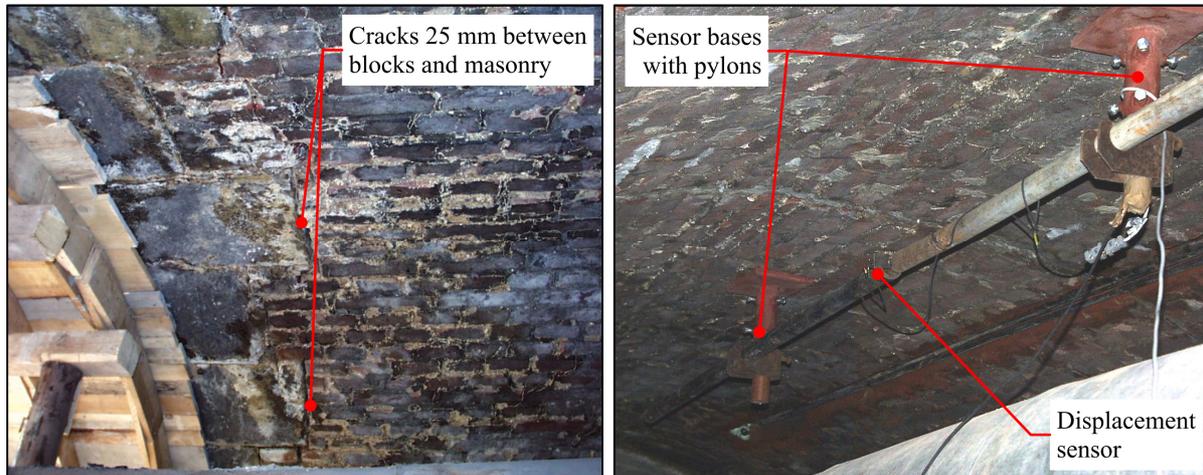
Figure 8. Defects in vault and sensor base; left - cracks between face wall blocks and masonry caused by buckling; right – sensor base in the crown with displacement sensor.

Original stone vault was provided with cable ducts, diameter 52mm for setting of prestressing cables. Cable ducts formed a frame with inclination 10 degrees to the longitudinal radial plane. They were drilled from the vault towards the faces. On the upper surface of the stone vault the cables were set in slots 70 × 50 mm. New RC walls were concreted against the original faces and remaining parts of the face walls. Defects of the original structure are shown in Figure 8.

Measurement of horizontal deformation of the structure was carried out in three reference lines 2.2m long. The reference lines were made of steel anchors fixed in the vault masonry and steel pipes. Deformations were captured by inductive displacement sensor WETA 2mm with a range 0.001mm. Prestressing force was measured by a tester Proceq 200 kN. Deformation was continually monitored by a computer. The temperature during monitoring was practically stable +5°C.

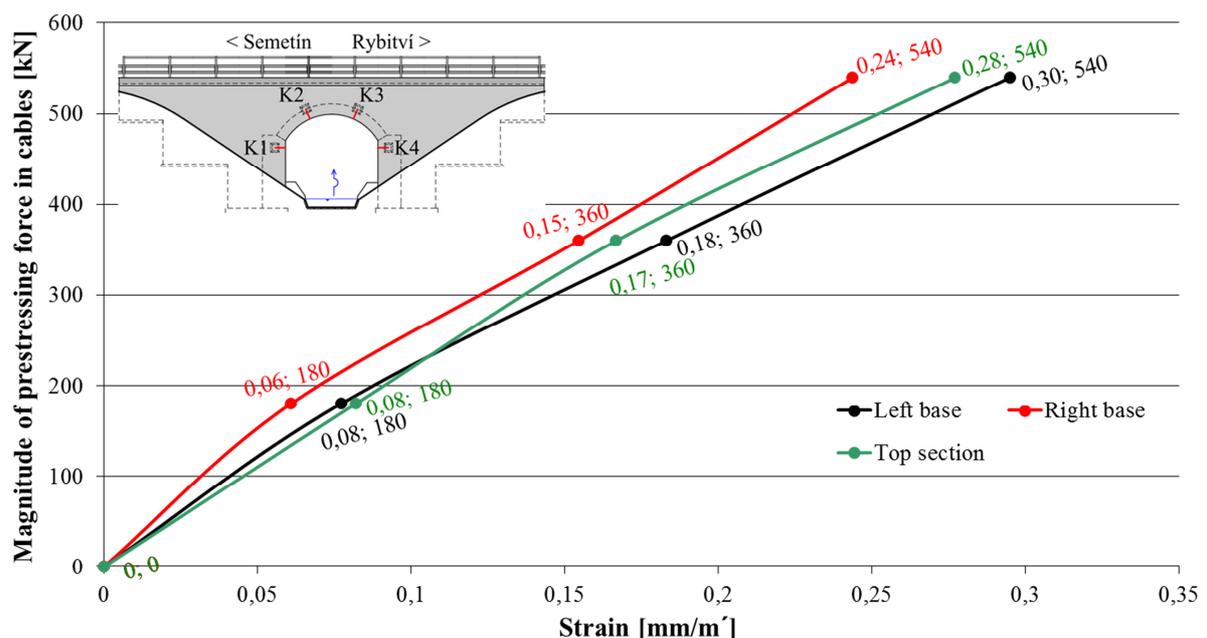
Figure 9. Relative compression of vault masonry during horizontal prestressing.

Relation between the deformation (compression) of masonry and magnitude of prestressing force is in Figure 9.

- 1) It was possible to stress the cables up to the predicted and designed force $3 \times 180 \text{ kN} = 540 \text{ kN}$ in one cable. Such forces were sufficient in relation to stability of the structure described in Paragraph 2. With such forces no negative impact occurred (cracks, crushing etc.). The concreted structure remained still without movement. The masonry was compressed practically linearly, i. e. prestressing was performed in elastic part of the masonry behaviour. It means that original longitudinal cracks in vault (between brick vault and original stone face walls) were properly filled with grout from the statical point of view, because no displacement occurred when there was no prestressing force. Subsequent grouting can reliably through drilled holes fill cracks and cavities that were created by defects in original vault.

- 2) Left side of the vault (left abutment area) was slightly softer – and it was compressed more. The difference is 10 % compared with the average value; and it is practically of no significance. Vault masonry compressed regardless of cohesion between vault and consolidated infill (reconstruction was carried out during operation without removal of infill) and without visible influence of newly realized walls on original walls and infill. Such influence is thus not big and with relatively small magnitude of compression only stiffness of vault and abutment in longitudinal direction may be important.

- 3) Average max. compression reached in springings was 0.27 mm/m' ; in the crown 0.28 mm/m' . It is almost constant compression in the transverse direction upwards and proves good design of prestressing forces and also good realization of the reconstruction. Deformation of the structure is in compliance with assumptions given in Paragraph 2 and it is possible to consider them as confirmation of this system of reconstruction of bridge vaults (Figure 10).

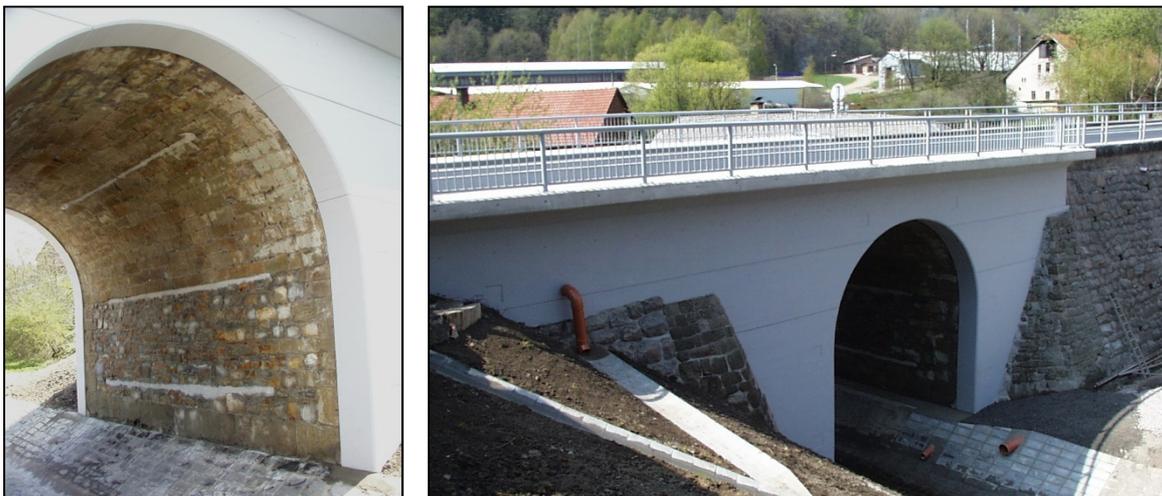
Figure 10. View into the barrel vault; the picture shows sand stone masonry of the vault and cable slots after completion.

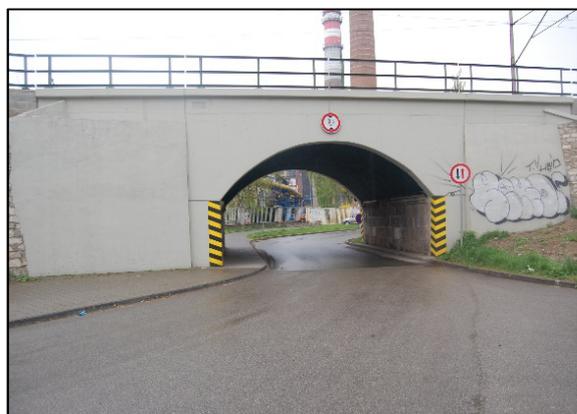
Figure 11. Monitored bridge vault, new cast-in-situ walls.

The superstructure of the railway vault bridge is formed by segment brick vault with a clearance 7.540 m and a rise of 1.970 m. The springing is 2.100 m above the pavement and the crown is 4.220 m above the road. Thickness of the vault is about 0.840 m; this value comprises in lower part about 35 – 60 mm of torcrete. The repairs of both vault faces were formed by new RC face walls (Figure 11)

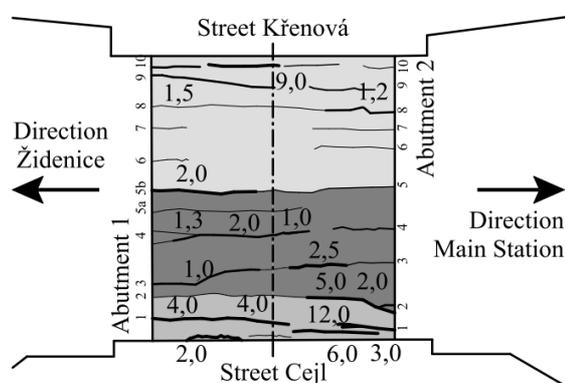
Figure 12. Location of cracks and division of vault into three separate parts.

Larger cracks divided the vault into three independent belts (Figure 12) which of course influenced the whole structure. The edge belt had also visibly dropped when compared with other parts of the vault. Diagnostics by probes confirmed that the cracks extended into masonry and that the masonry was saturated with water. The cracks were found in both abutments in approx. vertical direction. In abutment 1 there were mainly hair cracks, mostly below the springing, whereas in abutment 2 they were up to 2.0 mm wide and extended up to $\frac{3}{4}$ of the height from the springing. Other defects were corresponding to the age of the bridge. Surface defects were visible on both face walls especially below non-functional drainage.

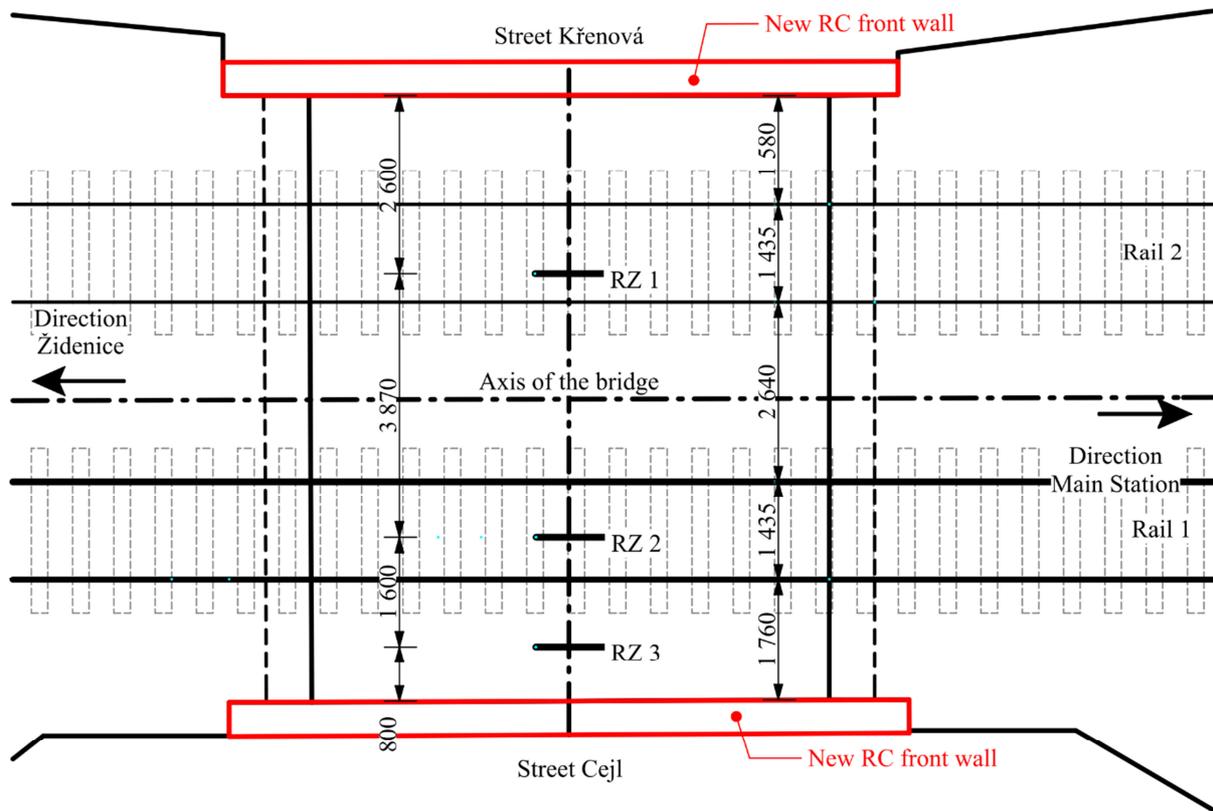
Figure 13. Positions of measuring basis RZ.

Deformation measurement was carried out in three places along the axis of the vault, similarly to measurement before the repair. (Figure 13) [1]. A set of arm amplifiers was placed in the same anchorage places. For the purpose of this paper data from arm amplifiers placed below track axes were also used. (RZ1 and RZ2).

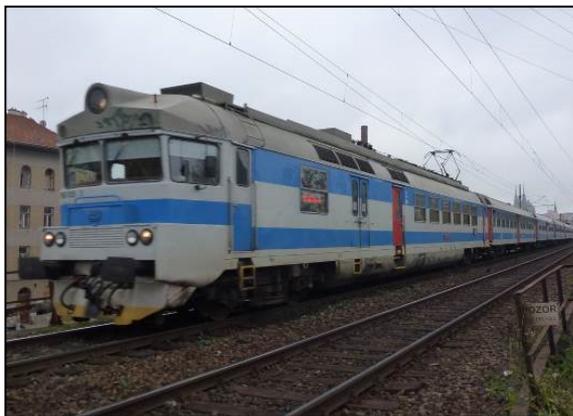
Figure 14. Train with engine 560 „Pantograf”.

For deformation measurement i.e. strain under traffic load a train with engine 560 „Pantograf“ (Figure 14) with weight of 37t was used. (more precisely – values measured under the first axle of the engine in the direction of traffic). Measured and recorded passages of this train were eight in 2013 and four in 2014. During measurement the direction and tracks were monitored. Sampling frequency was 20 Hz in 2013 and 50 Hz in 2014 (Figure 15). Frequency 50 Hz sufficiently documents all vibrations of the vault during train passages.

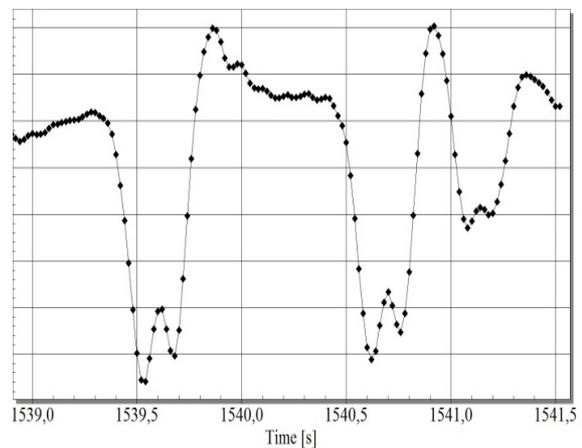
Figure 15. Train passage – sampling frequency 50 Hz.

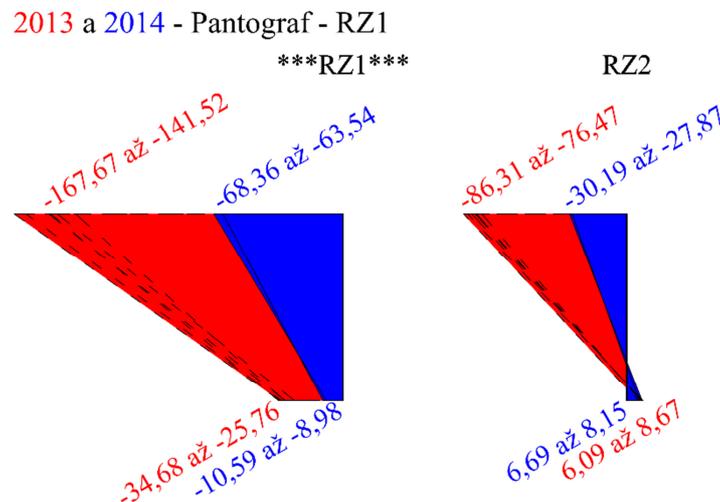
Figure 16. Strain of the vault in the location of RZ1 a RZ2 during passage above RZ1.

10.1. Passage on track 2 above RZ1 (Figure 16)

From the measured data after passage on Track 2 above the arm amplified RZ1 it is clear that the vault was before and after the repair fully compressed. However, after the repair the strain decreased on the back side from its minimal value $-167.67 \mu\text{m}/\text{m}$ to $-68.36 \mu\text{m}/\text{m}$ and on the face side from its minimal value $-34.68 \mu\text{m}/\text{m}$ to $-10.59 \mu\text{m}/\text{m}$. Proportionally the stiffness increase in the vault in transversal direction can be described for the back face as 2.45:1 and face side as 3.27:1. It can be stated that stiffness of the vault has increased three times in track 2 above the arm amplifier.

Similarly during passage on Track 2 the strain on the face side of the vault almost did not change in the place of Track 1 above the arm amplifier RZ2, on the back side of the vault it decreased from its minimal value of $-86.31 \mu\text{m}/\text{m}$ to $-30.19 \mu\text{m}/\text{m}$, i. e. ratio 2.86:1.

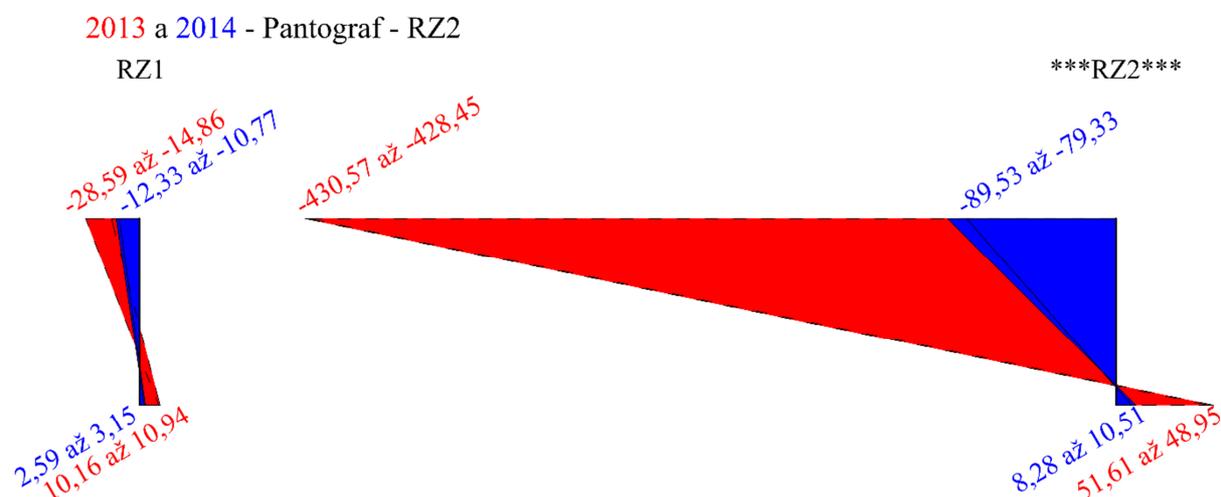
Figure 17. Strain of the vault in the location of RZ1 and RZ2 during passage above RZ2.

10.2. Passage on Track 1 above RZ2 (Figure 17)

From the measured data after passage on Track 1 above the arm amplifier RZ2 it is clear that the vault was before and after the repair on the back side in compression and on the face side in tension. After repair the strain on the back side decreased from measured minimal value $-28.59 \mu\text{m}/\text{m}$ to $-2.33 \mu\text{m}/\text{m}$. Strain on the face side decreased from $10.94 \mu\text{m}/\text{m}$ to $3.15 \mu\text{m}/\text{m}$. Proportionally the stiffness increase in the vault in transversal direction can be described for the back face as 2,32:1 and face side 3.47:1. It can be stated that stiffness of the vault has increased in the place of RZ1 three times.

During the passage on Tack 1 above RZ2 the strain on the face side decreased from measured maximal value of $51.61 \mu\text{m/m}$ to $10.51 \mu\text{m/m}$, i.e. ratio 4.91:1. On the back side of the vault the strain decreased from minimal value of $-430.57 \mu\text{m/m}$ to $-89.53 \mu\text{m/m}$, i. e. ratio 4.81:1.
