# The Comparison of 3D and 2D Measurement Techniques Used for the Analysis of Vehicle Deformation

**Abstract:** As one of the main assumptions for the accident analysis has been detailed information about vehicle deformation. The precise deformation depth allows to quantify deformation energy and related impact speed. The aim of this paper has been the comparison of two selected methods used for the determination of deformation depth. For the purpose of this paper were selected top-view photography as basic and cheap method and 3D scanning as modern and advanced method. Different vehicles and 2 basic types of damage - frontal and side impact - were chosen for the analysis. Also, the different range of vehicle deformation depth were selected. On the basis of obtained results is possible to determine the applicability of these methods, their advantages and limitations.

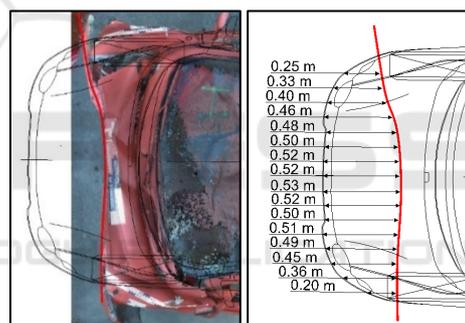
Figure 3: Analysis of photography – top-view.

For the measurement of the deformation depth using the top-view photography were used the photo of damage vehicle and undamaged vehicle model from the software Autoview (figure 3).

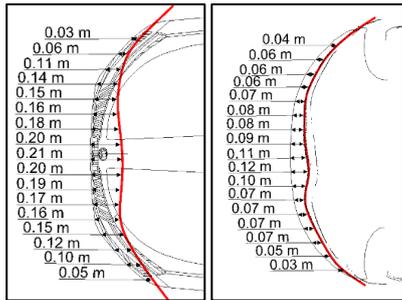
Figure 4, 5, 6, 7, 8, 9 show the obtained results – the deformation depth in predefined measurement points on the vehicle front. Figure 4 shows the deformation depth measurement using the top-view photography (left) and 3D scan (right) of the Skoda Karoq vehicle

(F1). The vehicle front has been damaged over the almost entire width - the front bumper, bonnet, longitudinal beams including damage of the vehicle deformation elements. The maximum deformation depth determined using the top-view photography was 21 cm, minimum about 3 cm. After a three-dimensional analysis of the maximum damage area, a 2D cut was made at the height of 55 cm. The maximum deformation depth determined using the scan was 12 cm, minimum similarly as using top-view photo about 3 cm.

Figure 4: Skoda Karoq frontal impact – top-view (left) vs. scanner (right).

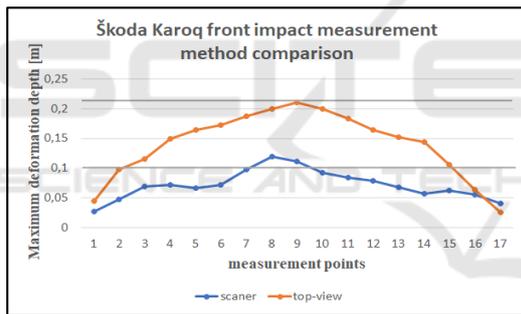
Figure 5: Skoda Karoq front impact measurement method comparison.

Comparison of the measured deformation depth value using the two selected methods demonstrates a considerable difference of the obtained data. Differences of the deformation depth could be influenced mainly by the quality of the top-view photography – e.g. taking photography at the wrong angle which can subsequently distort the deformation analysis.

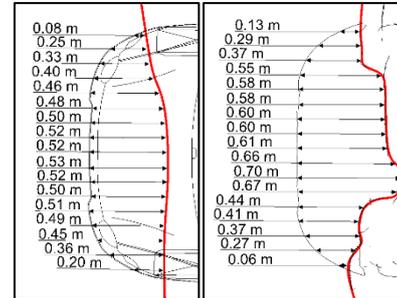
Figure 6 shows full-width deformation of the Fiat Multipla frontal part (F2). Compared to the previous case study, the deformation magnitude was larger – the front beams at the both sides of vehicle were damaged.

The maximum deformation depth determined using the top-view photography was 53 cm, minimum about 2 cm. After a three-dimensional analysis of the

maximum damage area, a 2D cut was made at the height of 50 cm. The maximum deformation depth determined using the vehicle scans was 70 cm, minimum about 6 cm.

Figure 6: Fiat Multipla frontal impact – top-view (left) vs. scanner (right).

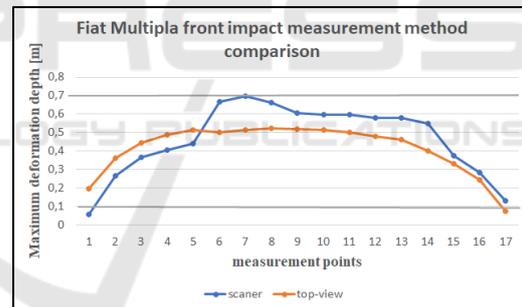
While in the previous case, the deformation depth values were small and the comparison of the selected methods showed significant differences, in this case the comparison of the selected methods shows only small differences. Larger differences of these individual methods have been caused by the covering of the deformation with the vehicle bonnet or other vehicle parts (bumper, etc.).

Figure 7: Fiat frontal impact measurement method comparison.

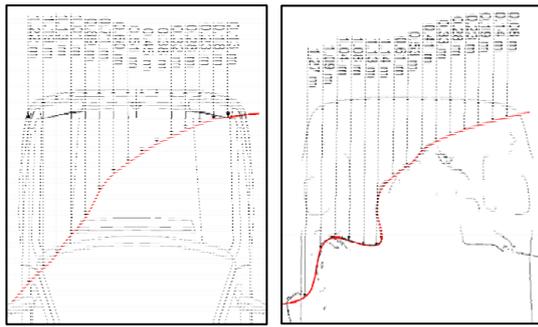
The following frontal collision of the Skoda Felicia (hereinafter referred to as F3) is the most prominent of the presented collisions. There was a complete destruction of the front side of the vehicle, including the front cross member, the left side beam and significantly damaged front axle.

In case of measuring the deformation depth using the top-view (Figure 8), the maximum deformation is 1,13 m and minimum is 13 cm. With the help of three-dimensional analysis, the cut was made in a 50 cm height, with a maximum deformation about 1,27 m and minimum about 4 cm.

Figure 8: Skoda Felicia frontal impact – top-view (left) vs. scanner (right).

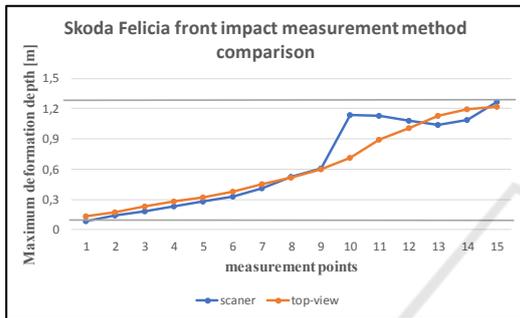
Figure 9: Skoda Felicia front impact measurement method comparison.

The graph (figure 9) shows us that even if such a significant deformation of frontal vehicle part occurs, the deviations are quite minimal. Deviations in measurement in this case occurs due to overlap of the deformation by the windscreen. In case of using combination of methods (e.g. top-view photography and photographs from different angles using of levelling meter), this deviation could be completely eliminated.

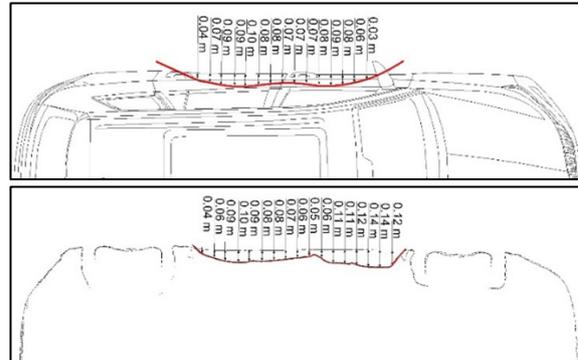
First case shows side impact of a Skoda Kodiaq (hereinafter referred to as S1). The deformation occurs on the left side of the vehicle, between the A and C pillars. The left front and rear doors were damaged and the B pillar was slightly deformed.

Figure 10 (up) shows the measurement of the deformation depth using the top-view, where the maximum deformation was about 10 cm and the

minimum was about 4 cm. In three-dimensional analysis, the maximum deformation section was measured at a height of 55 cm from the ground (Figure 10 - down). The maximum deformation of that section was about 14 cm and the minimum about 4 cm.

Figure 10: Skoda Kodiaq side impact – top-view (up) vs. scanner (down).

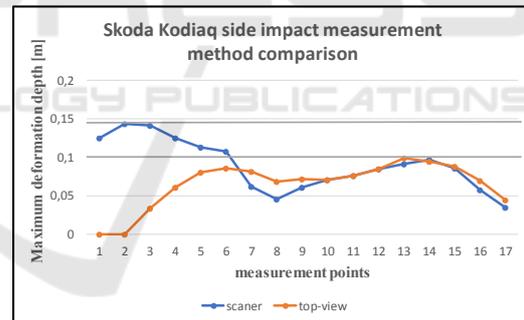
In the graph (figure 11) below could be observed that in case of deformation up to 10 cm the deviations are not significant, but above 10 cm the deviation is already visible, even if it is not a significant deformation.

Figure 11: Skoda Kodiaq side impact measurement method comparison.

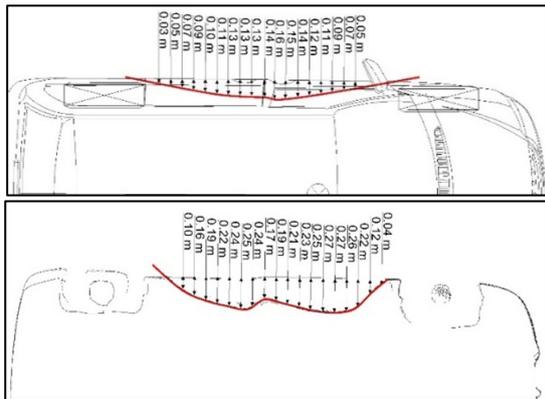
Another example of a side impact is presented in the following figure. This is the side impact of the Voyager Chrysler (S2). The deformation produced by this impact was already greater than in the previous example. The deformation depth of the S2 collision using the top-view is shown in Figure 12, where the maximum deformation was about 16 cm and the minimum about 2 cm. In a three-dimensional analysis, the maximum deformation section was at a height of 60 cm (Figure 12 - down). The maximum deformation was about 27 cm and the minimum about 3 cm.

Figure 12: Chrysler Voyager side impact – top-view (up) vs. scanner (down).

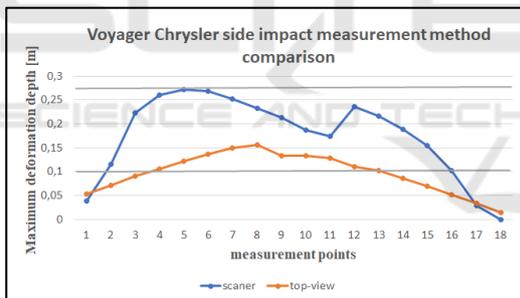
The following graph (figure 13) shows similarly as in previous case study not significant deviation in case of deformation up to 10 cm. A significant change occurs in the case of more extent side deformation, such a large deformation may not be apparent from the photograph. As can be seen e.g. in case of maximum deformation. When using a scanner, maximum deformation was measured about 27 cm. Using the top-view photograph at the same point there was the depth of deformation only about 12 cm.

Figure 13: Voyager Chrysler side impact measurement method comparison.

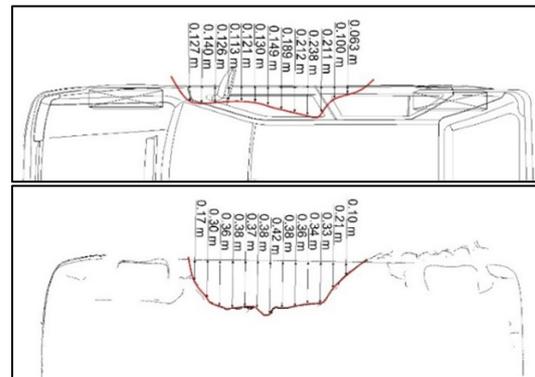
The last example of a side impact is the Skoda Felicia (hereinafter referred to as S3). The deformation of the S3 impact can be quantified as the most significant of the side impact measurement series. Almost the entire right side of the vehicle has been damaged. The apparent deformation was between the right A and C pillars and both vehicle doors were dented inside the vehicle. Furthermore, the right B pillar and the right doorsill (at the B pillar level) were broken.

When subtracting the deformations of the S3 impact using the top-view of the photograph (Figure 14 - up), the maximum deformation was about 26 cm and the minimum of 6 cm. The three-dimensional

analysis was again performed at the maximum deformation level and subsequently confirms that the impact was really striking (the greatest). The cut was measured at a height of 50 cm above the ground, the maximum deformation is is around 42 cm and a minimum about 10 cm.

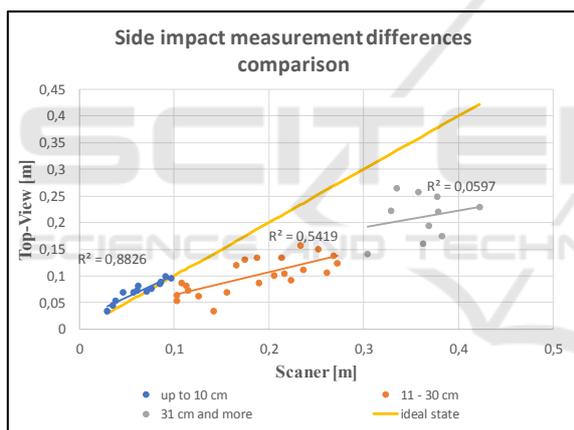
The deformation depth at the measured points was subsequently evaluated and plotted. From the graphs below, it is evident that in lateral impacts (Figure 16), the depth of deformation up to 10 cm is within a slight but acceptable tolerance. As the depth of deformation increases, so does the deviation from the ideal tendency. In some cases, it is up to 50% deviation, especially in the area of maximum deformation depth. There are several limitations of top-view photography. The accuracy of the obtained data is significantly influenced by the quality of photography, very important influence has been also the angle of taken photo. In cases where deformation interferes to the vehicle interior, the top-view photography method is not applicable for deformation analysis. Therefore, when evaluating these types of deformation, a combination of measurement methods must be considered to achieve higher measurement accuracy.

Figure 16: Side impact measurement differences comparison.

The aim of this study was to compare selected methods (top-view photography as basic and cheap method and 3D scanning as modern and advanced method) with respect to the achieved accuracy of deformation depth values as one of the basic parameters for the analysis of the accident. Similar methodology was used by Randles (2010) for the comparison of the photogrammetry and hands-on measurement. Different vehicles and 2 basic types of damage - front and side impact - were chosen for the analysis. Also, the different range of vehicle deformation depth were selected. Differences of the deformation depth measurement using scanning and top-view photography were illustrated by Figure 16 and Figure 17.

The highest deviations of the obtained results were related to the analysis of side impact. The usage of top-view photography has been very limited in case of side impact. While there are no significant deviations in the case of minor damage (up to 10 cm), bigger deformation depth (from 20 cm) shows significant inaccuracies when using top-view photography. It is therefore necessary to use a combination of several methods in such cases. The use of modern methods such as 3D scanning allows to achieve accurate results. The biggest disadvantage of three-dimensional methods has been the high purchase price and especially in case of photogrammetry the lack of time at the accident scene. (Massa a Barrette, 1998; Terpstra 2019).

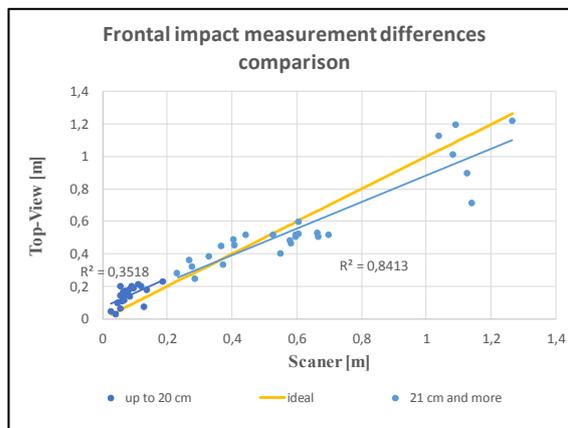
In the case of frontal impact and subsequent comparison of the measurement methods, the deviation is significantly lower compared to the side impact. With increasing depth of deformation, the deviation is higher but not as significant as in side impacts. But even here it is necessary to consider the so-called hidden deformations, which may not be obvious at first sight. These are, for example, deformations occurring at lower velocities, where elastic deformation is largely occurring plastic deformation is “hidden”. The elasticity of the material has an overall effect on the measurement of the deformation depth (regardless of the type of used

method), the measured values will be lower compared to the real vehicle damage.

Figure 17: Frontal impact measurement differences comparison.

Obtained results illustrate not significant differences between the selected methods used for the analysis of frontal impact. Inaccuracy could be caused if the vehicle deformation has been covered by some of the vehicle parts (e.g. bonnet, bumper). This is however limitation of most of the used methods. Similar results have been proved also by some of the previous studies – e.g. (Boddorff, 1990). As stated by Comeau or Boddorf (Comeau, 1996; Boddorff, 1990), more accurate results could be achieved by understanding of the methods for accident reconstruction and documentation limitation. These conclusions illustrate the importance of these type of studies.
