CASE STUDY OF SELECTED NATURE SWIMMING POOLS IN THE SOUTH MORAVIAN REGION

Poloprutská T., Nováček M., Opeeltová P.: Case study of selected nature swimming pools in the South Moravian Region. *Ekológia (Bratislava)*, Vol. 40, No. 4, p. 312–324, 2021.

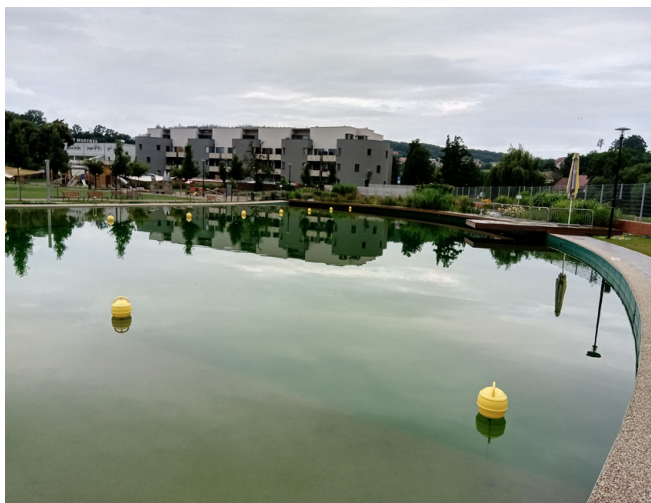
Fig. 2. Swimming section of the nature swimming pool in Oslavany. Source: author's archive.

The swimming area (Fig. 2) is divided into a deep swimming section with an area of approximately 600 m² and a depth of 2.5 m and a shallow section with a depth of up to 1.4 m and an area of approximately 600 m². The total volume of the swimming section is approximately 1.450 m³. The pool is lined with exterior swimming pool sheeting and embedded into a concrete shell, with vertical walls on one side and a gradual entrance inclined into the water on the other side.

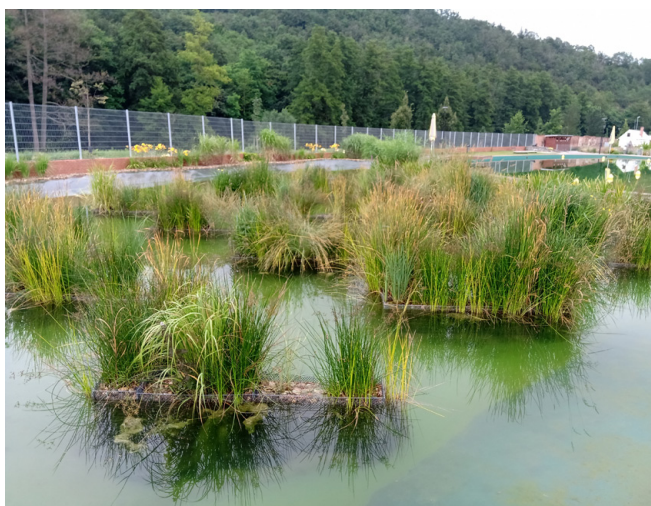
Fig. 3. Filtration walls with vegetation in the regeneration section in Oslavany. Source: author's archive.

Water is removed from the surface of the swimming section using skimmers and pumped into the pre-treatment zone. This nature swimming pool is the only one of the examined group with a pre-treatment system before the regeneration zone, which filters the water through fabric and subsequently aerates it using compressors. The pre-treated water is then pumped into the regeneration zone (Fig. 3).

The regeneration section, with an area of approximately 515 m² and a volume of 375 m³, contains a layer of gravel on the bottom and also a number of thin, separate, vertical walls made from filtration material with a cover of vegetation, which is visible in Fig. 3. These walls are located in the direction of the natural water flow and prolong the time the water stays in this section.

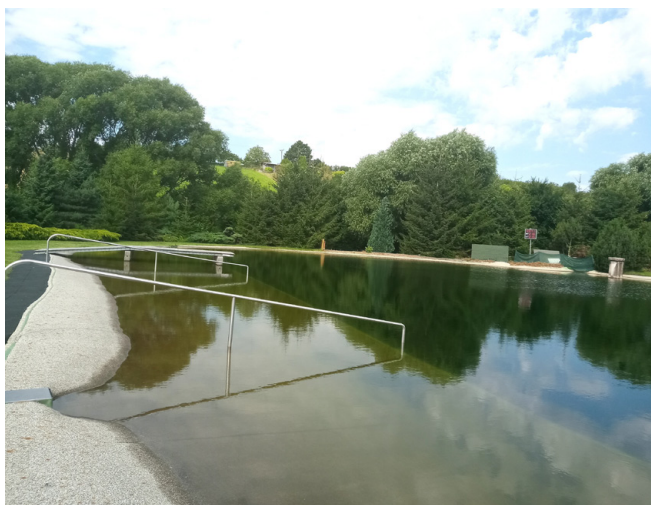
Fig. 4. Swimming section of the nature swimming pool in Kovalovce. Source: author's archive.

The swimming area (Fig. 4) consists of a small paddling pool and a large swimming pool. The paddling pool is separated from the main pool and was not the subject of this research. The main swimming pool, with an area of approximately 1000 m² and a vol-

ume of 3700 m³, has an elliptical shape with a gradual incline into the water up to a depth of 1.0 m. The entrance incline crosses into a deep pool with vertical walls, which reaches a depth of 4.2 m. This is, therefore, the deepest of the examined nature swimming pools, with the greatest volume. The surface of the pool consists of a pebble in cement screed on the shallow, inclined banks and concrete blocks lining the deep section, without a finishing layer.

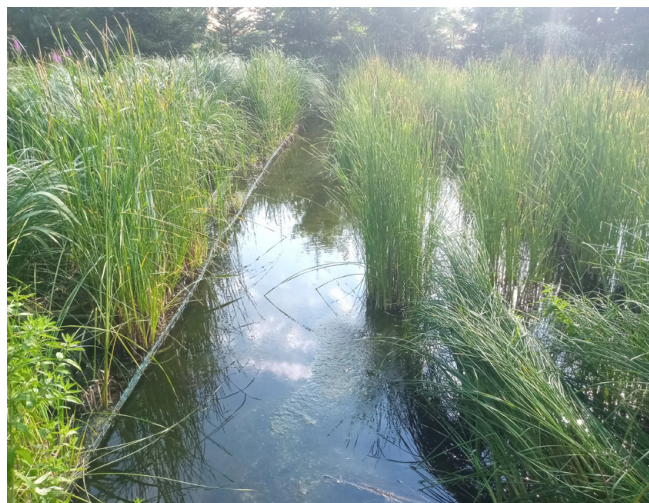
Fig. 5. System of dams in the regeneration section in Kovalovce. Source: author's archive.

The regeneration zone is of rectangular shape, with an area of approximately 500 m² and a volume of 250 m³ (the volume is determined on the basis of the depth of the mud bottom of the regeneration section). The entire area is dammed by a transverse system of dams (Fig. 5), which are planted extensively with vegetation. This nature swimming pool has the greatest proportion of vegetation per area of regeneration section. The density of the vegetation within the area of the regeneration section also assures significant slowing of the water flow. The water is filtered through a fine fabric at the outlet from the regeneration section.

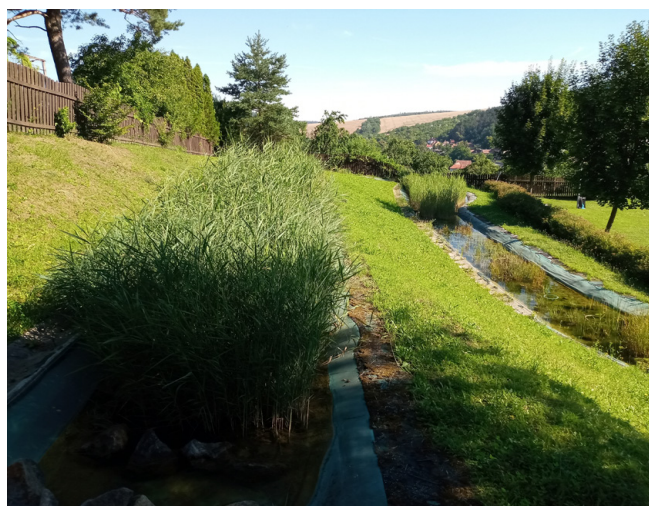
Fig. 6. Linear-shaped regeneration section in Bohuslavice u Kyjova. Source: author's archive.

The regeneration section is usually in the form of a linear element (trough), which overcomes a height difference of over 2 m, over a length of approximately 80 m, which is visible in Fig. 6. This height difference is overcome using a system of small dams (see Fig. 7) over which the water overflows. This is a so-

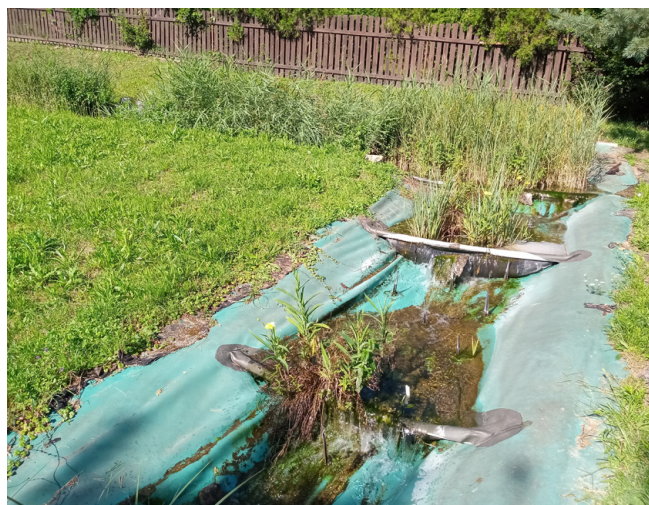
Fig. 7. Cascade in the regeneration section in Bohuslavice u Kyjova. Source: author's archive.

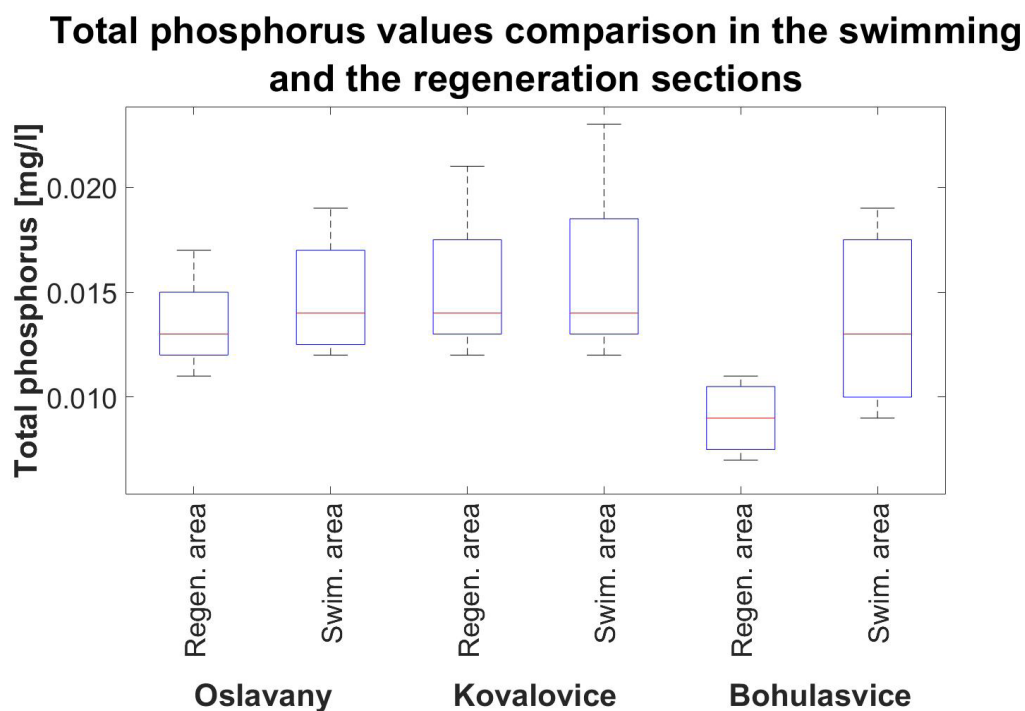
Fig. 11. Comparison of total phosphorus values in the regeneration and swimming sections. Source: author's archive.

The examined nature swimming pools registered total phosphorus values for mesotrophic environments (apart from Bohuslavice u Kyjova, where this concerns limit values), which are in conflict with the standards. However, the values for an oligotrophic environment were not exceeded significantly. Compared to other experimental measurements (Baxa et al., 2019), the values from this research are more consistent.

It can be assumed, on the basis of the difference in P-PO_4 and total phosphorus values in samples, that all the nature swimming pools are capable of effectively eliminating free phosphorus from water. Total phosphorus is eliminated from water, thanks to the regeneration zone, which is evidenced by the difference in values of total phosphorus in the swimming section and regeneration section. Water flowing into the regeneration zone (water from the swimming section) always had a higher concentration of total phosphorus than water flowing from the regeneration zone.

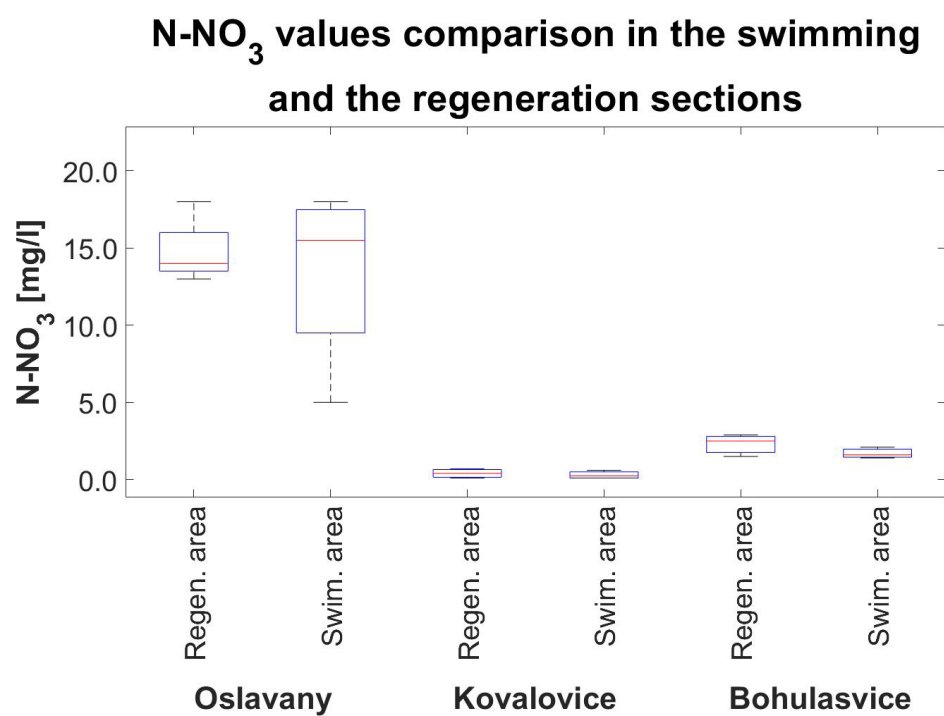
Fig. 12. Comparison of N-NO₃ values in the regeneration and swimming sections. Source: author's archive.

The results indicate that the highest value of N-NO₃ is in Oslavany, which may be caused by intensive aeration or the generally intensive pre-treatment with a number of technologies (Pollice et al., 2002). This is the nature swimming pool with the most extensive technological system and simultaneously the least autonomy. During the last visit, the pump was switched off over-

N-NO_3 values in the nature swimming pool in Bohuslavice were satisfactory. The higher N-NO_3 value compared to Kovalovice may be caused by aeration of water in the regeneration zone, thanks to the system of cascades and overflows. The quality of water did not seem too good visually because the small area of the regeneration zone and the high flow-through rate of water through the zone cause algae to be flushed into the swimming zone. The small area, with a relatively shallow depth, is therefore prone to overheating (Pavlis, 2017). The period for which water remains in the regeneration section may not be sufficient. The management of the swimming pool handles the unsatisfactory quality of water by draining water and adding fresh water from the water mains. The swimming pool is, therefore, colder, with a lower nutrient content.

The nature swimming pool in Kovalovice had the lowest N-NO_3 values, which may be due to lack of aeration. On the other hand, it contained a significant quantity of total phosphorus, but minimum P-PO_4 in water. However, this is the nature swimming pool with the most autonomy and is intervention free. Its great depth and large volume of water may contribute to the overall stability of the environment.

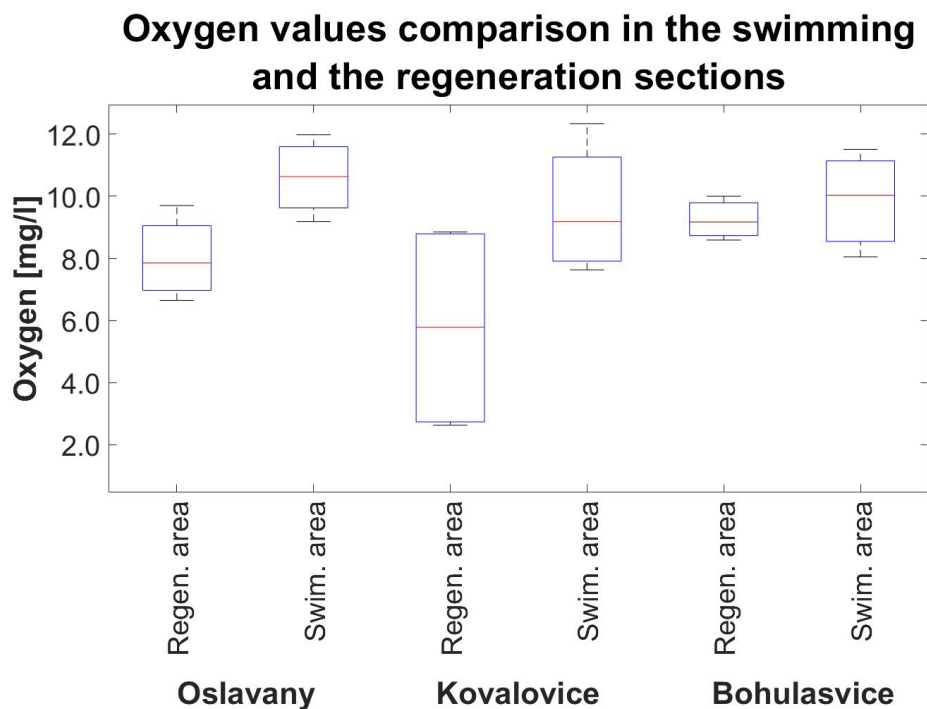
Fig. 13. Comparison of dissolved oxygen values in the regeneration and swimming sections. Source: author's archive.

The values of dissolved oxygen, which is an indicator of the purity of water in the nature swimming pool, are significant, particularly for the swimming section of the swimming pool in Oslavany (mechanical aeration) and in Bohuslavice, where the regeneration system consists of a system of cascades and overflows (Kircher, Thon, 2019).

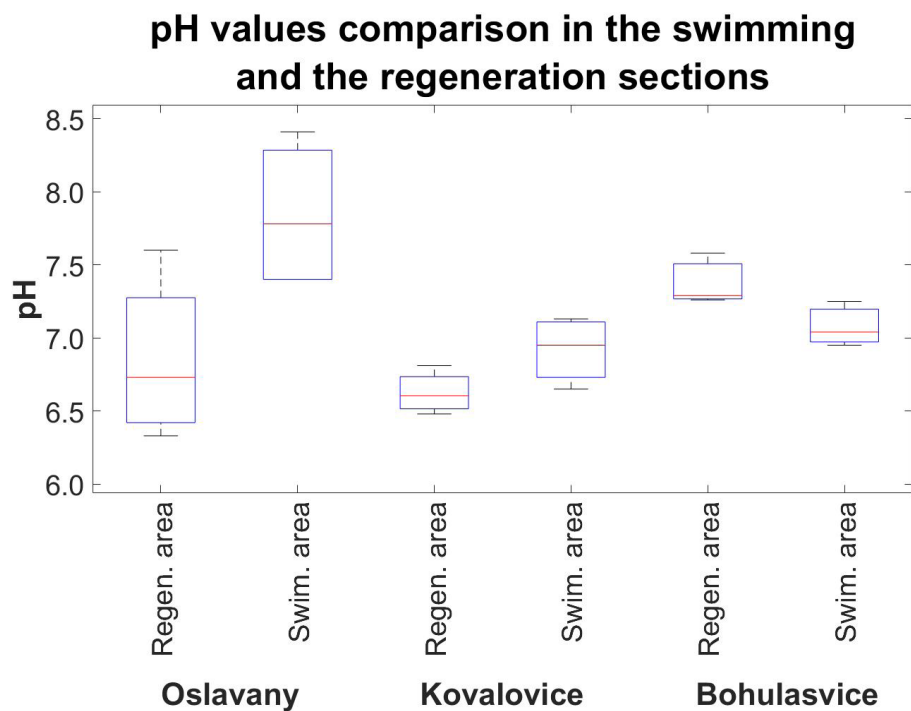
Fig. 14. Comparison of pH values in the regeneration and swimming sections. Source: author's archive.

The best (highest) pH value was obtained in Oslavany. On the contrary, the worst (lowest) pH value was obtained in the nature swimming pool in Kovalovice. The ideal pH for nature swimming pools is 8.4 due to formation of a biofilm on the walls of the pool (Farb, 2020).

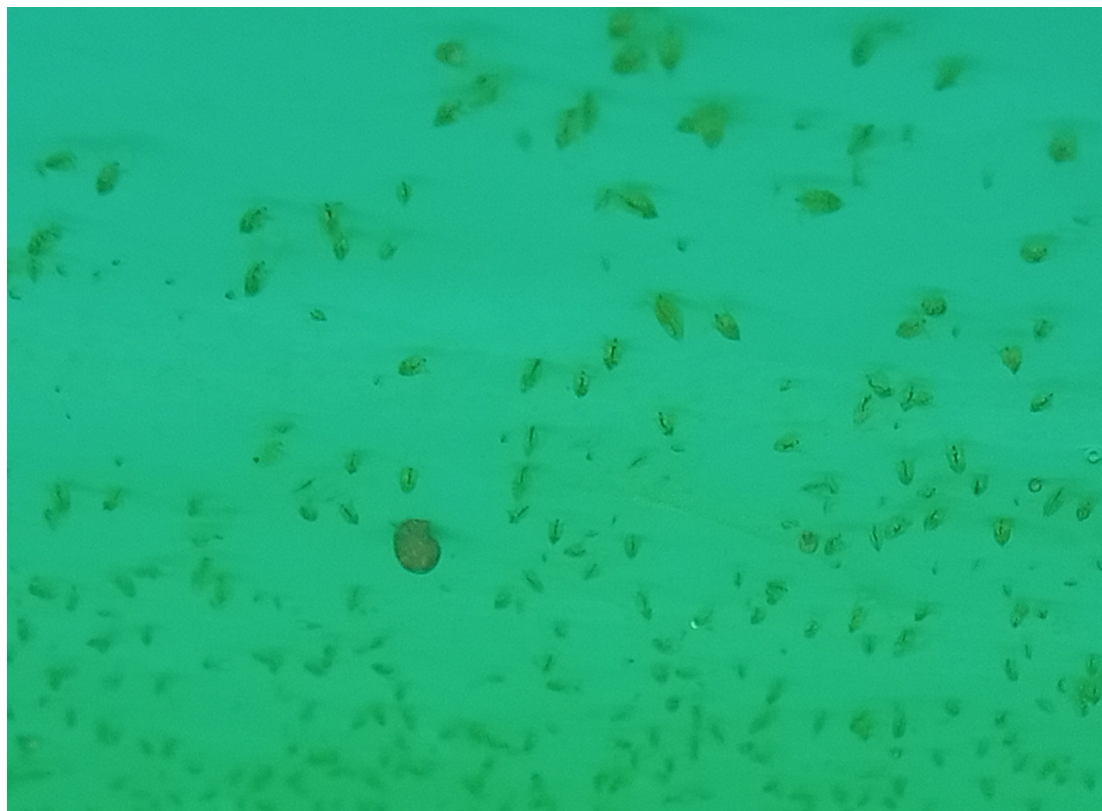
Fig. 16. *Daphnia* in the swimming section in Oslavany. Source: author's archive.

During the first visit, it was evident that this was a functioning ecosystem by the visibly good transparency of water and the presence of *Daphnia* in the swimming section, which have a beneficial effect on water purity (Shiny et al., 2005) (Fig. 16). However, as the season progressed, the presence of visible *Daphnia* declined. Allochthonous pollution from bathers or from mowed grass, observed in Fig. 17, was the cause of the declining quality of water. If nitrogenous fertilisers are applied to the adjoining extensive grassy area, this may result in occurrence of a large quantity of nitrogen in the form of allochthonous pollution, which was confirmed by the analyses.

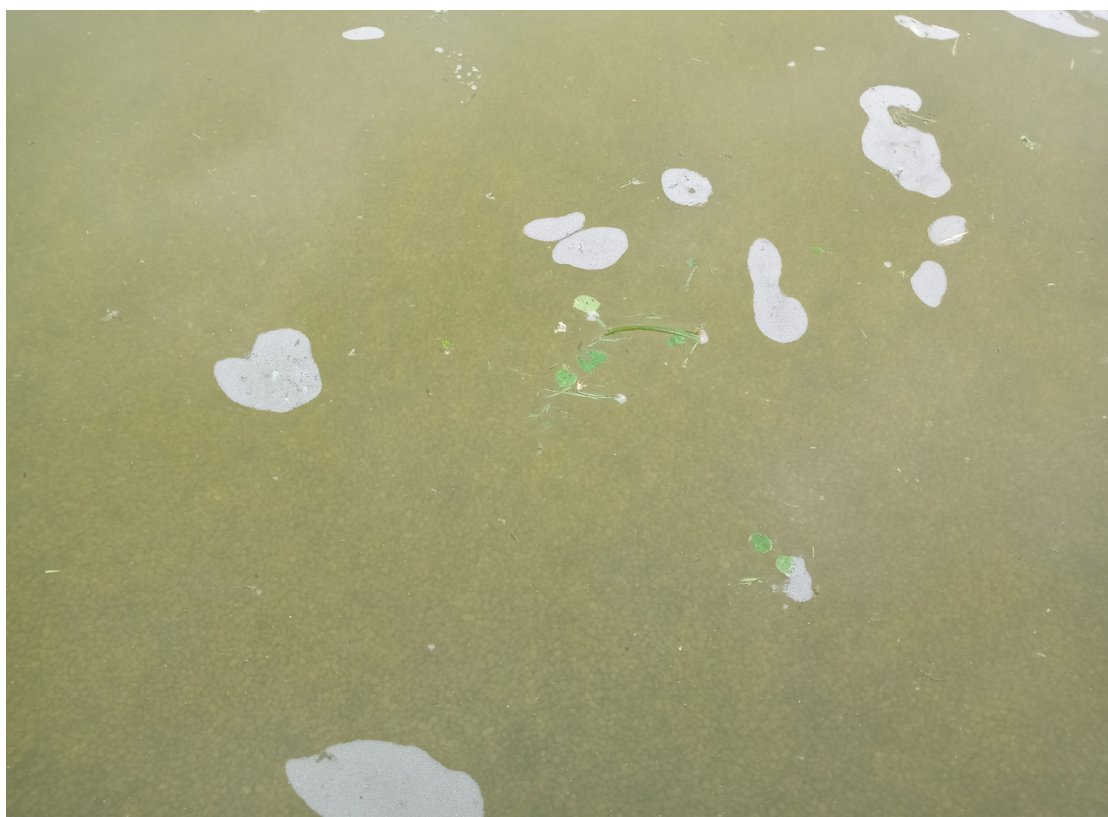
Fig. 17. Mowed grass on the surface of the nature swimming pool in Oslavany. Source: author's archive.

night for the first time in the season, and this had a substantial visual impact on the quality of water. The declining quality can chiefly be attributed to the high ratio of swimming area to the volume or small depth of the pool. This makes the system less stable and leads to an imbalance more quickly (Pavlis, 2017). The N-NO_3 value in the swimming section during the last measurement, which was significantly lower than the previous values, is also an evidence of this fact. During aeration, the N-NO_3 values were also high in comparison with other experimental measurements (Baxa et al., 2019).
