Analysis of Daylight Control in a Chateau Interior

Abstract: Assessment of daylighting in the residential hall of a historical chateau is presented. The evaluation is based on both the daylight measurement and simulations. Illuminance levels in the interior were controlled in accordance with requirements for light exposition of light sensitive materials. Valuable paintings and claddings as well as wallpapers and furniture upholstery in the hall are extremely light sensitive and they need to be protected from light damage. The daylight measurements and simulations give an overview of daylight conditions in the annual profile for clear sky conditions and for different levels of window shadings.

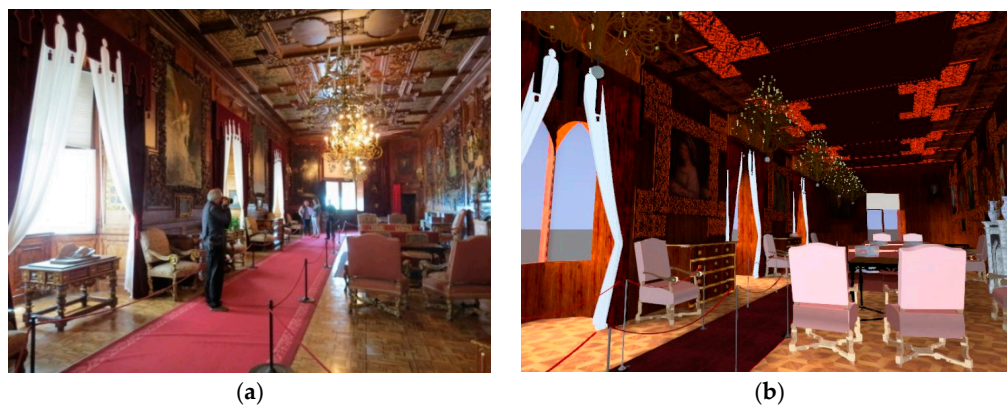
Figure 19. View to windows, (a) photograph; (b) DIALux model.

The simulations for the view to the windows shows that the high rise of illuminance is between 10:00 and noon. The floor area is highly affected. Ceiling soffit has increased illuminance level from March to June and between September to December. The view to the windows was also simulated for shading activation at 25%, 50%, and 75% (Figure 22).

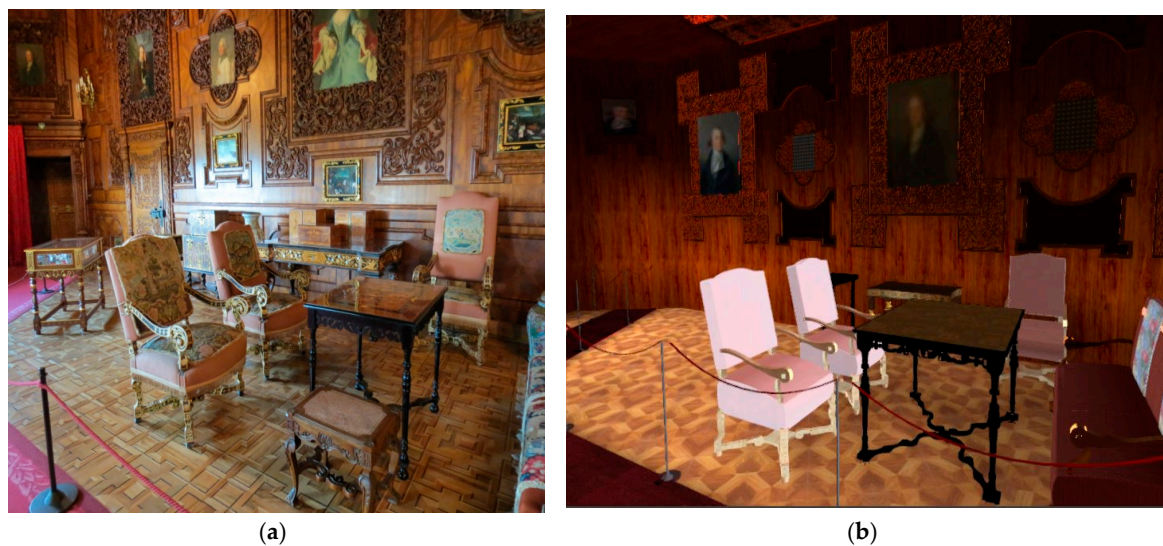
Figure 23. Furniture, (a) photograph; (b) DIALux model.

The area of the furniture location in the middle of the salon is all the time exposed to high illuminance level, as it is seen from the simulations in Figures 24 and 25. This is a problem influencing the quality of textiles of armchairs and sofa upholstery in the salon. The furniture area was also simulated for variations with the window shading activation for 25%, 50%, and 75% shown in Figure 26.

The salon interior and furnishing needs to be protected from the high light intensity and solar gain. Excessive direct solar radiation causes glare discomfort and overheating of indoor climate [36]. It is recommended that strict shading control is maintained. As any automatic shading systems are not permitted in such a historically valuable place, the full-time activation of the rollers and shading blinds is recommended in mornings for the whole year, especially during summer. Full-time activation of the shading blinds, especially in the morning because of the south-east orientation of the Morning Salon is also recommended. Especially at sun rise and then until about 10:00 or 11:00 the Morning Salon should be protected by blinds at 100 percent full blind shading. The Salon should be controlled by at least 75 percent shading activation at noon. In the afternoon, the shading can be reduced, but the illuminance should be controlled all the time.

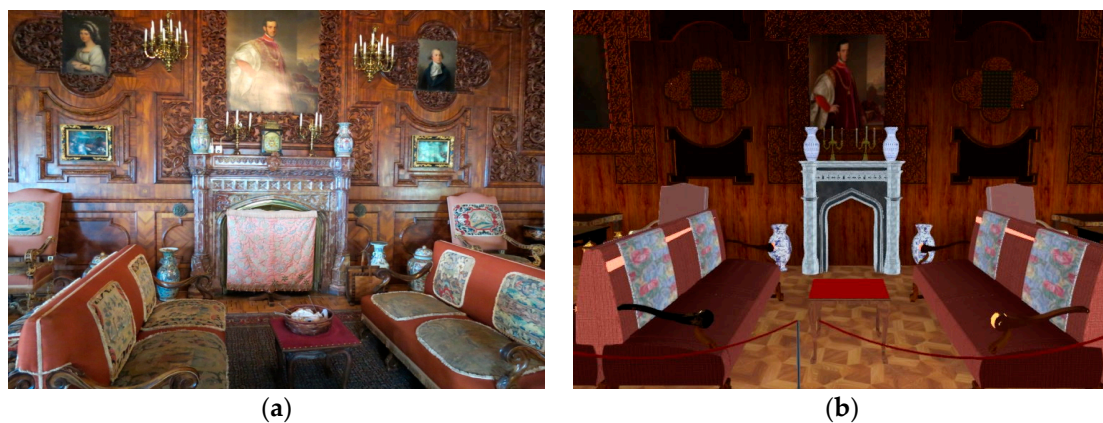
Figure 27. View to the painting of the chateau possessor, (a) photograph; (b) DIALux model.

The area of the painting is overexposed for a substantial part of the year. It represents a high potential damage of painting degradation and color bleaching. The view of the painting was simulated for shading activation at 25%, 50%, and 75%, as shown in Figure 30. The light level on the vertical plane close to the painting (Figure 31) is shown in detailed evaluation in Figures 32 and 33.

If possible, some ultraviolet filters which are known for conservation [37] are recommended. Special protective coatings could be applied to protect the paintings against ultraviolet radiation bleaching [38]. If the historical value of glass panels allows application of special shading systems, these might be completed with transparent spectrally selective glazing [39]. Special glass is used for reduction of transmission of ultraviolet and infrared ranges of solar radiation into the interior. Switchable glazing could solve demands for reduction of daylight transmission in time of intensive solar shining and transparency for diffusive skylight conditions [40]. Nevertheless, selected glazing must not influence the architectural style of the historical monument. In special cases, advanced daylight guiding and redirecting systems can also be applied [41]. All these special system applications must be consulted over with architects and historical monument preservation authorities.

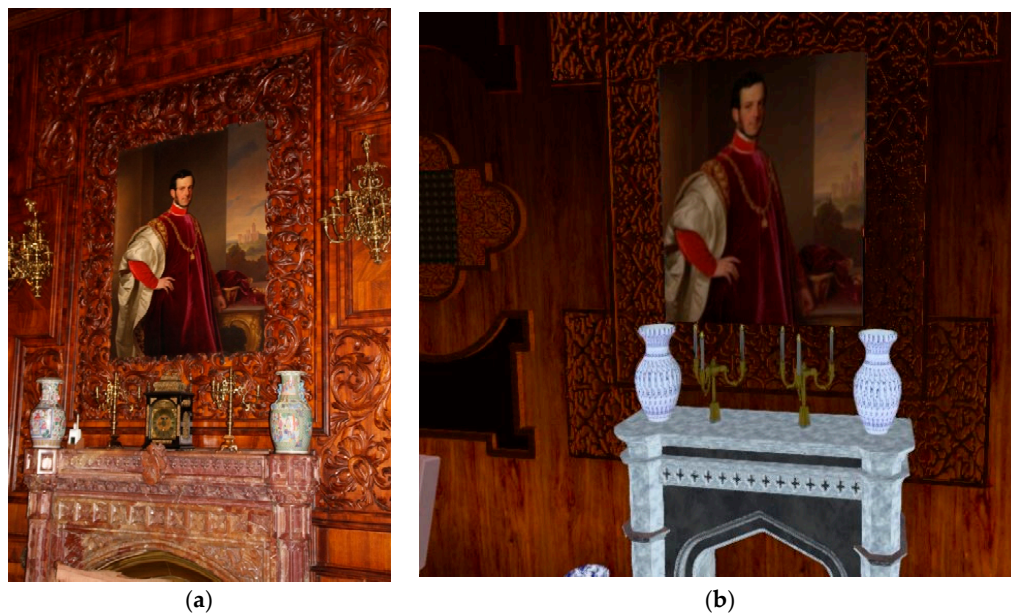
Figure 31. Painting in detail, (a) photograph; (b) DIALux model.

Figures 32 and 33 give an overview of the illuminance level of a part of the vertical plane close to the painting is over the 50-lux limit all year except in the early morning time in December. The painting light exposition was also studied for window shading activation at 25%, 50% and 75%, as shown in Figure 34.

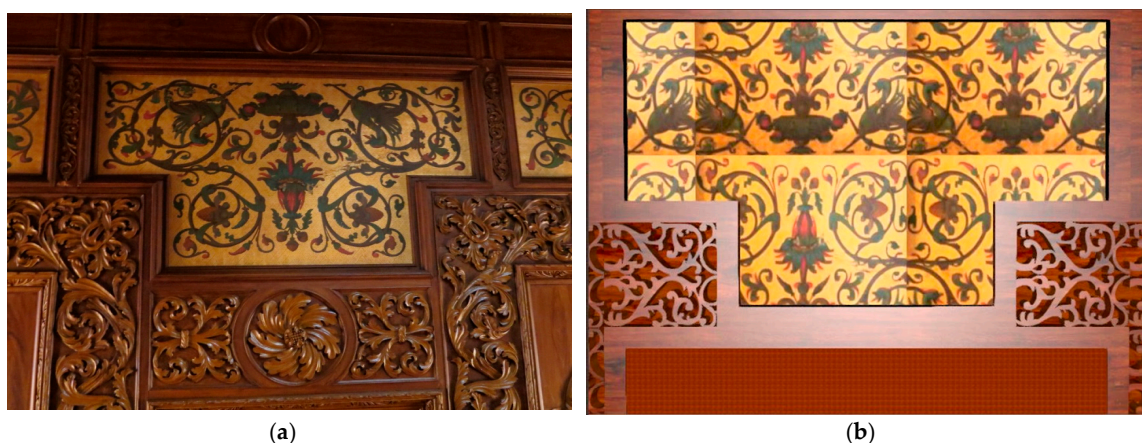
Figure 35. Detail of the ceiling wallpaper decoration, (a) photograph, (b) DIALux model.

The extremely light-sensitive material is the original wallpaper on the ceiling soffit, Figure 35. The illuminance on the horizontal plane close to the soffit was simulated for the specified daylight conditions.

The simulation outputs in Figures 36 and 37 show that the wallpapers are exposed to higher illuminance levels in the period of year between March and June at noon. The rest of the year the wallpaper decoration is not damaged because illuminance level close to the ceiling wallpaper surface is not for more than 50 lux.
