Influence of plasma electrolytic oxidation on fatigue performance of AZ61 magnesium alloy [☆]

The effect of plasma electrolytic oxidation (PEO) on the fatigue of AZ61 magnesium alloy has been investigated under high cycle conditions in air and 3.5% NaCl solution. PEO employed an alkaline pyrophosphate–silicate–fluoride electrolyte, with an offset square waveform, a frequency of 50 Hz, and current density of 130 mA cm⁻². The PEO treatment led to reductions in the fatigue limit by 38% in air and by 56% in 3.5% NaCl solution. The reduction of the fatigue limit is attributed to cracking of the coating, roughness of the alloy/coating interface, corrosion and influences of Al–Mn particles.

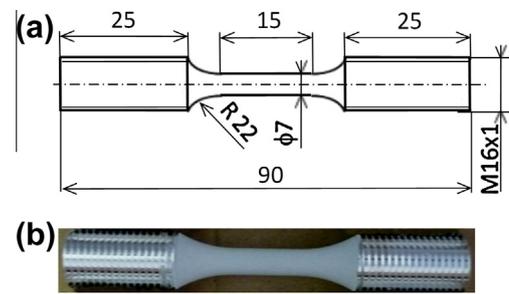
Fig. 1. (a) Schematic diagram of the fatigue specimen (dimensions in mm). (b) Photograph of a specimen after PEO for 300 s at 130 mA cm^{-2} (rms) in the silicate–pyrophosphate–fluoride electrolyte.

PEO was carried out in 1 dm^{-3} of stirred electrolyte in a double-walled glass cell, with water cooling that maintained the electrolyte temperature in the range 293–303 K. The counter electrode was a cylinder of type 304 stainless steel, with a length of 150 mm and a diameter of 90 mm. The specimens were placed at the centre of the counter electrode. The coatings were formed at a constant root mean square (rms) current density of 130 mA cm^{-2} and a frequency 50 Hz, using a square waveform with a positive to negative current ratio of -1.2 . The electrolyte, which contained 10 g dm^{-3} sodium pyrophosphate ($\text{Na}_4\text{P}_2\text{O}_7 \cdot 10\text{H}_2\text{O}$), 11 g dm^{-3} sodium silicate solution (specific gravity 1.5), 2.5 g dm^{-3} potassium hydroxide (KOH) and 8 g dm^{-3} potassium fluoride (KF), was prepared using deionized water and analytical grade chemicals. The duration of the PEO treatment was 300 s. Following PEO, the specimens were rinsed with deionized water and dried in warm air. Fig. 1(b) shows the appearance of a fatigue specimen after PEO, with an off-white coating of uniform appearance on the gauge length.

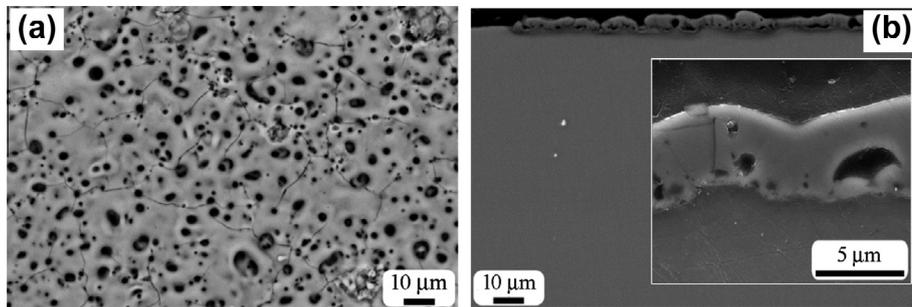
Fig. 2. Scanning electron micrographs (backscattered electrons) of a PEO coating formed on AZ61 magnesium alloy for 300 s at 130 mA cm^{-2} (rms) in the silicate–pyrophosphate–fluoride electrolyte; (a) surface and (b) cross-section.

The surface of the coating formed following PEO treatment of a flat specimen for 300 s at 130 mA cm^{-2} is shown in the scanning electron micrograph of Fig. 2(a), which reveals a relatively uniform distribution of pores of size up to $\sim 5 \mu\text{m}$ and a network of fine cracks. Fig. 2(b) shows a cross-section of the specimen. The thickness of the PEO coating is $5.4 \pm 0.7 \mu\text{m}$. The alloy surface that was protected by lacquer during PEO can be seen at the left-hand side

of the micrograph. The outer half of the coating thickness lies above the original alloy surface. Thus, the growth of the coating has oxidized the alloy to a depth of $\sim 2.5 \mu\text{m}$. The inset image of Fig. 2(b) shows an enlargement of the coating, revealing a barrier layer next to the alloy, of roughly $1 \mu\text{m}$ thickness, an outer coating layer and an intermediate porous region of $\sim 1\text{--}2 \mu\text{m}$ thickness. From previous studies [28], EDX elemental mapping revealed a relatively uniform distribution of magnesium, fluorine, oxygen, phosphorus and silicon species throughout the coating thickness, with XRD indicating the presence of $\text{Mg}_3(\text{PO}_4)_2$ and possibly MgO . EDX mapping, shown in Fig. 3, discloses that Al–Mn second phase

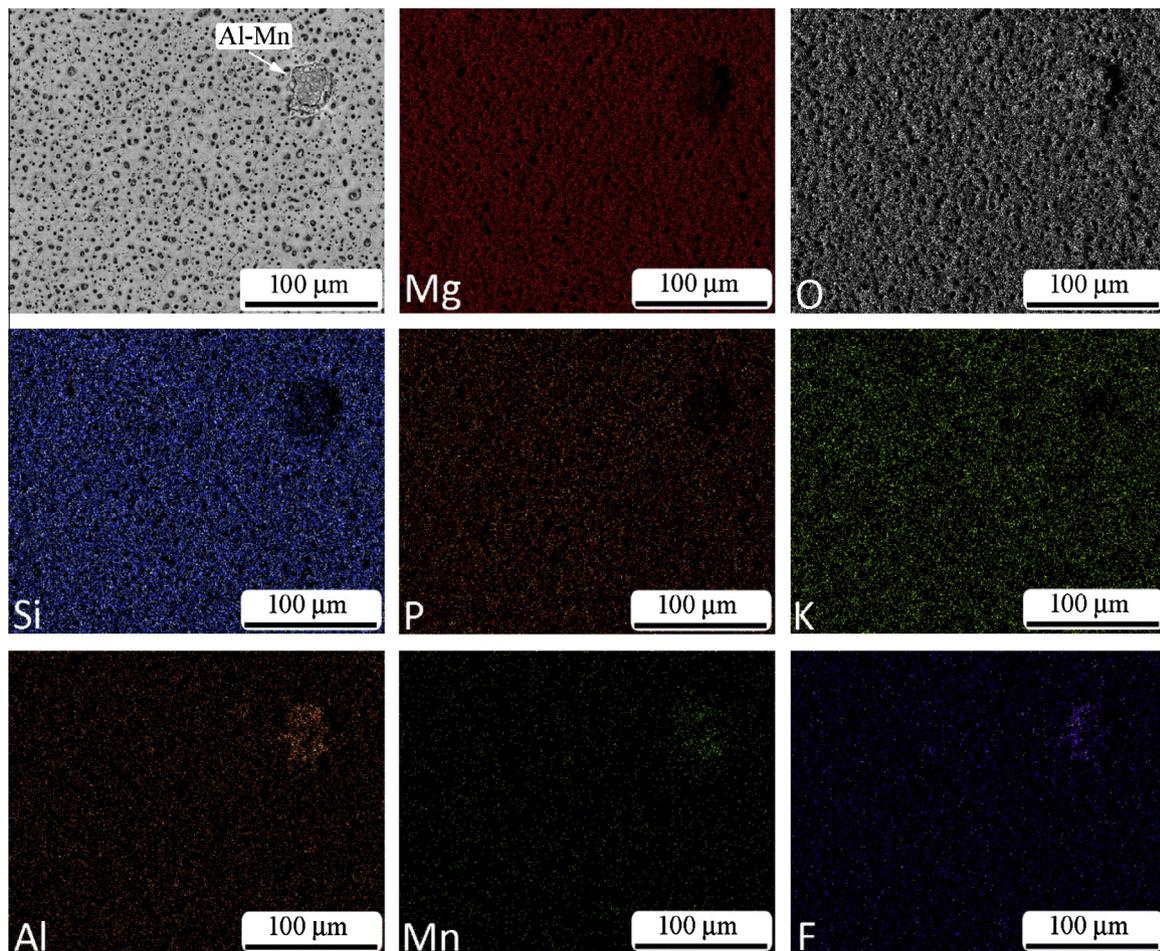
Fig. 3. EDX elemental mapping of the surface of AZ61 magnesium alloy with a PEO coating formed for 300 s at 130 mA cm^{-2} (rms) in the silicate–pyrophosphate–fluoride electrolyte.

particles in the alloy modified the local composition and morphology of the coating, with the concentration of fluorine increased and that of magnesium, silicon, phosphorus and potassium decreased near the particles.

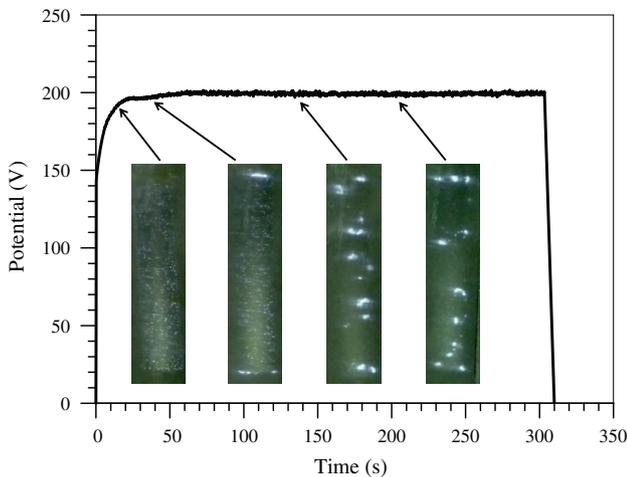
Fig. 4. Voltage–time response and appearance of sparks during PEO of a cylindrical specimen of AZ61 magnesium alloy for 300 s at 130 mA cm^{-2} (rms) in the silicate–pyrophosphate–fluoride electrolyte.

Fig. 4 shows the voltage–time response and the appearance of a cylindrical specimen during PEO. The voltage rose to $\sim 190 \text{ V}$ in 25 s, when small, white discharges appeared. It then increased slowly to $\sim 200 \text{ V}$ after 60 s, with large, white discharges becoming evident, first at the specimen edges and then elsewhere. Scanning electron micrographs of cross-sections of the cylindrical specimen at distances of 10, 25 and 40 mm from the bottom end are shown in Fig. 5. There were no significant differences in the coatings at the three locations, which were of thicknesses 5.2 ± 0.7 , 5.8 ± 0.9 and $6.4 \pm 0.8 \mu\text{m}$ at the respective positions. The thicknesses are similar to that of the flat specimen, namely $5.4 \pm 0.7 \mu\text{m}$, which produced a similar voltage–time response to that of Fig. 4.

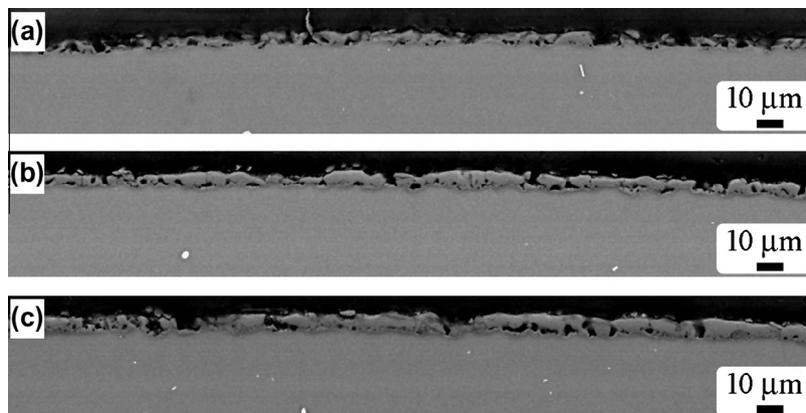
Fig. 5. Cross-sections of a cylindrical specimen of AZ61 magnesium alloy at distances of (a) 10 mm, (b) 25 mm and (c) 40 mm measured from the bottom end following PEO for 300 s at 130 mA cm^{-2} (rms) in the silicate–pyrophosphate–fluoride electrolyte.

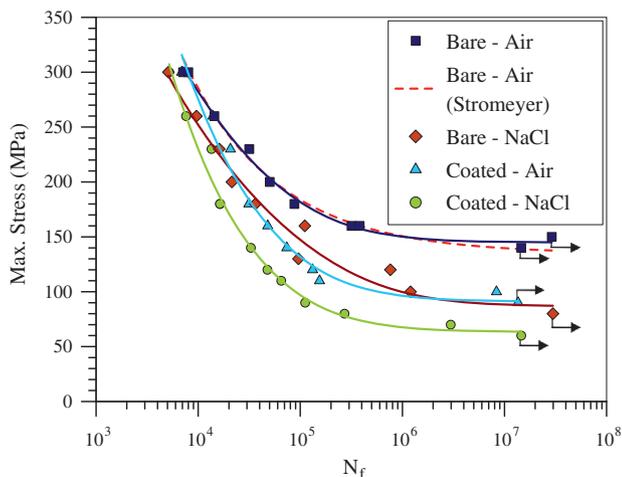
Fig. 7. S–N curves of extruded AZ61 magnesium alloy in the bare and coated conditions tested in air and 3.5% NaCl solution fitted with the Kohout and Věchet function. A fit using the Stromeyer function is also shown for the bare alloy tested in air.

The results of fatigue tests are shown in Fig. 7. The tests that reached 10^7 cycles, marked with arrows, were terminated before fracture of the specimens. The data were fitted by minimizing the sum of squares of the deviations with two regression functions [32]:

where a , b , C and σ_{∞} are parameters of the regression function, N_f is the number of cycles and σ is the maximum applied stress measured in MPa. The K and V function gave a better fit to data above 10^5 cycles, as shown for the uncoated specimen tested in air, and only this fitting is shown for other test conditions. Fig. 7 reveals the highest fatigue strength for the bare alloy tested in air and the lowest fatigue strength for the coated alloy tested in 3.5% NaCl solution. The bare alloy exposed to 3.5% NaCl and the coated alloy exposed to air exhibited similar, intermediate fatigue behaviours. The fatigue strengths predicted at 10^7 cycles are listed in Table 3 together with the parameters of the K and V function. For aluminium or magnesium alloys, which have no well-defined fatigue limit, it is common to report the fatigue strength at 10^8 cycles. However, the present fitted curves suggested that the fatigue strengths at 10^7 and 10^8 cycles differ by less than 2%. The fatigue limit of the bare alloy in air and 3.5% NaCl solution was 145.4 and 88.0 MPa respectively, indicating a reduction of 40% due to the NaCl solution. The corresponding values for the PEO-coated alloy were 91.5 and 63.8 MPa, indicating reductions of $\sim 40\%$ and 56% in comparison with the bare alloy in air. Bhuiyan et al. [25] found an 85% reduction of the fatigue limit of bare AZ61 alloy in 5% NaCl solution, which exceeds the present reduction of 40%. However, Yerokhin et al., for a different magnesium alloy and PEO process, reported reductions of up to 10% for tests in air, compared with 40% for the present coating [21].

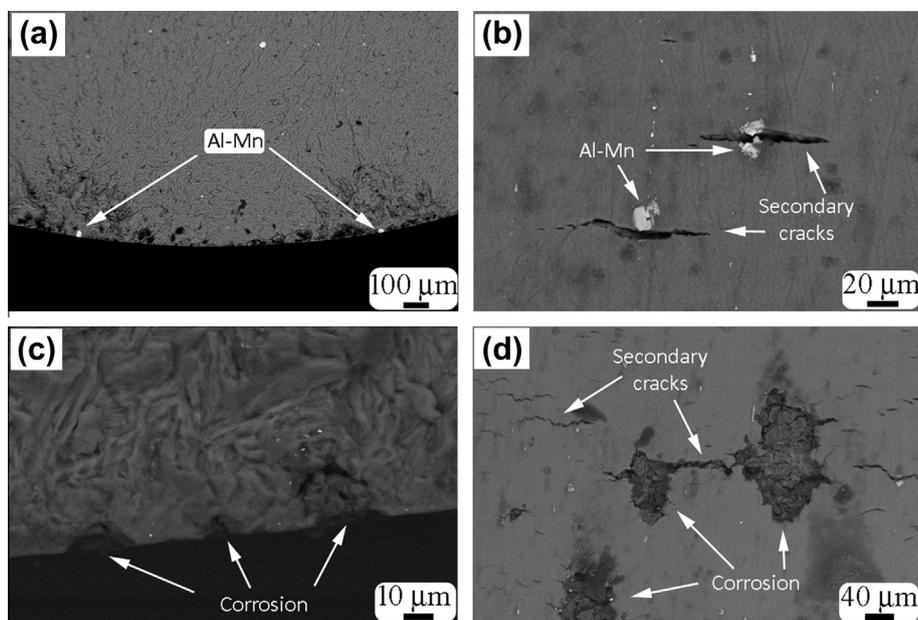
Fig. 9. Scanning electron micrographs showing fatigue crack initiation in the bare AZ61 magnesium alloy: (a) air – fracture surface, $\sigma_{\max} = 200 \text{ MPa}$, $N_f = 50,200$; (b) air – gauge length close to the fracture, $\sigma_{\max} = 300 \text{ MPa}$, $N_f = 7100$; (c) 3.5% NaCl solution – fracture surface, $\sigma_{\max} = 160 \text{ MPa}$, $N_f = 110,800$; (d) 3.5% NaCl solution – gauge length close to the fracture, $\sigma_{\max} = 120 \text{ MPa}$, $N_f = 763,000$.

Crack initiation in the bare alloy tested in air often occurred near Al–Mn particles, which were typically of size between 1 and 15 μm . The backscattered electron micrographs of Fig. 9(a and b) shows examples for a test in air under stress amplitudes of 200 and 300 MPa, in which the particles are evident on the main fatigue crack (Fig. 9(a)) and at secondary cracks on the gauge length (Fig. 9(b)). The crack initiation is probably related to the stress

In the presence of the 3.5% NaCl solution, fatigue cracks initiated at regions of localized corrosion of the alloy, as shown by the example of Fig. 9(c and d) for a test at a stress amplitude of 120 MPa. EDX analysis at these locations revealed 60 at.% O, 26 at.% Mg, 7 at.% Al, 1 at.% Si and 6 at.% Cl, with the presence of oxygen and chlorine being associated with corrosion products. Other studies [23,24,26,36] have shown also that corrosion sites are favourable for fatigue crack initiation. Localized corrosion is promoted by corrosion cells formed by second phase particles and the matrix, which cause dissolution of the matrix adjacent to the particles [8]. Further, Bhuiyan et al. showed that cyclic loading of AZ80 alloy can enhance localized corrosion compared with the non-stressed condition [37]. The number of secondary cracks on the gauge length reduced with reducing stress amplitude for tests of the bare alloy both in air and in NaCl solution. At high stress amplitude, relatively large secondary cracks occurred over most of the gauge length whereas, under a low stress, such cracks were finer and confined mainly to the vicinity of the fracture surface.

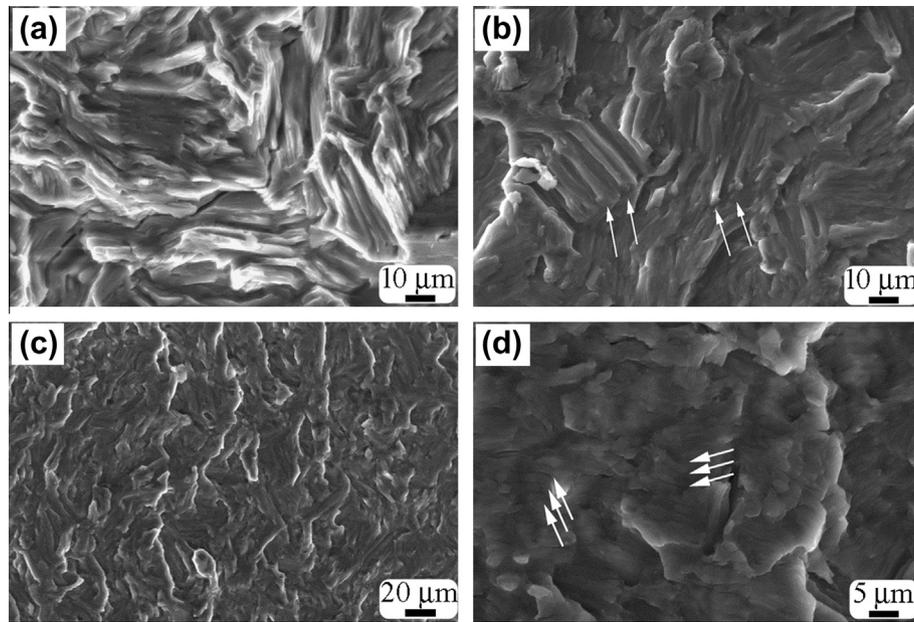
Fig. 10. Scanning electron micrographs of the fatigue crack propagation region of bare AZ61 magnesium alloy tested in (a) air, $\sigma_{\max} = 160$ MPa, $N_f = 381,800$; (b) 3.5% NaCl solution, $\sigma_{\max} = 160$ MPa, $N_f = 110,800$; (c) 3.5% NaCl solution, $\sigma_{\max} = 120$ MPa, $N_f = 763,000$; (d) PEO-coated alloy tested in 3.5% NaCl solution, $\sigma_{\max} = 230$ MPa, $N_f = 13,500$.

For tests both in air and 3.5% NaCl solution, the fatigue crack surface had a coarse lamellar appearance near the initiation site, with secondary cracks that propagated along the lamellae, as revealed in Fig. 10(a) for a test in air at a stress amplitude of 160 MPa. Paired features, indicated by arrows in Fig. 10(b), on the fracture surface generated in NaCl solution, are possibly indications of twin boundaries [36]. The fracture surface close to the final fracture was of smoother appearance (Fig. 10(c)), as observed in other work [36]. Secondary cracks and striations, the latter indicated by arrows, were observed in this area (Fig. 10(d)).

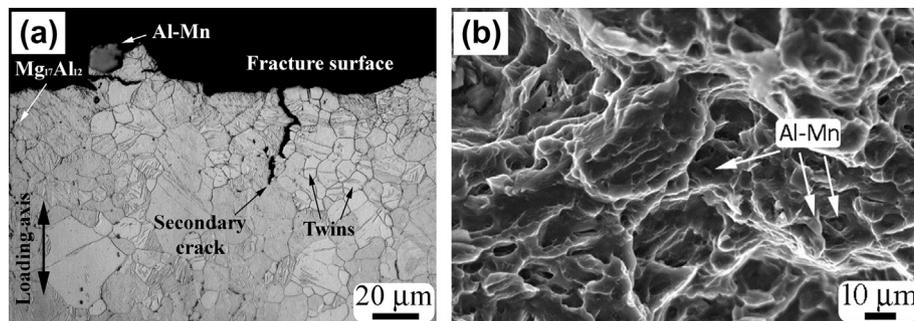
Fig. 11. (a) Optical micrograph showing twins beneath the fatigue fracture of bare AZ61 magnesium alloy tested in 3.5% NaCl solution, $\sigma_{\max} = 160$ MPa, $N_f = 110,800$. (b) Scanning electron micrograph of the final fracture in air of PEO-coated AZ61 magnesium alloy, $\sigma_{\max} = 300$ MPa, $N = 6900$.

Cross-sections of specimens were examined for tests carried out at a stress amplitude of 160 MPa in air and in 3.5% NaCl solution. Fig. 11(a) shows twins adjacent to the fatigue crack generated in 3.5% NaCl solution. The twins were particularly apparent from a depth of about 30% of the specimen diameter and were most abundant near the end of fatigue crack. Similar twinning was observed in the specimen tested in air. The occurrence of twinning in the region of fatigue crack propagation agrees with previous work [38,39]. Other studies have considered in detail the occurrence of twinning during fatigue testing. Zeng et al. found that crack initiation and propagation in extruded AM60 is related to the synergistic influences of slip bands, double twinning, intermetallic compounds and grain boundaries [35]. Shiozawa et al. observed crack growth along twin boundaries in an extruded AZ80Mg alloy, with the direction of propagation changing at grain boundaries [40]. Zhang et al. examined the formation of twins ahead of the crack tip during cyclic deformation of an extruded AZ61A alloy under different loading modes, finding the highest volume fraction of the residual twins under tension–compression, with almost every grain containing twins on reaching a strain amplitude of 1% [41].

The cross-section of Fig. 11(a) reveals that the alloy had a duplex grain size, with a non-uniform distribution of large grains, up to ~ 40 μm size, and fine grains, ~ 1 μm in size. This hindered

identification of the crack path, which appeared to be mainly transgranular, although the presence of intergranular regions could not be ruled out. The cross-section displays secondary cracks and decohesion of Al–Mn particles, as well as $Mg_{17}Al_{12}$ at grain boundaries. The final fracture surfaces in all test conditions revealed a dimpled appearance, characteristic of a ductile failure. Al–Mn particles were observed inside the dimples. A representative example of the final fracture is shown for a coated specimen tested in air at a stress amplitude of 300 MPa (Fig. 11(b)).

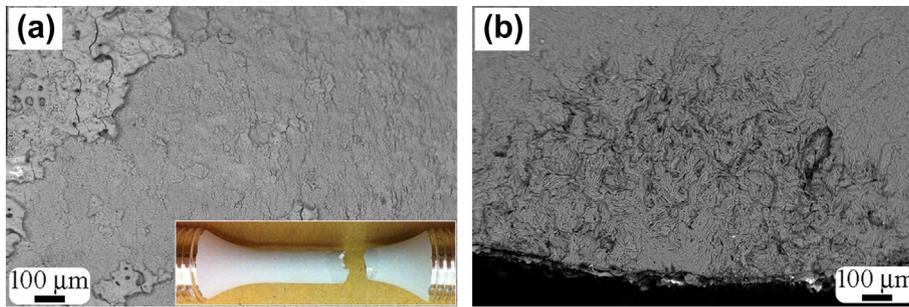
Fig. 12. (a) Scanning electron micrographs showing spalling of the outer coating layer from the gauge length of PEO-coated AZ61 magnesium alloy tested in air, $\sigma_{\max} = 180$ MPa, $N_f = 31,300$. (Inset: photograph of the specimen.) (b) Fatigue crack initiation in the PEO-coated alloy tested in air, $\sigma_{\max} = 100$ MPa, $N_f = 8,345,100$.

In the case of tests of the coated alloy, spalling of the outer layer of the coating was observed. The spalling was confined to the region of the gauge length near the main fracture under low or medium stress amplitudes. In contrast, under a high stress amplitude, spalling of the outer layer affected most of the gauge length. An example of the spalling is provided by the photograph of a specimen tested at 180 MPa shown in the inset of Fig. 12(a), which reveals a slightly darker, adherent inner layer where the outer coating layer has detached. Fig. 12(a) also shows a micrograph of the boundary of the spalled region, which discloses narrow cracks, transverse to the loading axis, in the outer coating layer and occasional fine cracks in the inner layer.

Fig. 12(b) shows a relatively rough fracture surface near a site of fatigue crack initiation, with a transition to a region of a smoother

appearance, in a coated specimen tested in air at a low stress amplitude of 100 MPa, similar to observations for the bare alloy. Fatigue cracks on a specimen tested in NaCl solution at a low stress amplitude of 70 MPa appeared to initiate at a few closely-spaced sites, where beach-mark-like features were observed, as shown in Fig. 13(a). At low stress amplitudes, secondary cracking of the alloy on the gauge length was negligible, although a network of fine cracks in the coating was evident. In contrast, secondary cracks were relatively abundant at higher stress levels. Fig. 13(b) shows a secondary crack near an Al–Mn particle on the gauge length of a coated specimen tested in NaCl solution at a relatively high stress amplitude of 300 MPa. Under low stress amplitudes, a layer of corrosion product formed beneath the coating; Fig. 14 shows a specimen tested at 60 MPa for a time of ~ 45 h, which displays a ~ 2 μm thick layer. The corrosive environment can reach the substrate through the open pores and cracks formed due to either the PEO process or the cyclic loading. Liang et al. [42] has previously suggested that the formation of magnesium hydroxide at the alloy/coating interface exerts a stress that can lift the coating from the substrate.

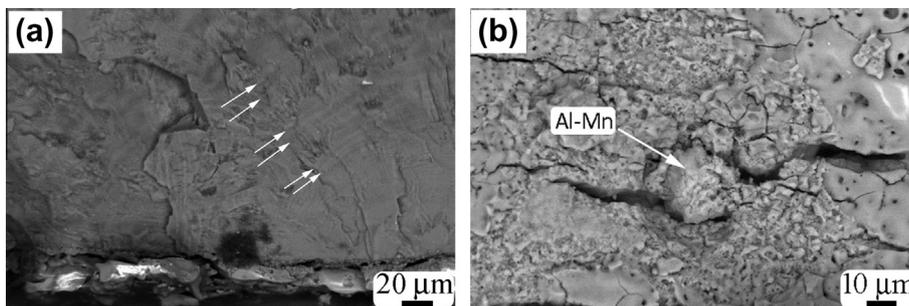
Fig. 13. Scanning electron micrographs of fatigue crack initiation in the PEO-coated AZ61 magnesium alloy tested in 3.5% NaCl solution: (a) fracture surface with beach-mark-like features (marked with arrows), $\sigma_{\max} = 70$ MPa, $N_f = 2,975,900$; (b) gauge length close to the fracture surface, $\sigma_{\max} = 300$ MPa, $N_f = 5200$.
